Storm Water and Erosion Study Implementation

Parkfairfax 547

Drainage Analysis

Project No. 21261.001.00
September 21, 2021

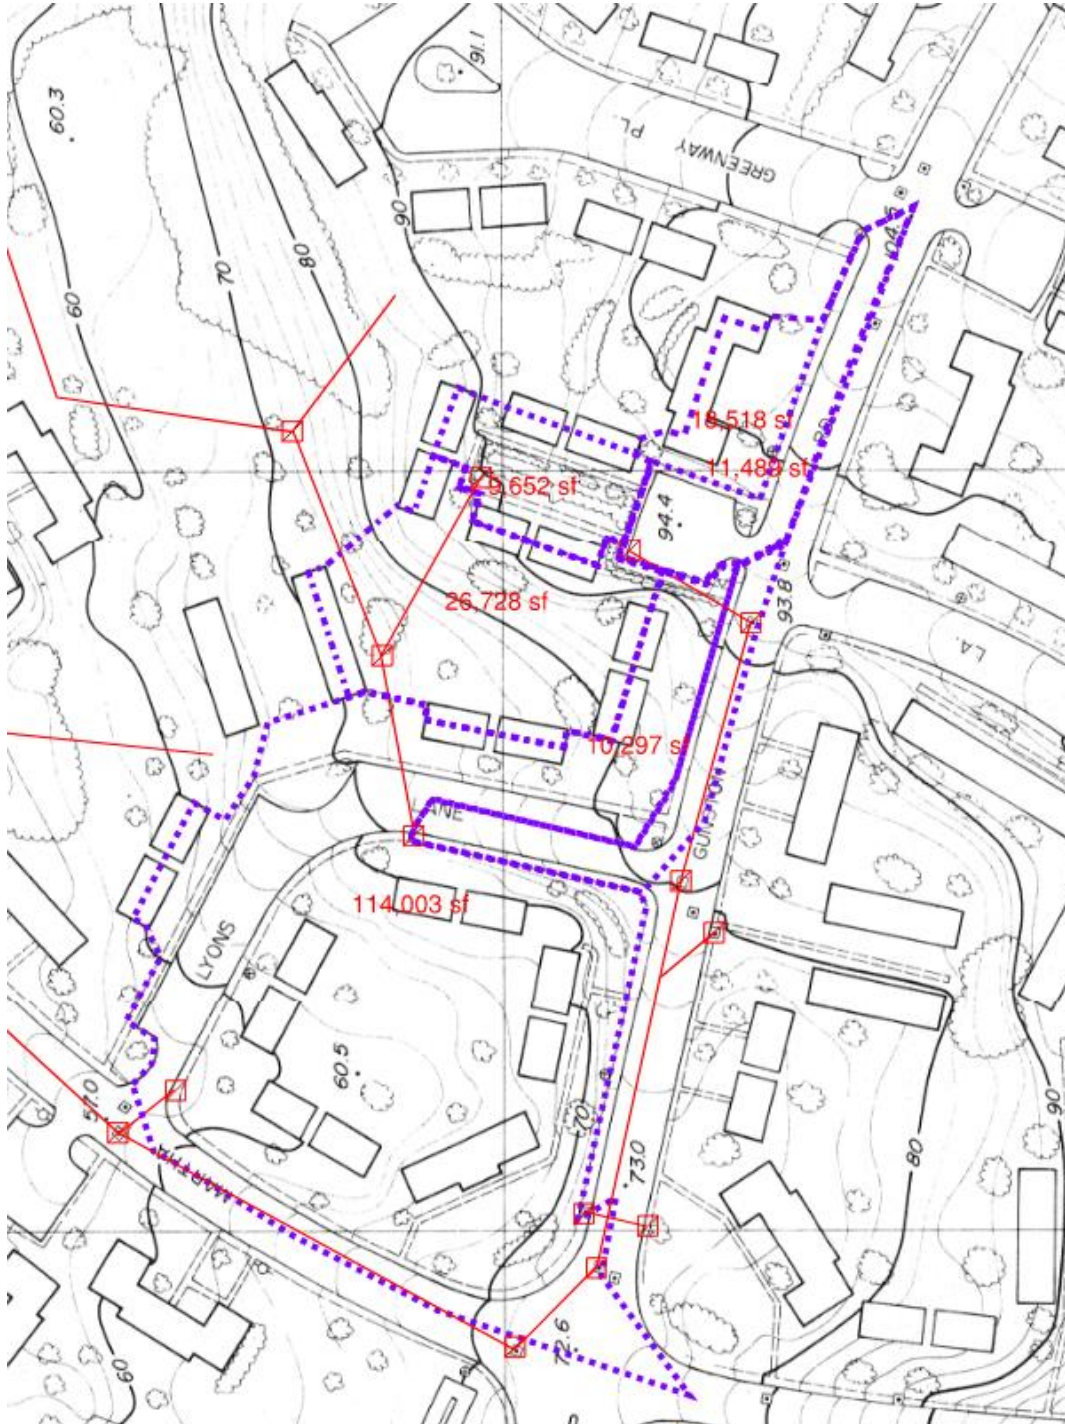
Below are this the drainage divides for the storm sewer system in the area. This information was used to analyze the inlets and storm sewer system in this area.

The drainage area to storm structure #1010 is 0.62 Ac with a weighted c value of 0.61. The drainage area to storm structure #1100 is 0.22 Ac with a weighted c value of 0.62. The drainage area to storm structure #21 is 2.62 Ac with a weighted c value of 0.66. Below are the inlet and storm sewer calculations. The storm sewer and inlet at structure #21 are inadequate.

The storm sewer structure #1010 by building 547 appears to be inadequate to handle significant storm events. Diverting drainage away from this area would improve this condition. While diverting water from storm structure #1010 improves this area, the drainage area to storm structure #21 is significant and the 10-year storm event generates a ponding depth of approximately 1.3'. The conceptual design diverts additional drainage to this area and christopher recommends meeting with City of Alexandria to discuss prior to moving forward with final design.

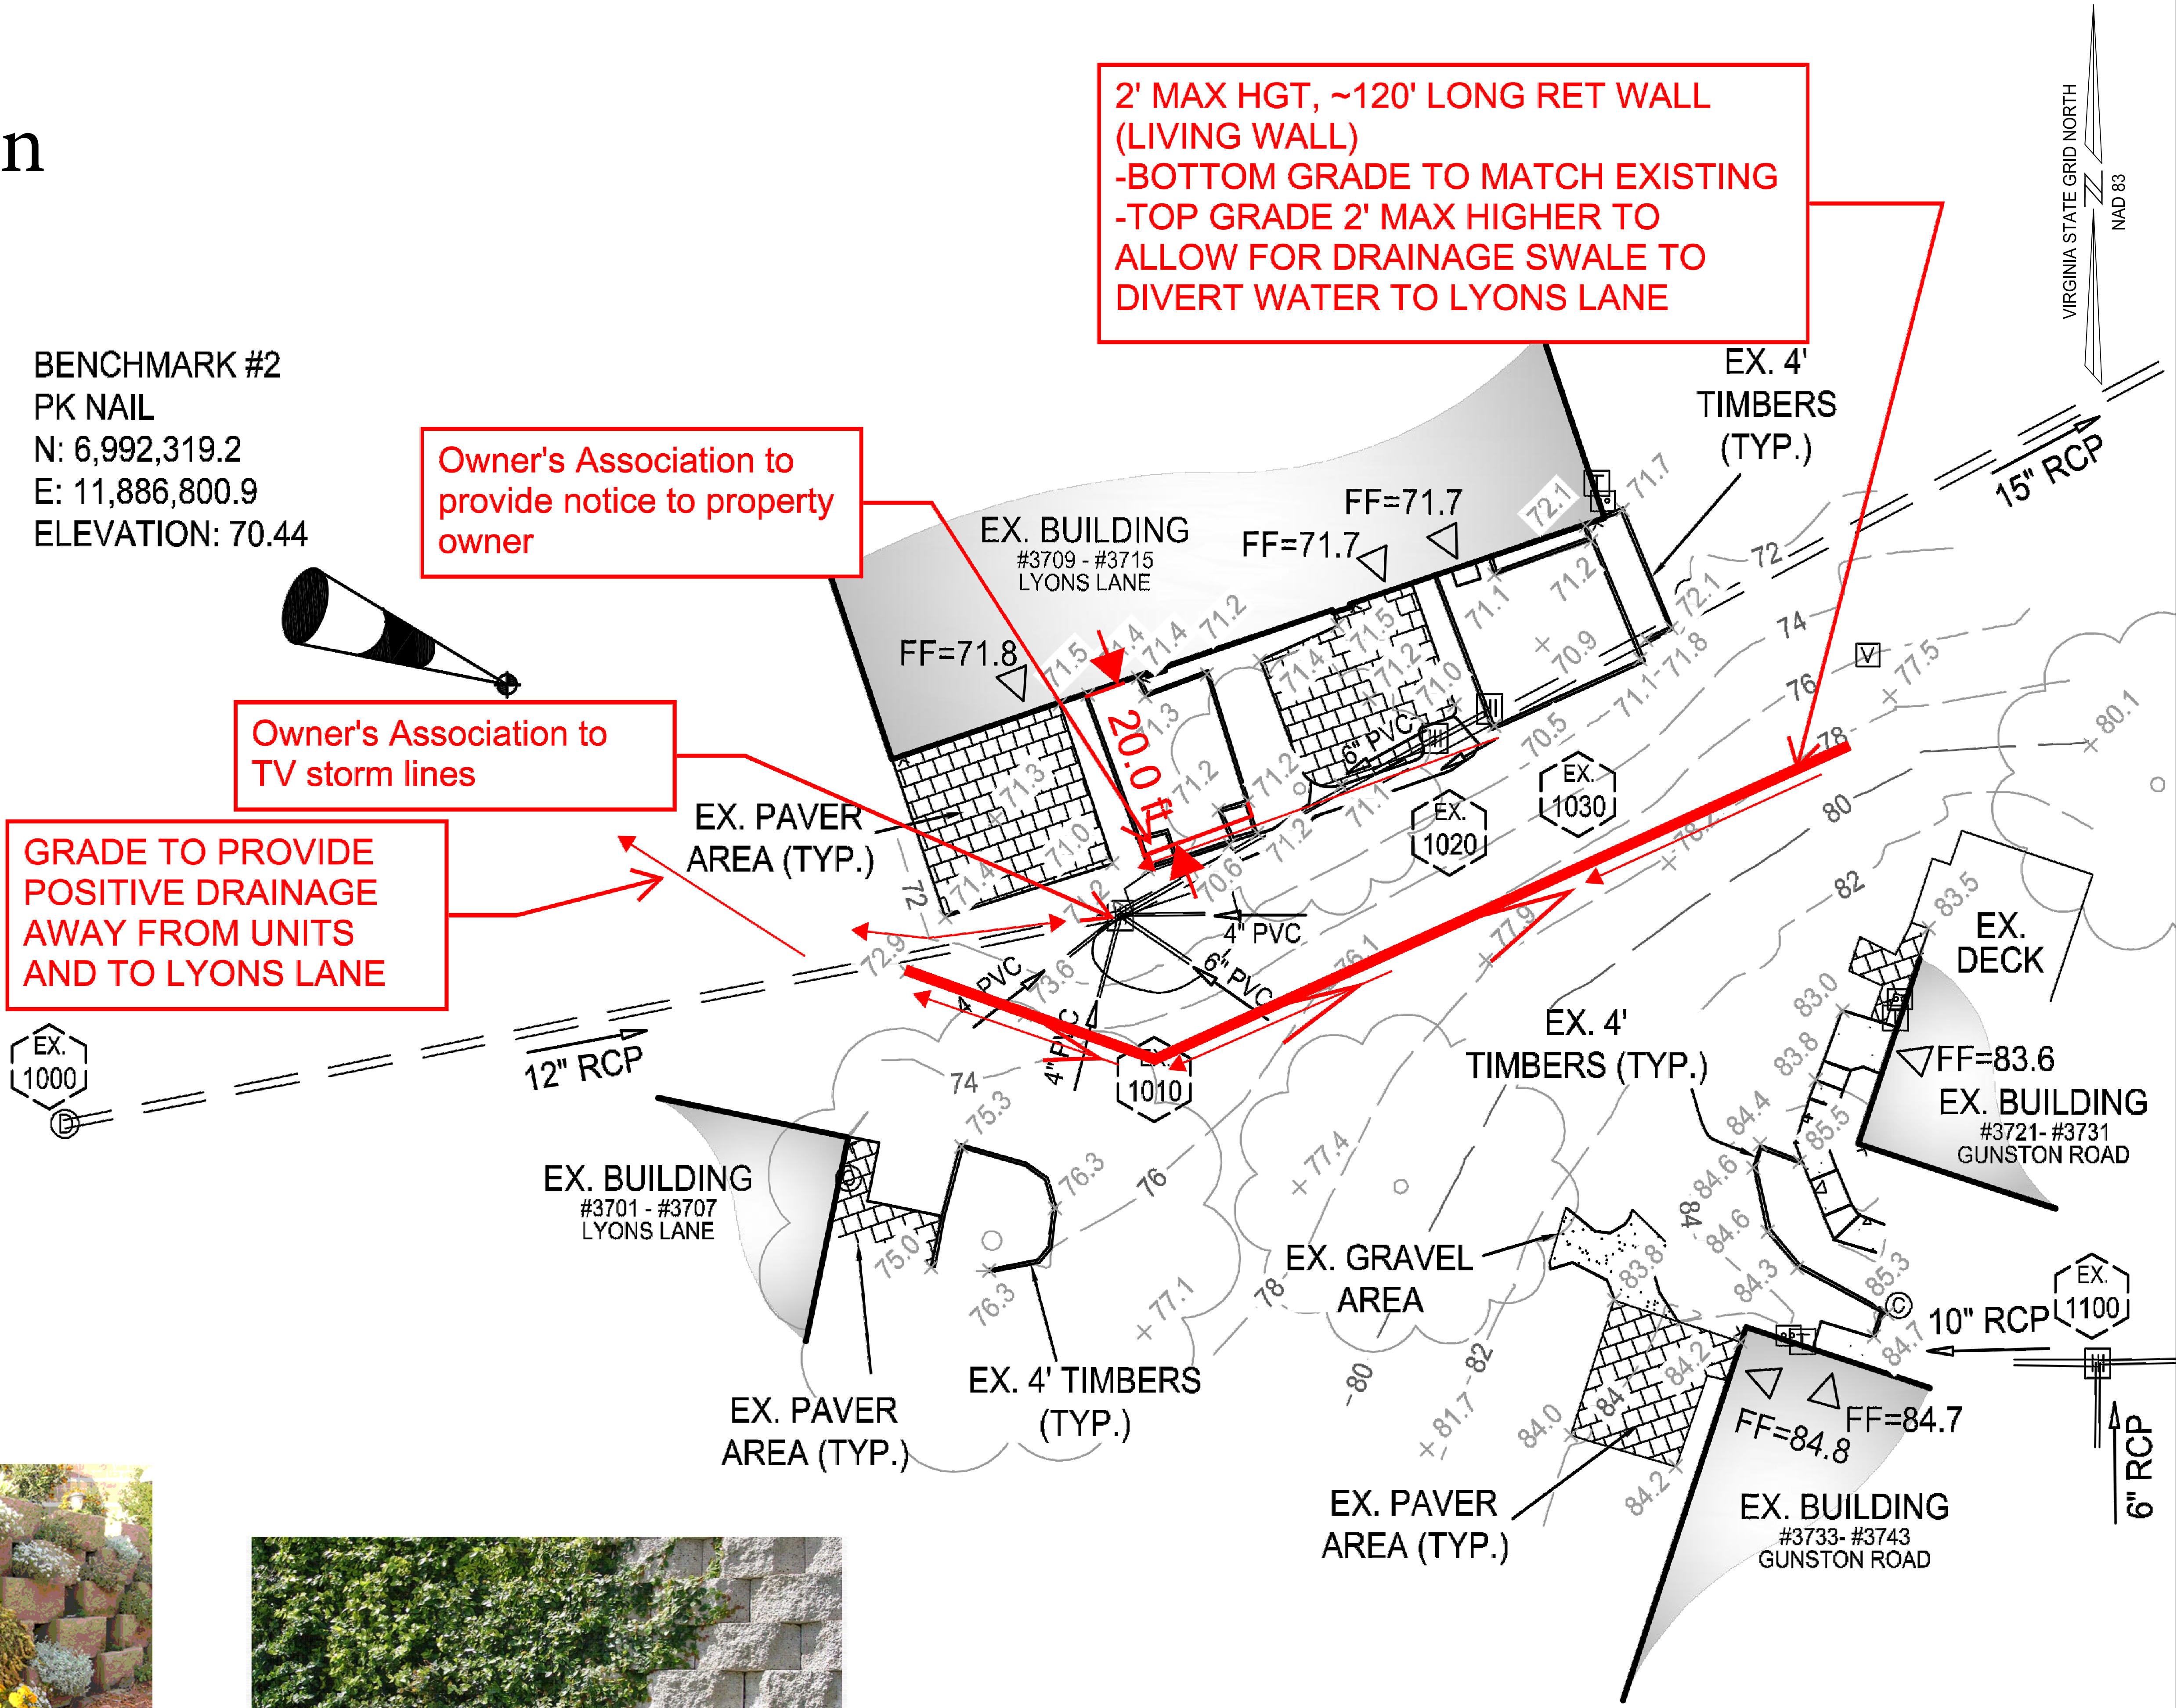
SHEET No. **C-100**

2' MAX HGT, ~120' LONG RET WALL (LIVING WALL)
-BOTTOM GRADE TO MATCH EXISTING
-TOP GRADE 2' MAX HIGHER TO ALLOW FOR DRAINAGE SWALE TO DIVERT WATER TO LYONS LANE

GRADE TO PROVIDE POSITIVE DRAINAGE AWAY FROM UNITS AND TO LYONS LANE

Owner's Association to provide notice to property owner

Owner's Association to TV storm lines

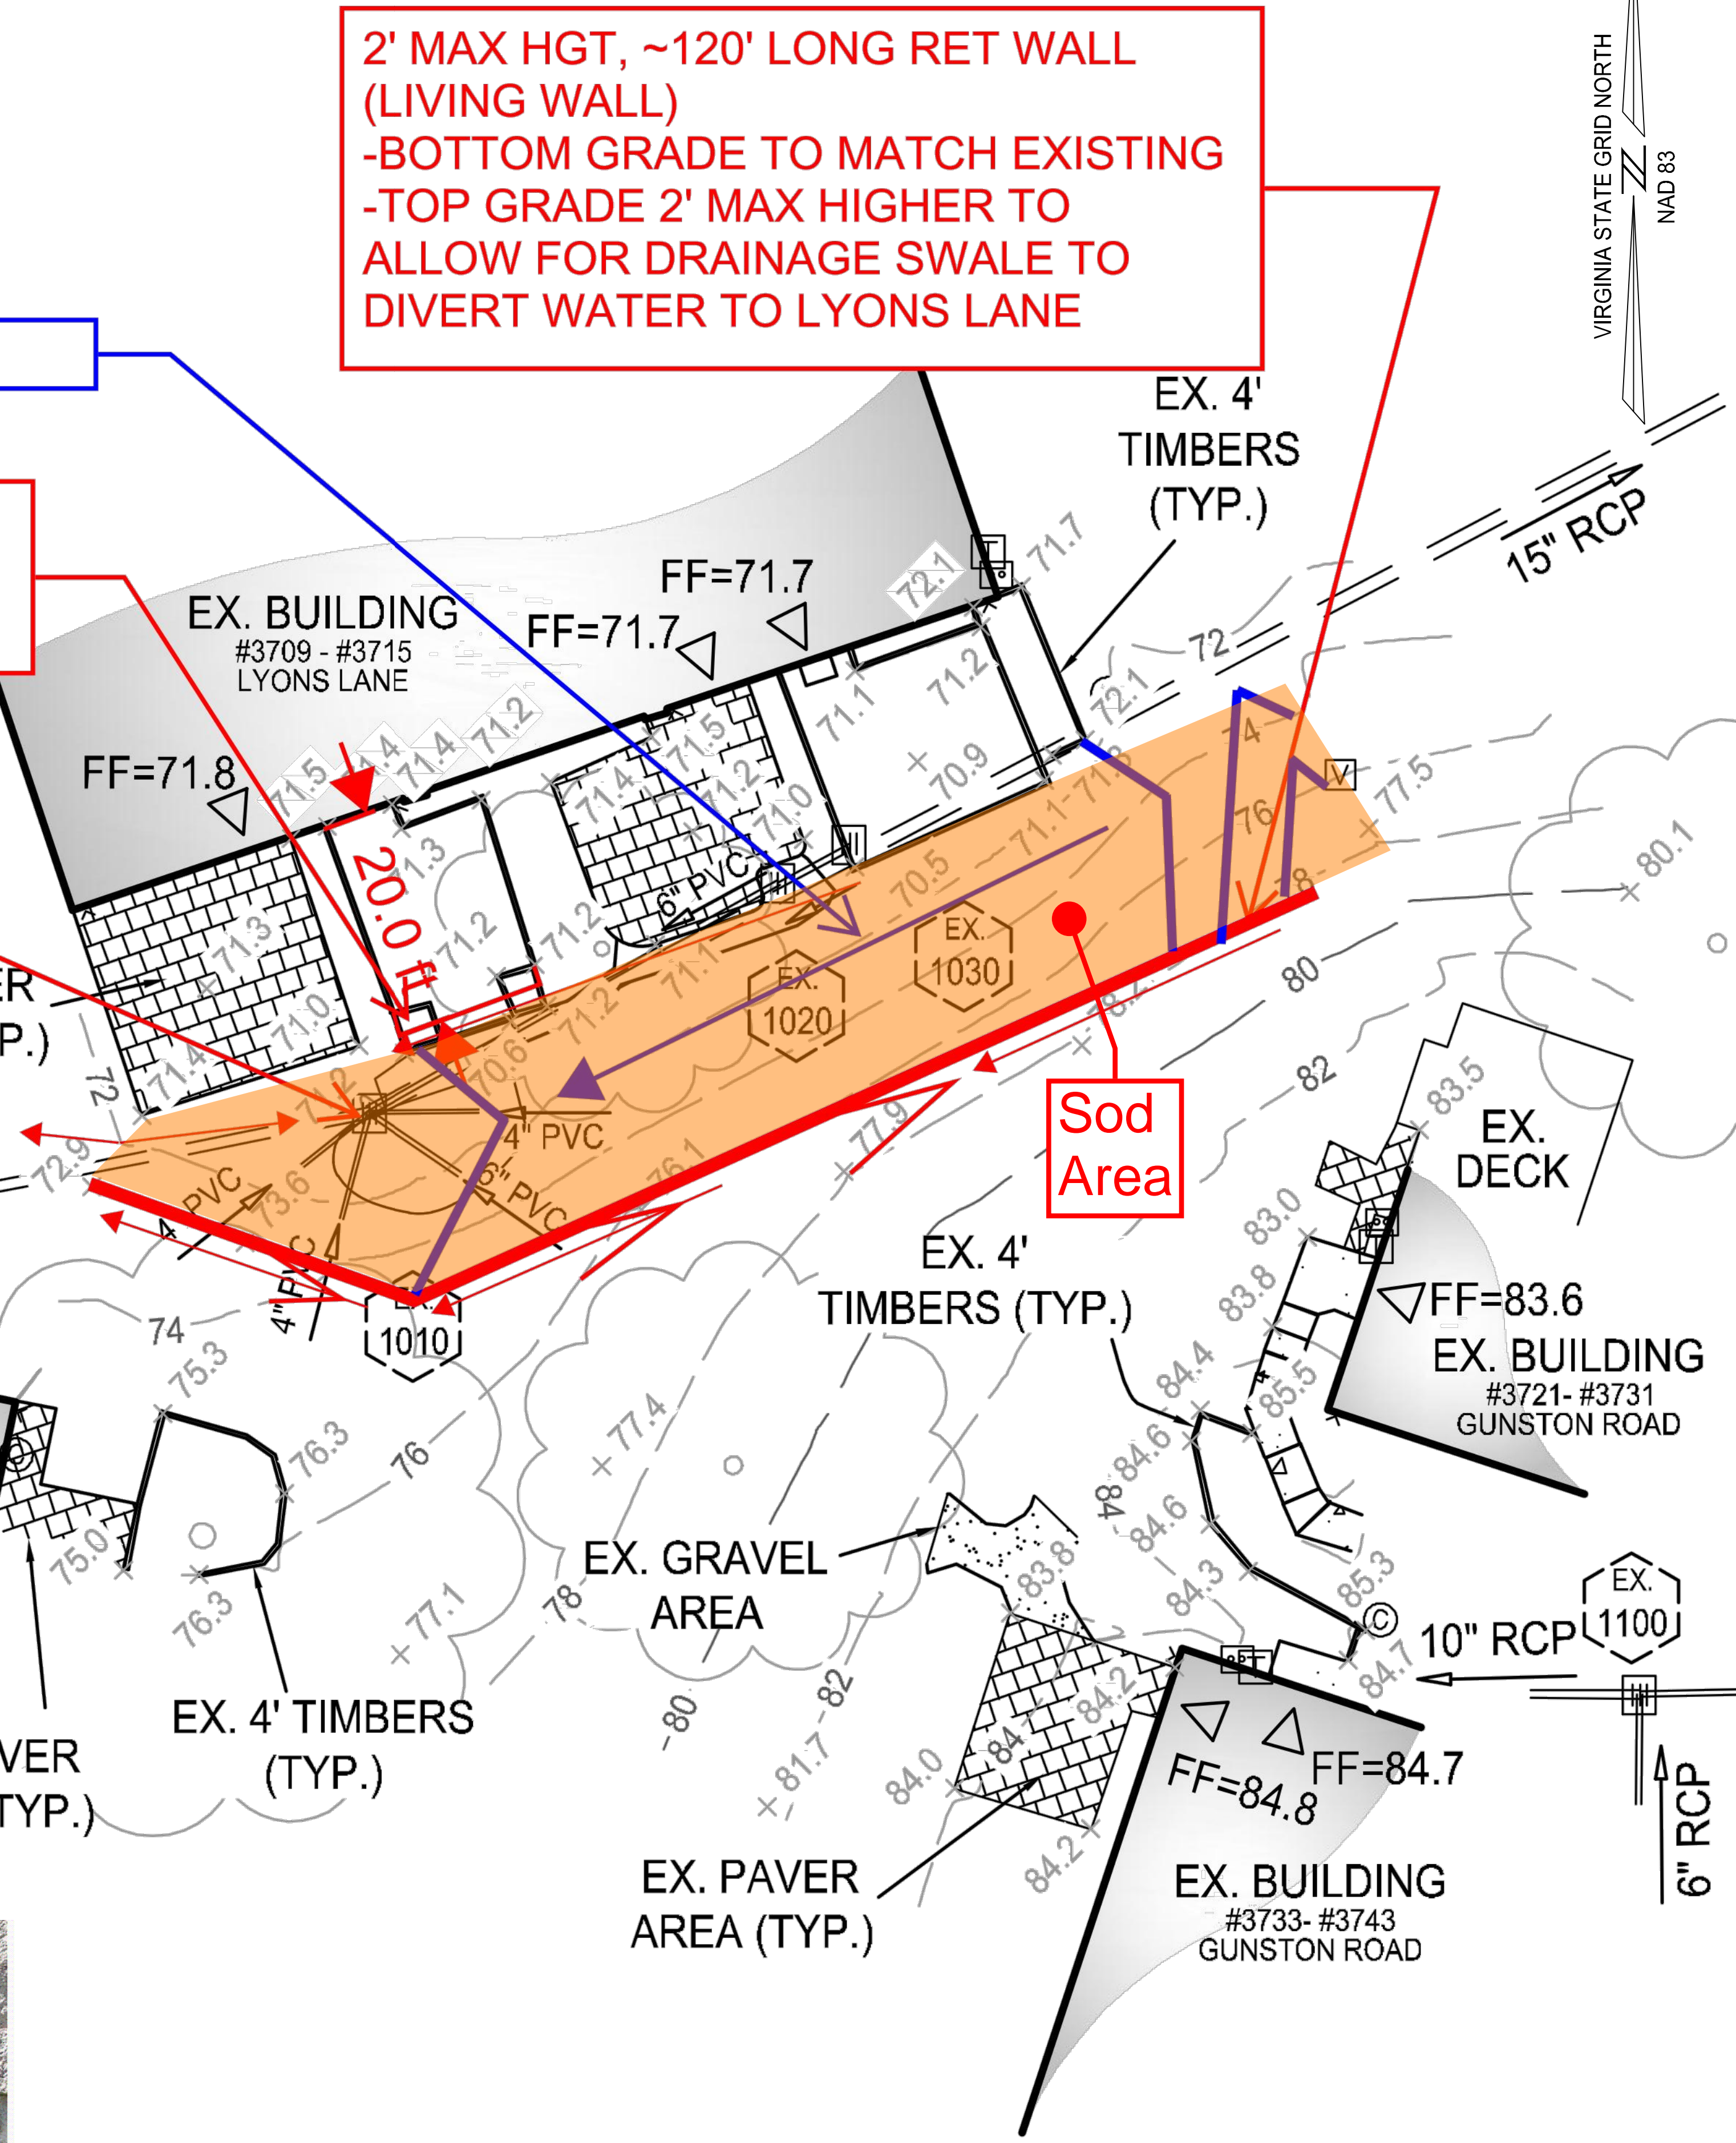
SHEET No.
C-100

2' MAX HGT, ~120' LONG RET WALL (LIVING WALL)
 -BOTTOM GRADE TO MATCH EXISTING
 -TOP GRADE 2' MAX HIGHER TO ALLOW FOR DRAINAGE SWALE TO DIVERT WATER TO LYONS LANE

Dry swale at 3%

GRADE TO PROVIDE POSITIVE DRAINAGE AWAY FROM UNITS AND TO LYONS LANE

Owner's Association to provide notice to property owner

Owner's Association to TV storm lines

Potential location for doghouse grate inlet to collect stormwater from above the retaining wall
