December 8, 2010

Parkfairfax Condominium  
3360 Gunston road  
Alexandria, VA 22301

Subject: Summary Report for Professional Engineering and Consulting Services  
Brief visual survey of the exterior masonry façade of 289 Structures  
for visible evidence of potential Foundation Settlement Issues  
Parkfairfax Condominiums  
Alexandria, VA 22302  
SRG Project #R10042.00

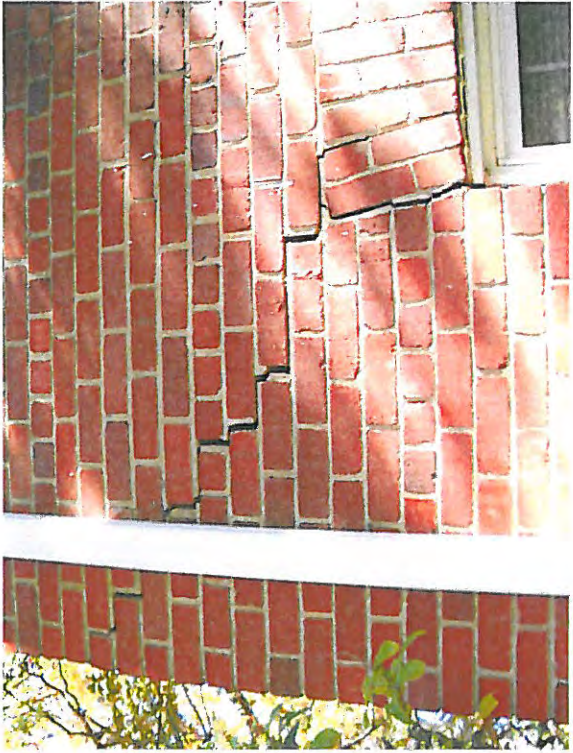
1. Bldg 849: Step crack at rear corner of Unit 3231 (Side elevation).

| Priority | Building | Comments |
|---|---|---|
| 2 | 849 | Concentration of masonry cracks with large façade displacement at rear corner and side elevation of Unit 3231<br>Evidence of previous façade repairs along rear elevation<br>Evidence of previous monitoring (Crack Gauges)<br>Recommend temporary masonry repairs and monitoring at Unit 3231 until detailed investigation can be performed |

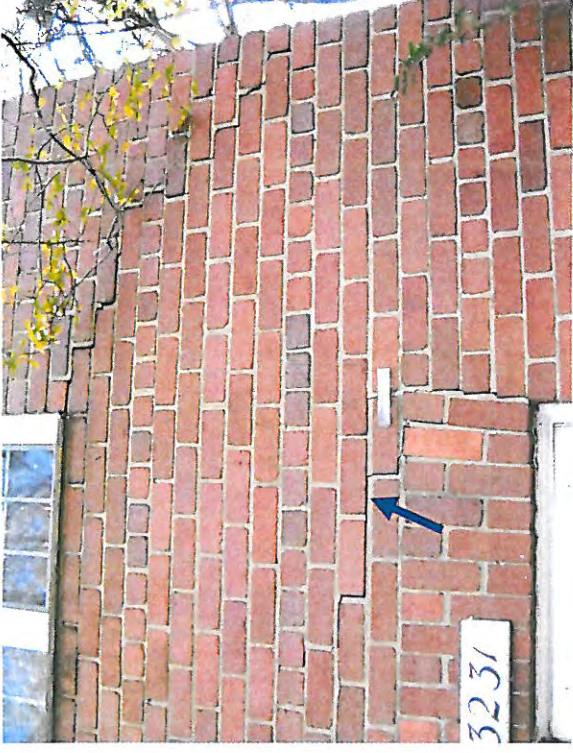
2. Bldg 849: Step crack at rear corner of Unit 3231 (Rear elevation).

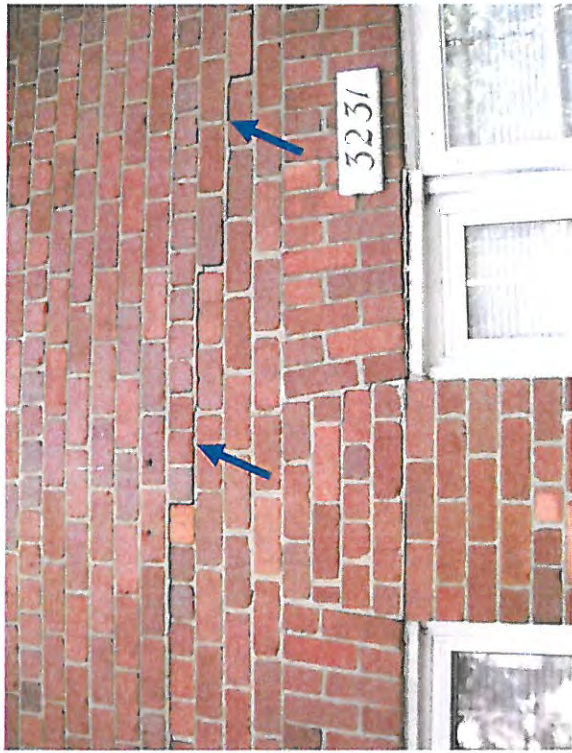
3. Bldg 849: Step crack at rear elevation of Unit 3231.

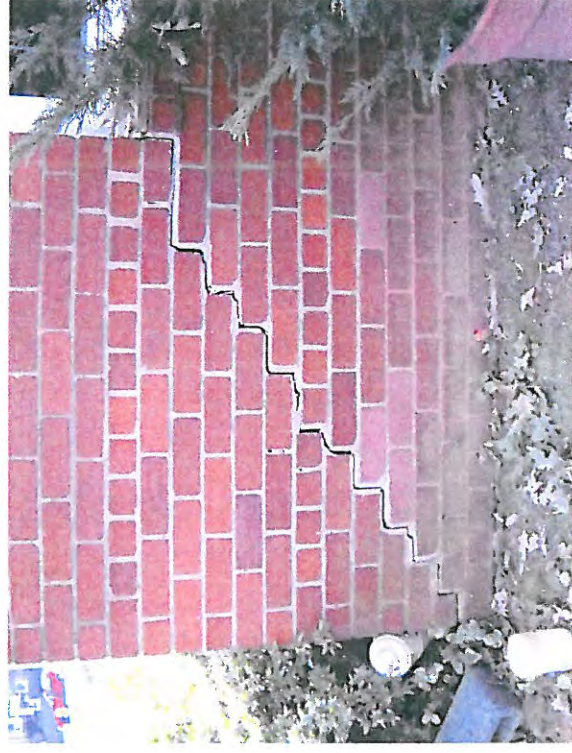
4. Bldg 830: Step crack at front corner of Unit 3133 (Side elevation).

| Priority | Building | Comments |
|---|---|---|
| 3 | 830 | Concentration of masonry cracks and large façade displacement at front corner and side elevation of Unit 3133<br>Evidence of previous façade repairs along rear elevation<br>Evidence of previous monitoring (Crack Gauges)<br>Recommend temporary masonry repairs and monitoring at Unit 3133 until detailed investigation can be performed |

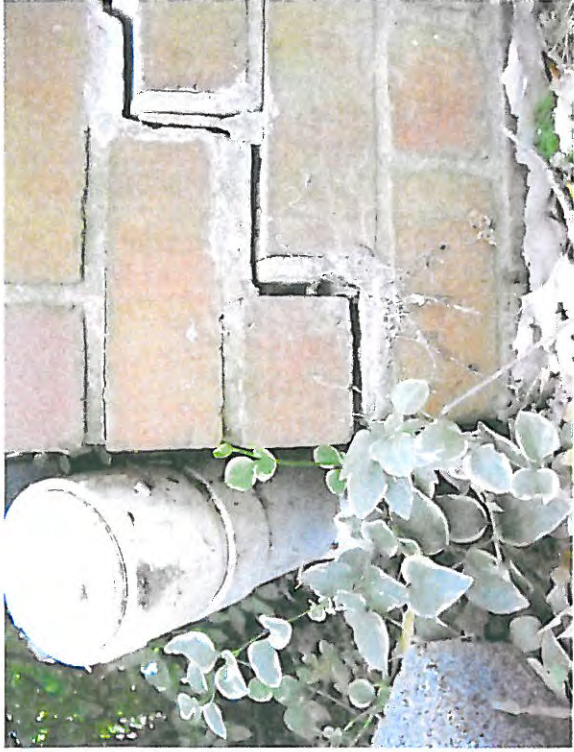
5. Bldg 830: Horizontal displacement at front corner of Unit 3133 (Side elevation).

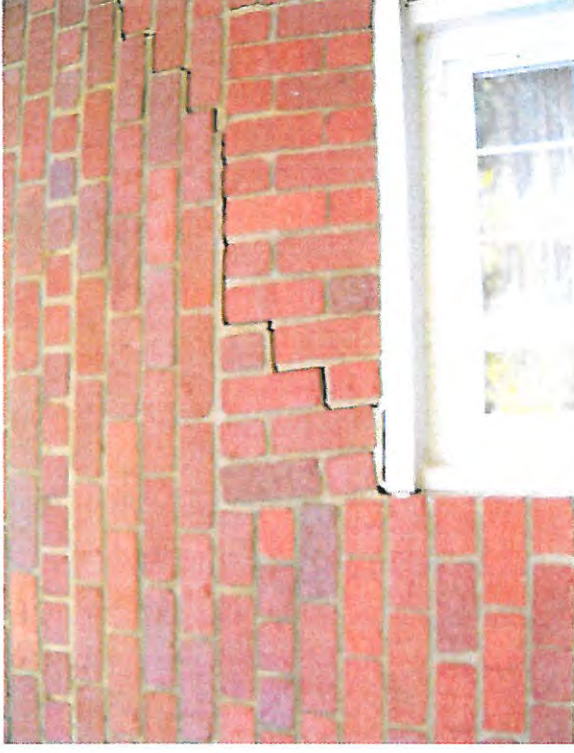
6. Bldg 830: Step crack at masonry lintel of Unit 3133 (Side elevation).

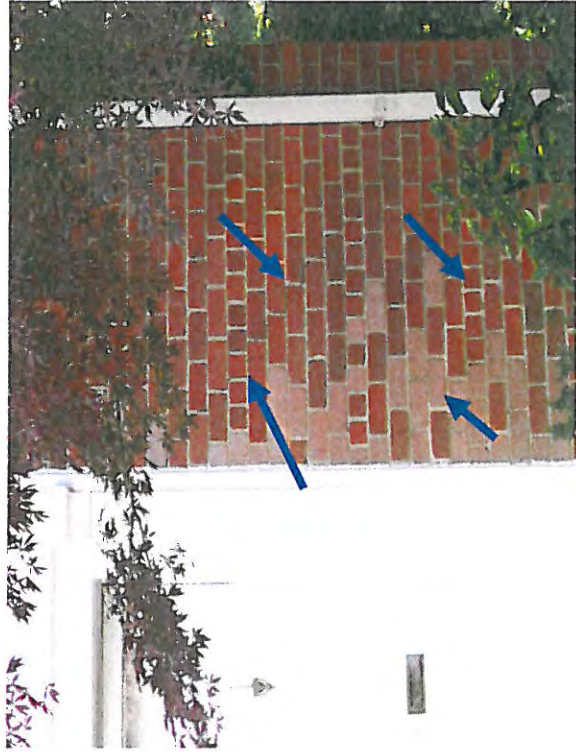
7. Bldg 838: Step crack at front corner at Unit 3227 (front elevation), as well as evidence of previous repairs.

| Priority | Building | Comments |
|---|---|---|
| 4 | 838 | Concentration of masonry cracks at three building corners (out of four)<br>Cracking at previously repaired mortar joints<br>Evidence of previous monitoring (Crack Gauges) |

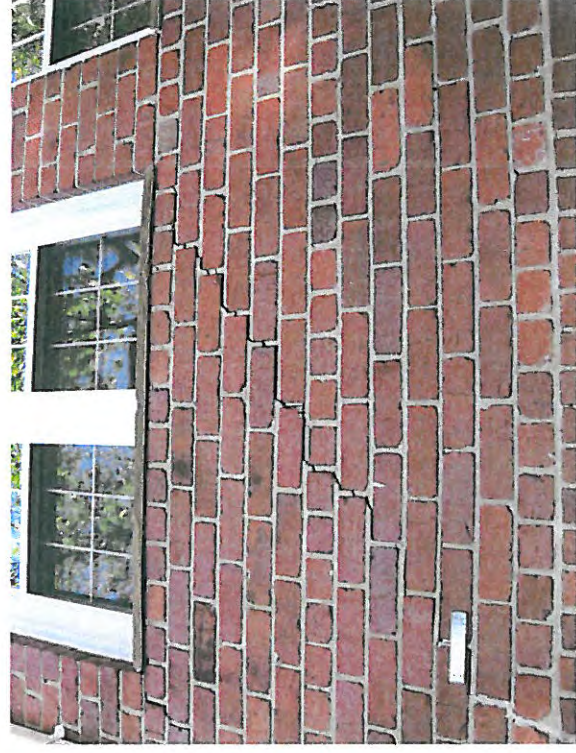
8. Bldg 838: Step crack and masonry separation at rear elevation of Unit 3227.

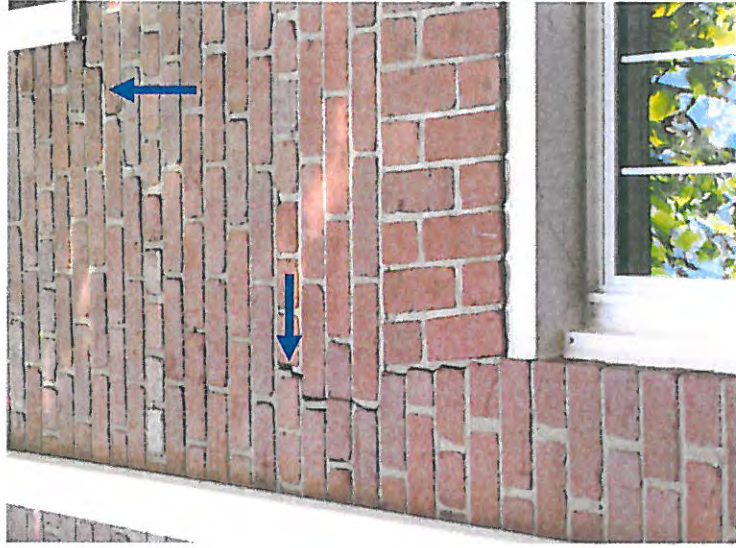
9. Bldg 838: Step crack at rear corner of Unit 3227 (rear elevation).

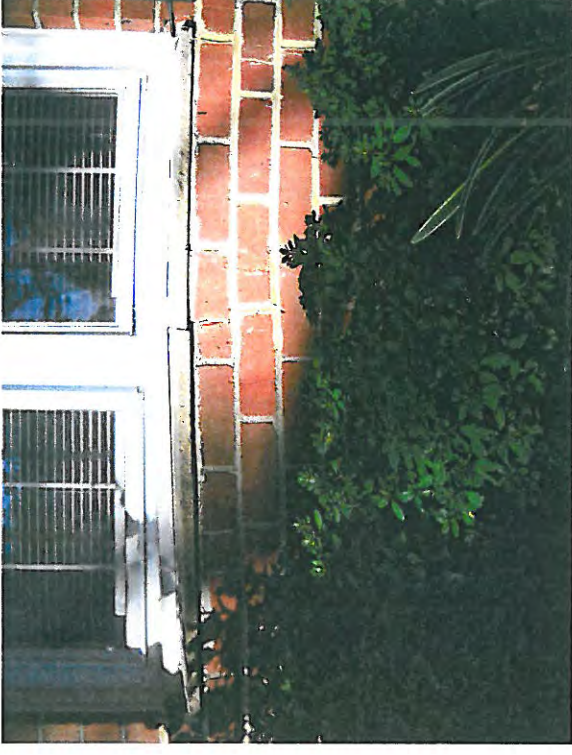
10. Bldg 111: Window sill rotation at front elevation.

| Priority | Building | Comments |
|---|---|---|
| 5 | 111 | Rotation of masonry pier at front elevation near Unit 3114<br>Evidence of movement at window sill at rear elevation near Unit 3112<br>Cracking at previously repaired mortar joints<br>Evidence of previous façade repairs at all elevations<br>Evidence of previous monitoring (Crack Gauges) |

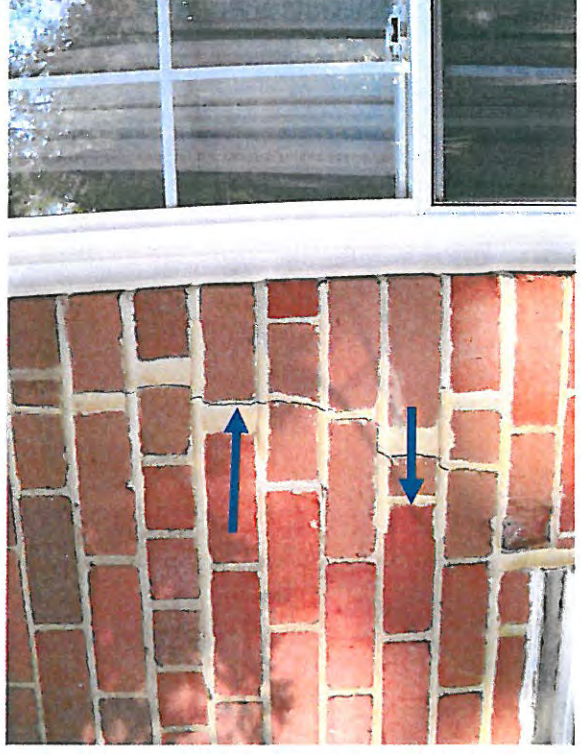
11. Bldg 111: Crack at previously repaired masonry at rear elevation.

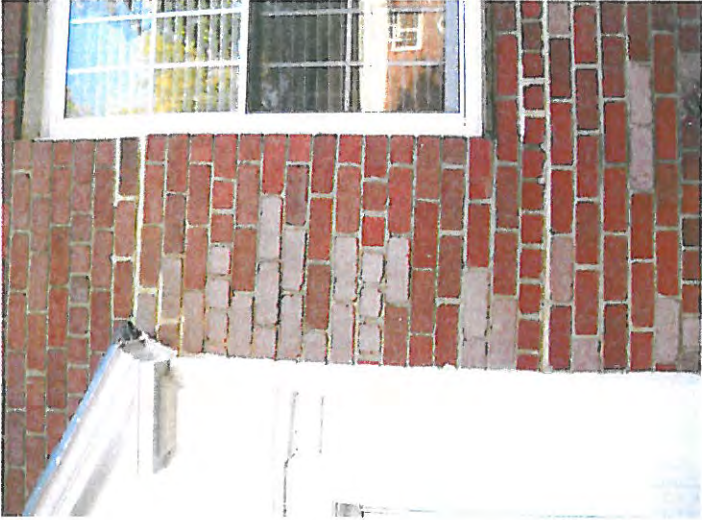
12. Bldg 111: Rotation at masonry pier at front elevation.

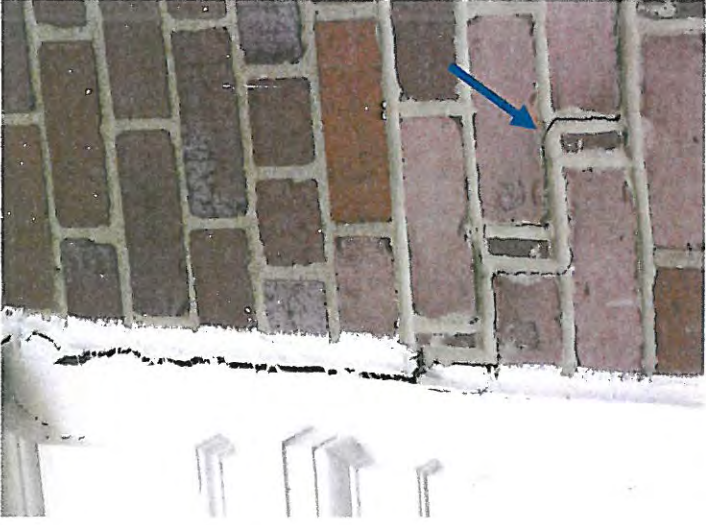
13. Bldg 836: Masonry step crack at previously repaired masonry at Unit 3215 (front elevation), as well as separation at exterior sealants.

| Priority | Building | Comments |
|---|---|---|
| 6 | 836 | Concentration of masonry cracks and bulging at front corner of Unit 3215<br>Evidence of previous façade repairs along front, rear and right elevations<br>Evidence of previous monitoring (Crack Gauges) |

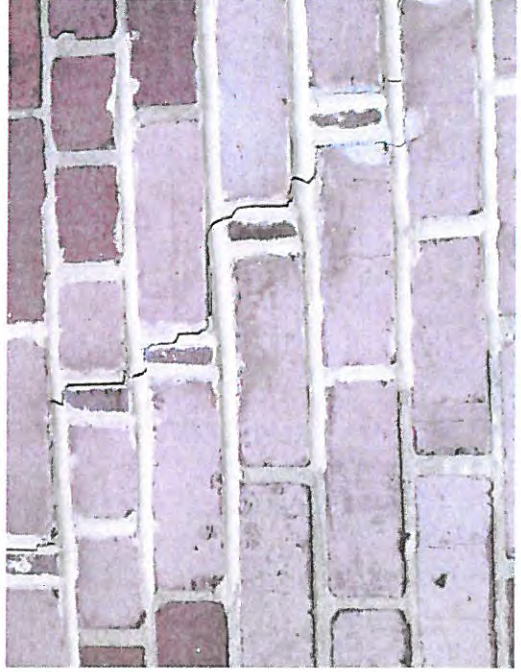
14. Bldg 836: Step crack in previously repaired masonry at Unit 3215 (front elevation).

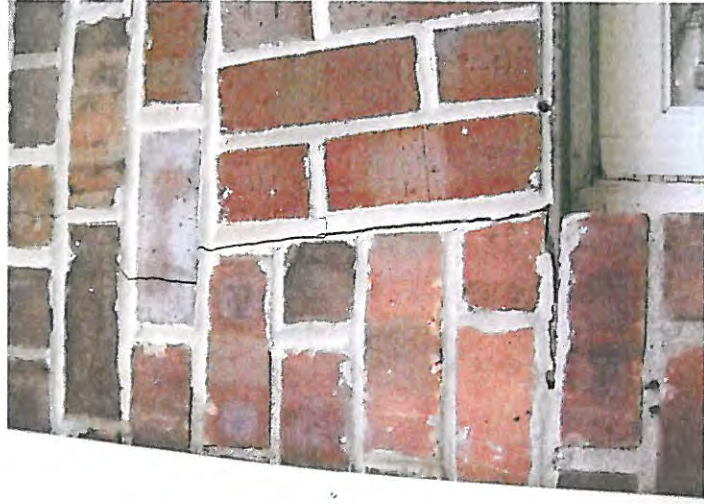
15. Bldg 716: Crack at previously repaired masonry at rear corner of Unit 3210 (Rear elevation).

| Priority | Building | Comments |
|---|---|---|
| 7 | 716 | Evidence of significant façade repairs along front and rear elevations including new steel lintels, façade replacement and installation of expansion joints<br>Cracking at previously repaired mortar joints and masonry façade including the rear corner of Unit 3210<br>Evidence of previous monitoring (Crack Gauges and Façade Benchmarks) |

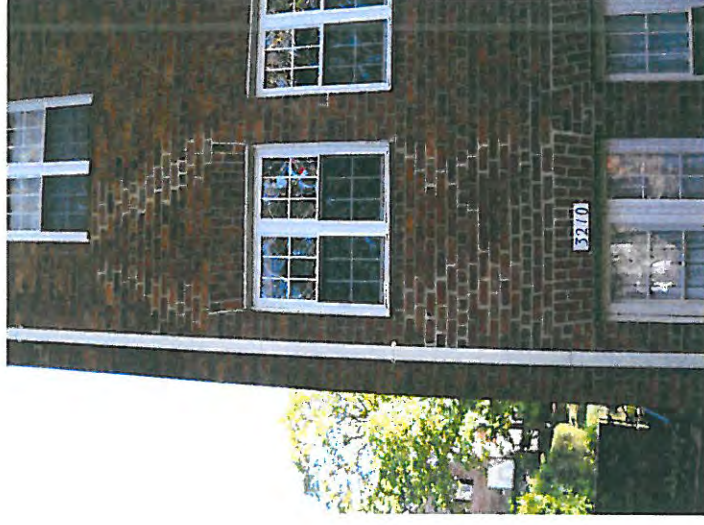
16. Bldg 716: Evidence of significant wall repair and masonry façade replacement at rear corner of Unit 3210 (Rear elevation) including lintel replacement.

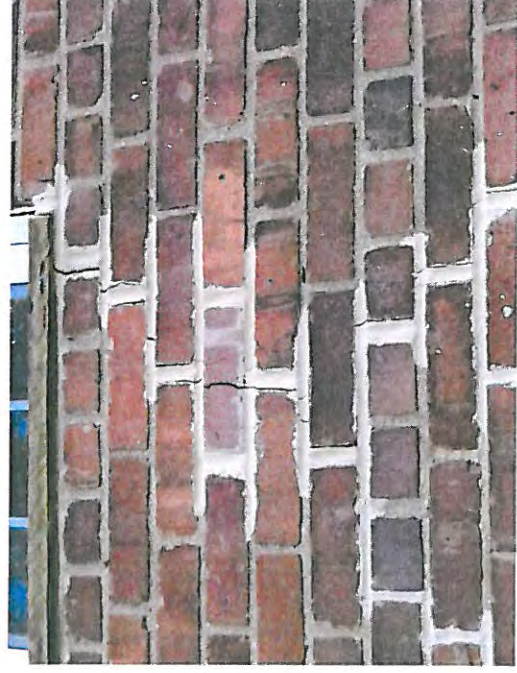
17. Bldg 716: Step crack at previously repaired masonry at rear elevation.

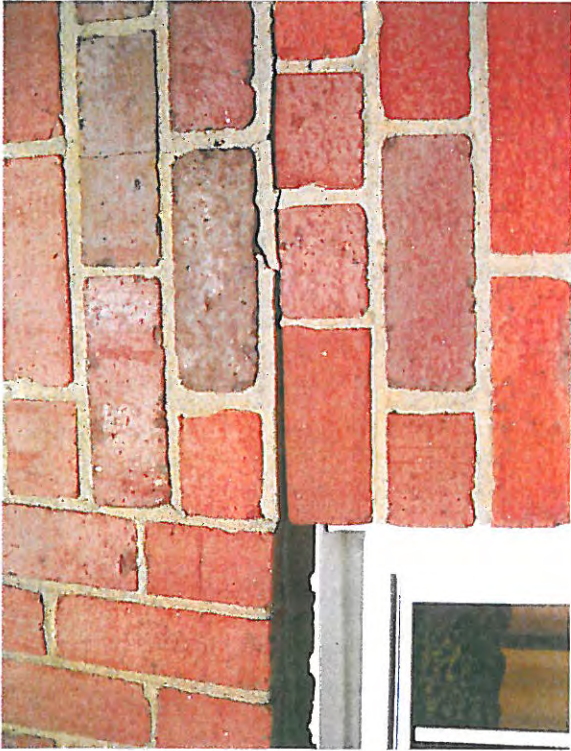
18. Bldg 537: Separation and rotation at masonry pier at Unit 3718 (Rear elevation).

| Priority | Building | Comments |
|---|---|---|
| 8 | 537 | Rotation of masonry piers at rear elevation at Unit 3718<br>Concentration of masonry cracks at rear elevation of Unit 3718 |

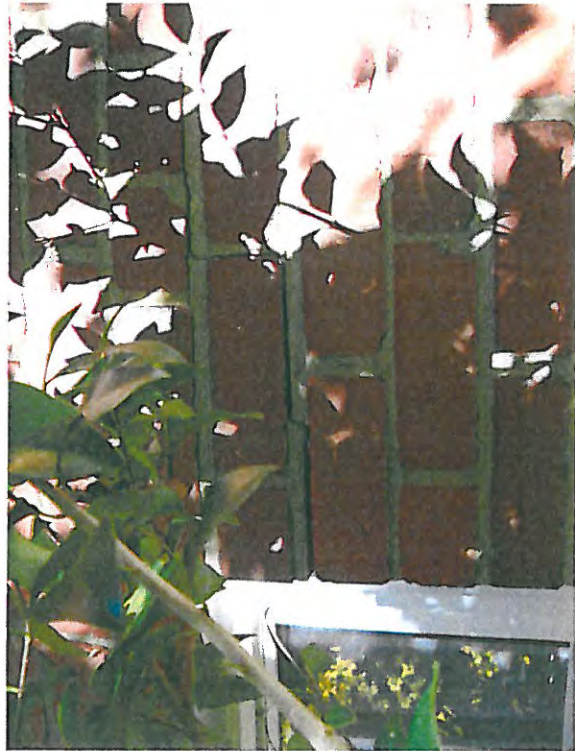
19. Bldg 537: Separation and rotation at masonry pier at Unit 3718 (Rear elevation).

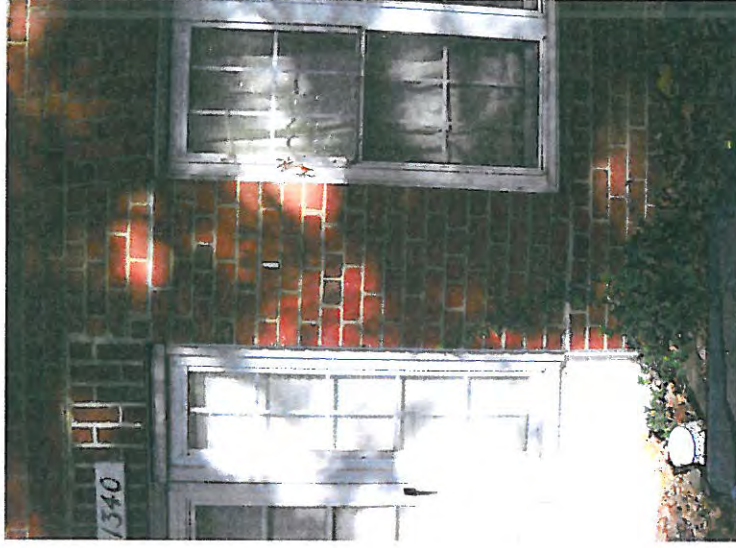
20. Bldg 527: Rotation at masonry pier at Unit 1340 (Rear elevation).

| Priority | Building | Comments |
|---|---|---|
| 9 | 527 | Cracking at previously repaired mortar joints<br>Evidence of previous façade repairs at front and rear elevations<br>Rotation of masonry piers at rear elevation |

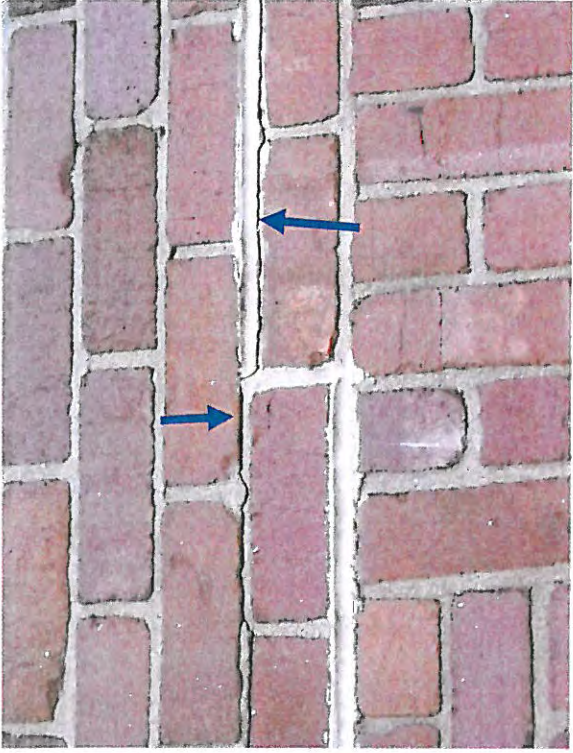
21. Bldg 527: Mortar crack at previously repaired masonry at Unit 1340 (Front elevation).

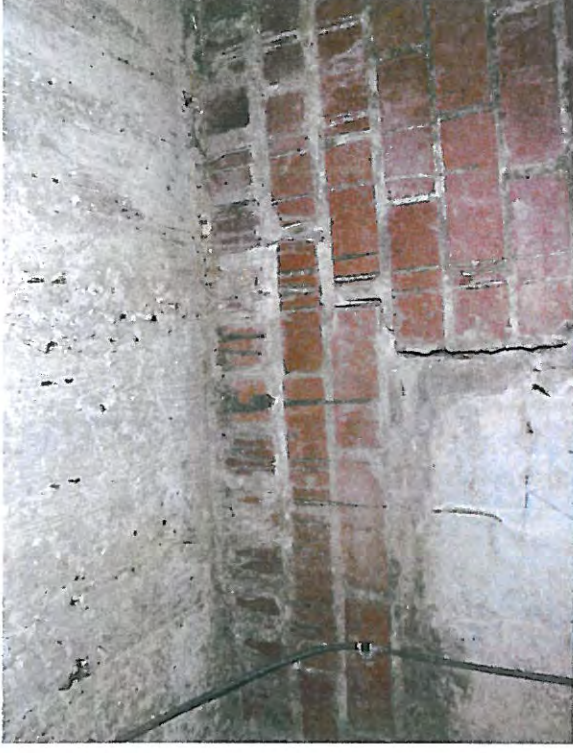
22. Bldg 718: Step crack/separation at foundation wall (as viewed from crawl space).

| Priority | Building | Comments |
|---|---|---|
| 10 | 718 | Currently under investigation<br>Evidence of significant façade repairs along front and rear elevations<br>Evidence of previous monitoring (Crack Gauges)<br>Cracking and large separation at foundation walls |

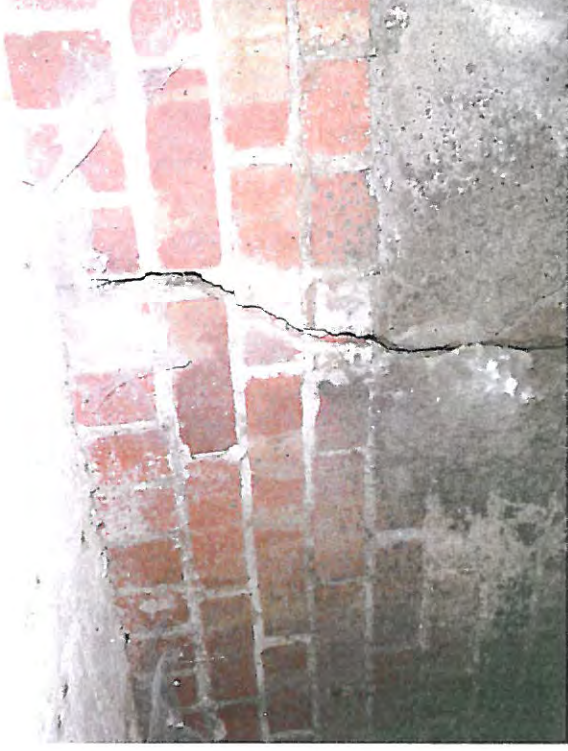
23. Bldg 718: Step crack and horizontal separation at foundation wall (as viewed from crawl space).

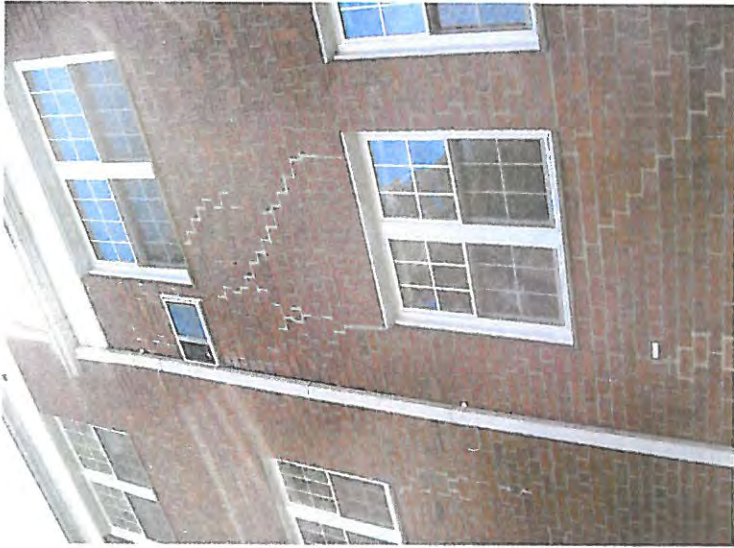
24. Bldg 718: Evidence of several masonry repairs throughout rear elevation.

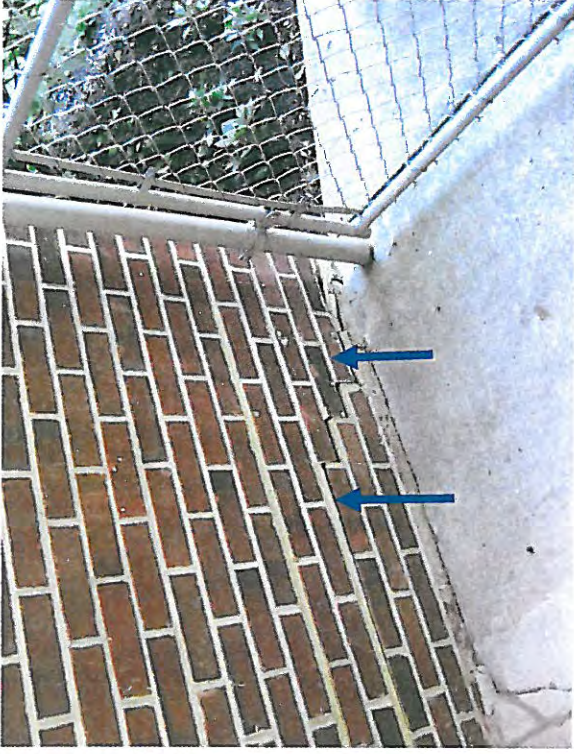
25. Pool Bldg A: Step crack with substantial separation at breezeway front corner.

| Priority | Building | Comments |
|---|---|---|
| 11 | Pool Bldg A | Concentration of masonry cracks with large façade displacement at front elevation adjacent to breezeway (entrance)<br>Evidence of significant façade repairs along front elevation<br>Cracking of previously repaired mortar joints |

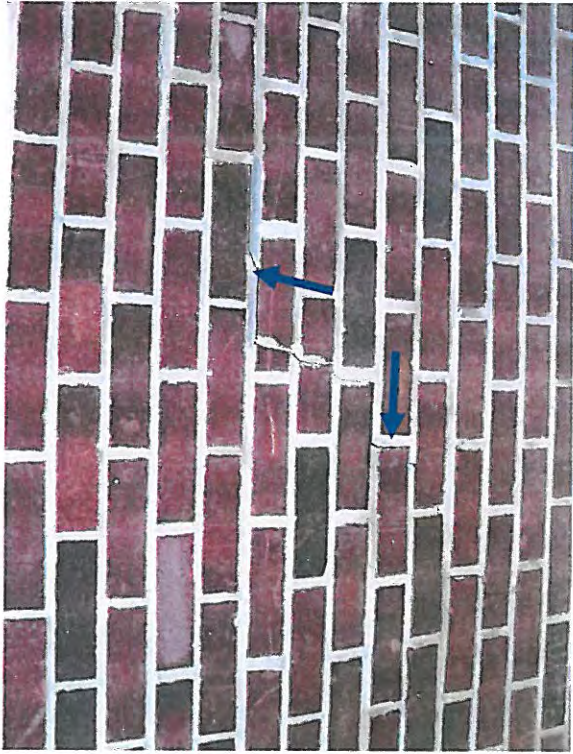
26. Pool Bldg A: Step Crack at previously repaired masonry (Front elevation).

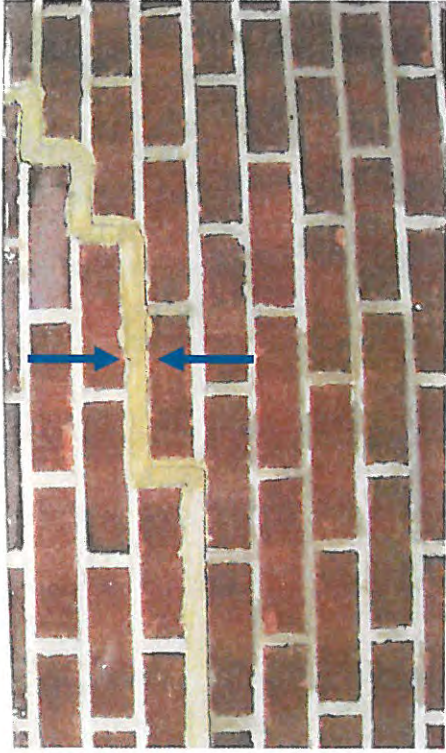
27. Pool Bldg A: Evidence of significant movement at previous masonry repairs (Front elevation).

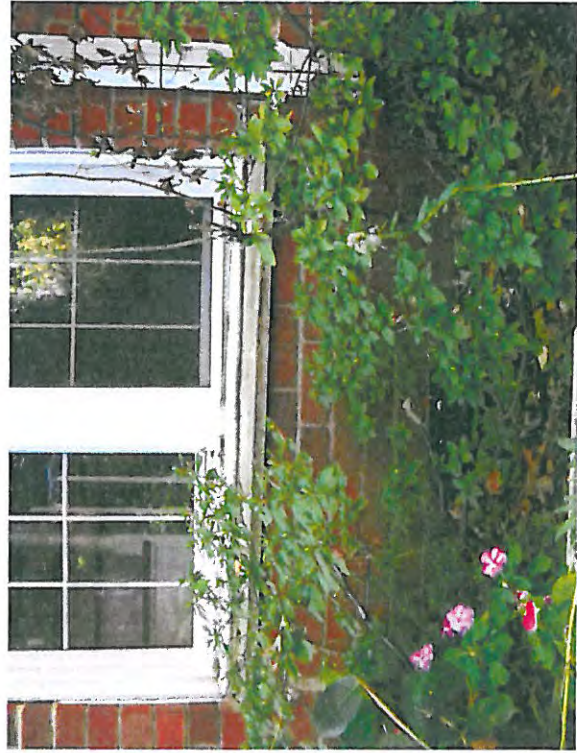
28. Bldg 112: Window sill rotation at rear elevation.

| Priority | Building | Comments |
|---|---|---|
| 12 | 112 | Evidence of façade repairs at all elevations<br>Cracking of previously repaired mortar joints<br>Rotation of masonry piers at rear elevation impacting window operation |

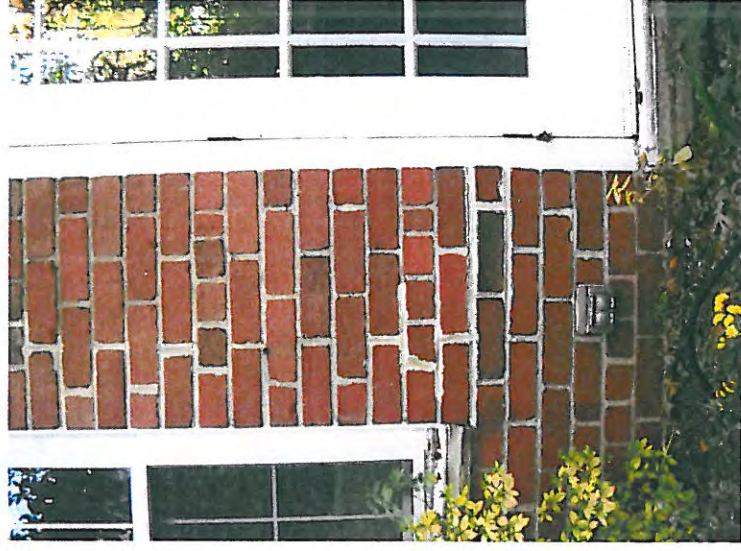
29. Bldg 112: Rotation at masonry pier at rear elevation.

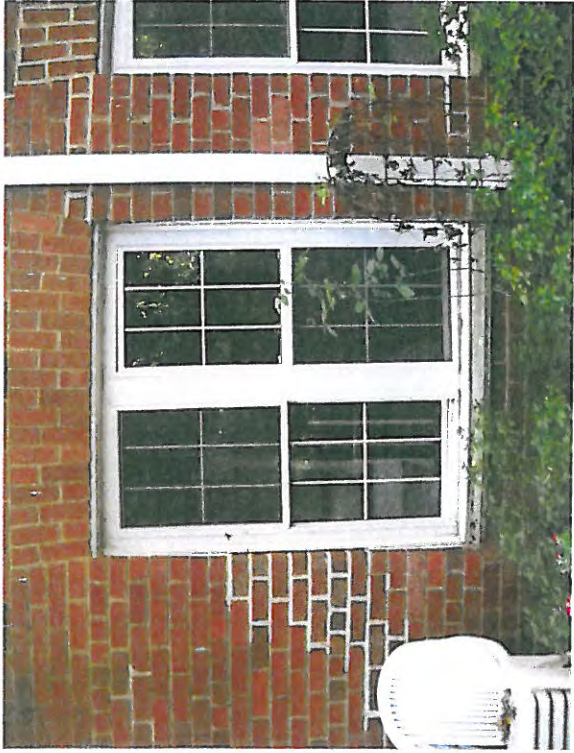
30. Bldg 112: Displacement (racking) of window assembly at rear elevation.

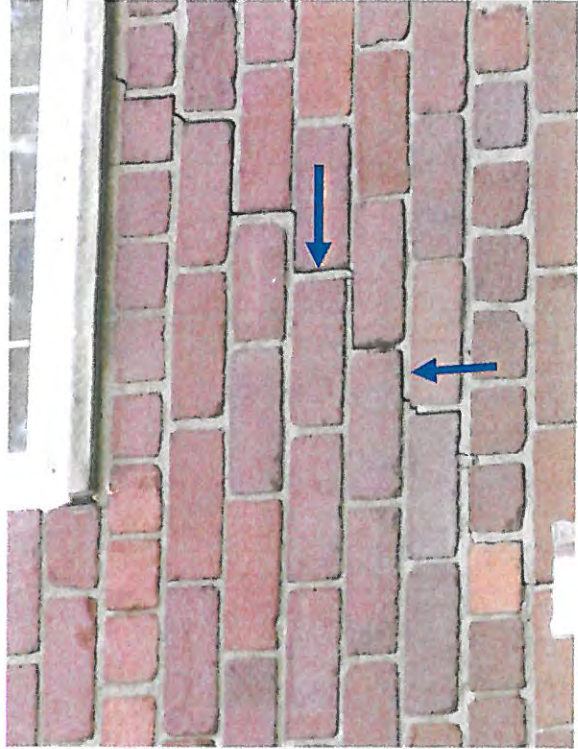
31. Bldg 723: Step crack at rear façade (potentially exacerbated by August 5, 2010 storm/tree fall damage).

| Priority | Building | Comments |
|---|---|---|
| 13 | 723 | Significant cracking with façade displacement at side and rear elevations |

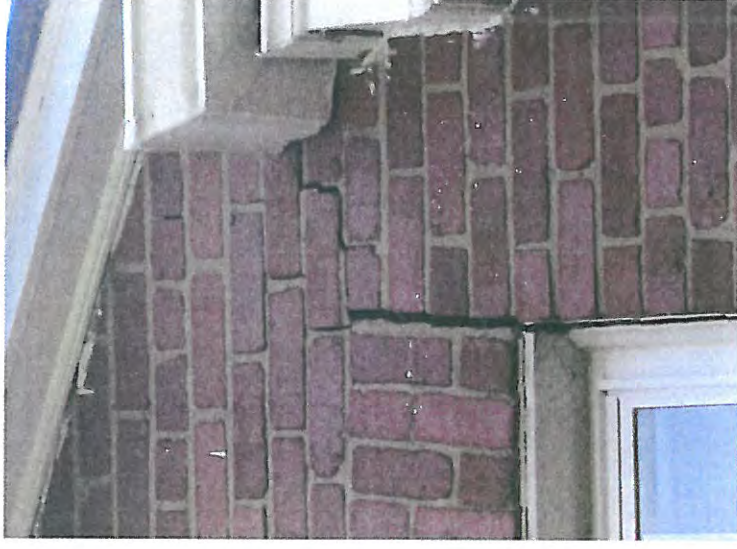
32. Bldg 723: Step crack at rear façade (potentially exacerbated by August 5, 2010 storm/tree fall damage).

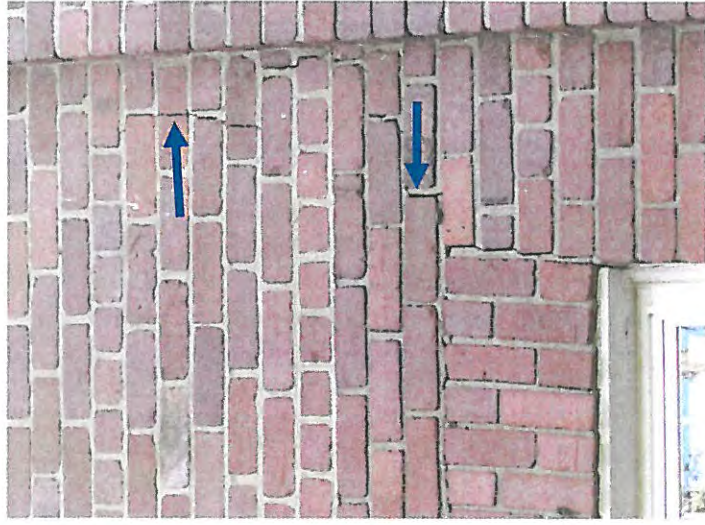
33. Bldg 723: Step crack at rear façade (potentially exacerbated by August 5, 2010 storm/tree fall damage).

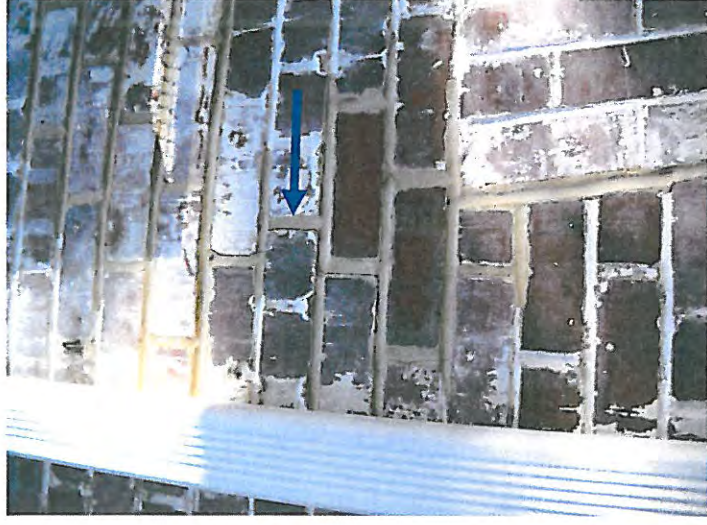
34. Bldg 709: Cracks at previously repaired masonry.

| Priority | Building | Comments |
|---|---|---|
| 14 | 709 | Cracking of previously repaired mortar joints |

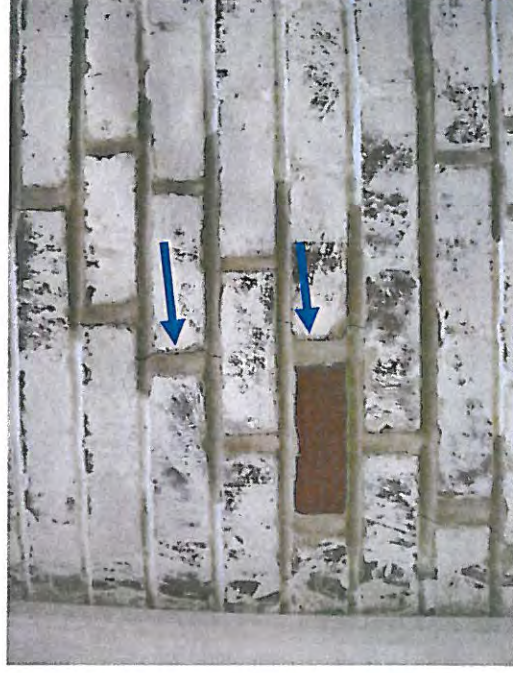
35. Bldg 709: Cracks at previously repaired masonry.

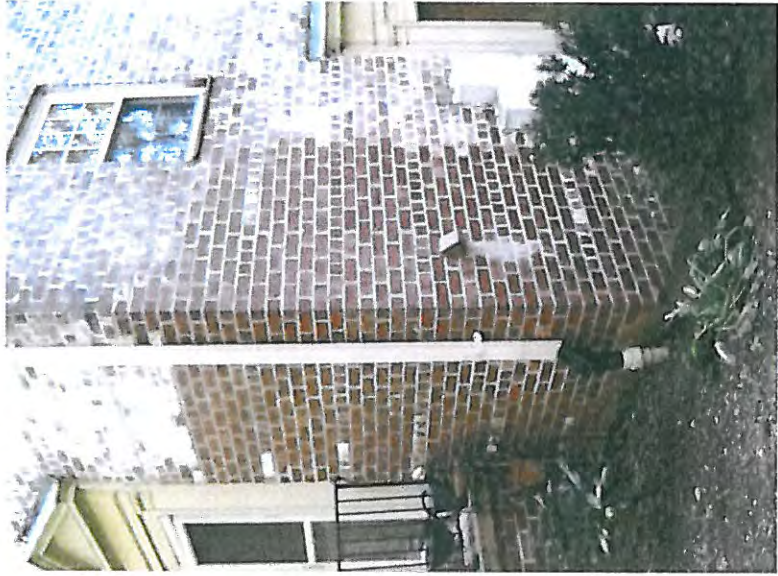
36. Bldg 709: Evidence of significant wall repairs/replacement at front corner of Unit 3521.

| Priority | Building | Comments |
|---|---|---|
| | | Evidence of significant façade repairs including replacement of front right corner |
