2277 Research Boulevard, Suite 275
Rockville, MD 20850
202.510.9366

February 29, 2024

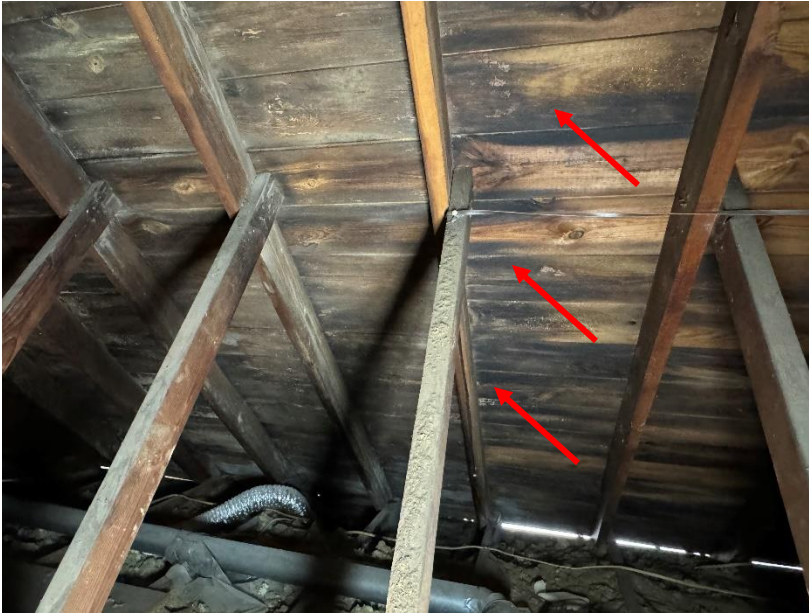
Photo 2. Bldg. 827 – Unit 3329: Red arrows pointing to dark staining on sheathing and roof truss suggesting moisture intrusion.

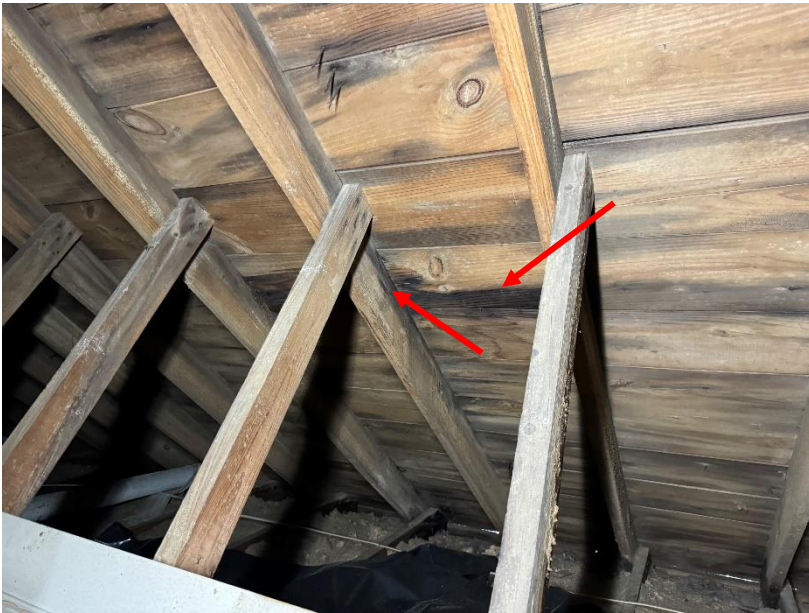
Photo 3. Bldg. 305 – Unit 3578: Red arrows pointing to dark staining on sheathing and roof truss suggesting moisture intrusion. Yellow arrows pointing to nail punctures through roof sheathing.

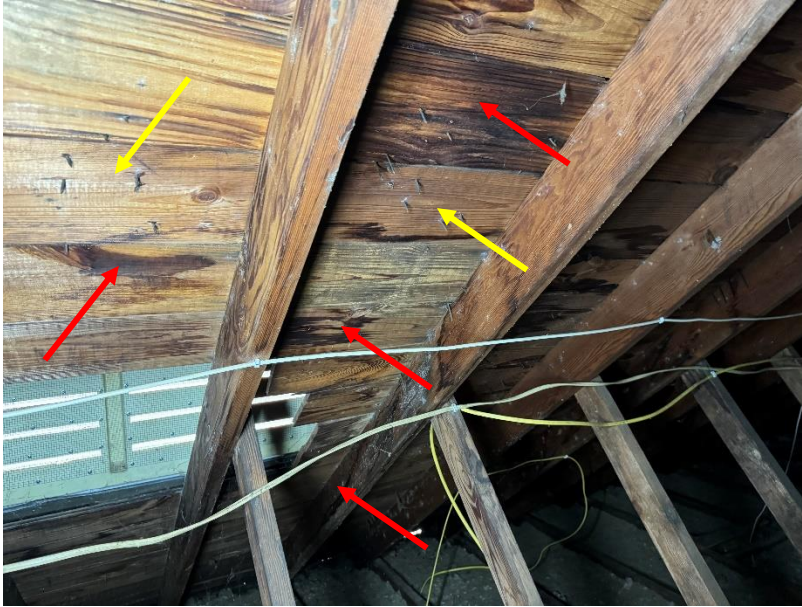
Photo 4. Bldg. 403 – Unit 1429: Red arrow pointing to crack in roof sheathing.

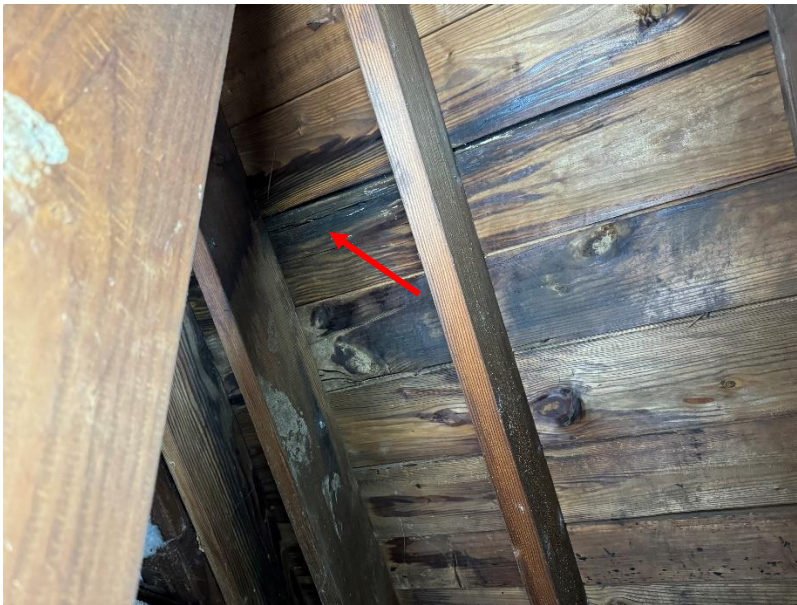
Photo 5. Bldg. 510 – Unit 3714: Red arrow pointing to crack in roof sheathing.

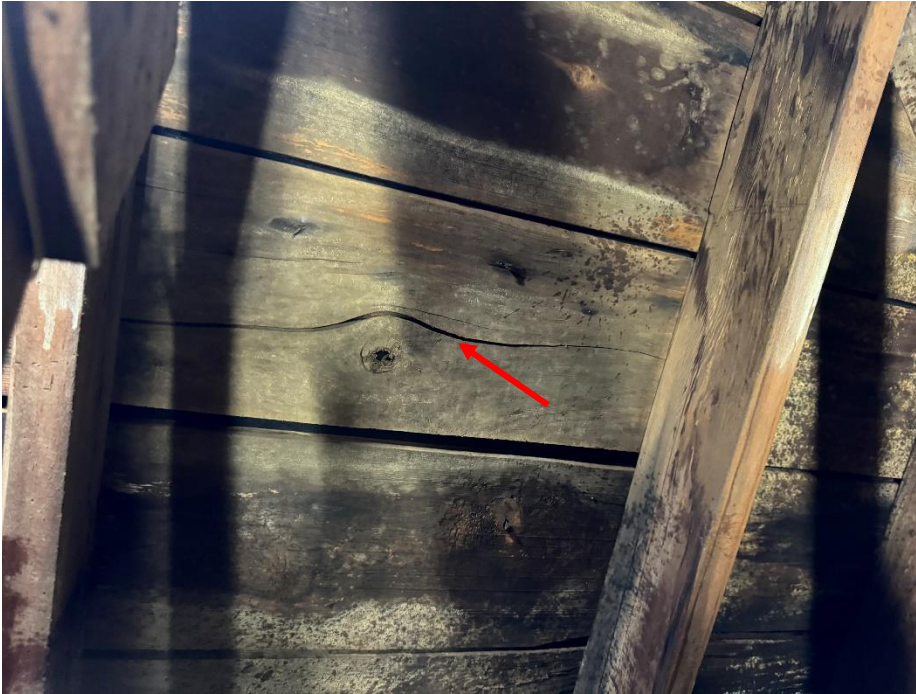
Photo 6. Bldg. 403 – Unit 1427: Top chord of roof truss with split.

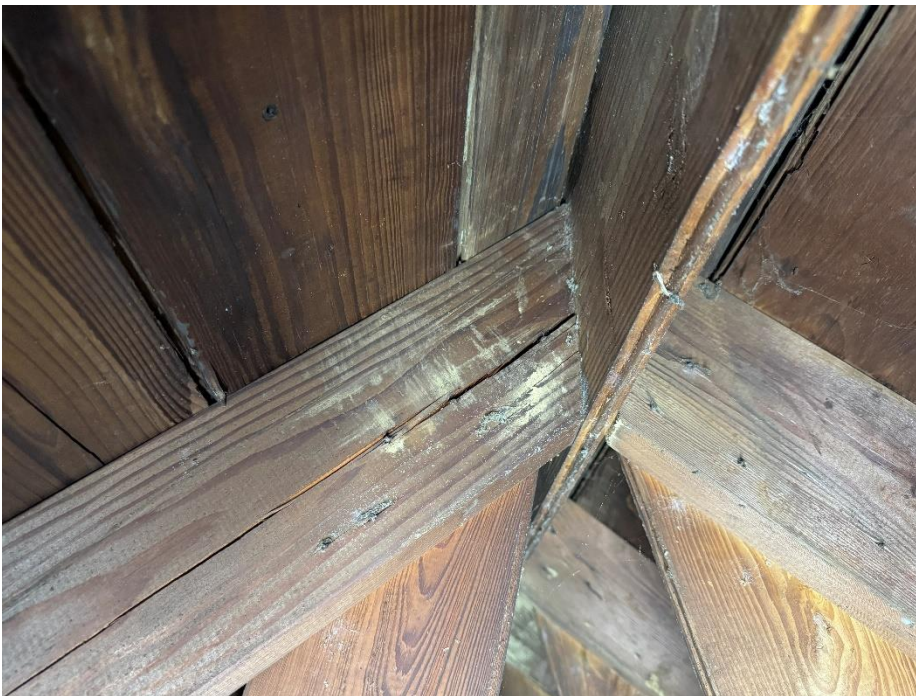
Photo 7. Bldg. 827 – Unit 3331: Red arrow pointing to broken web chord of roof truss.

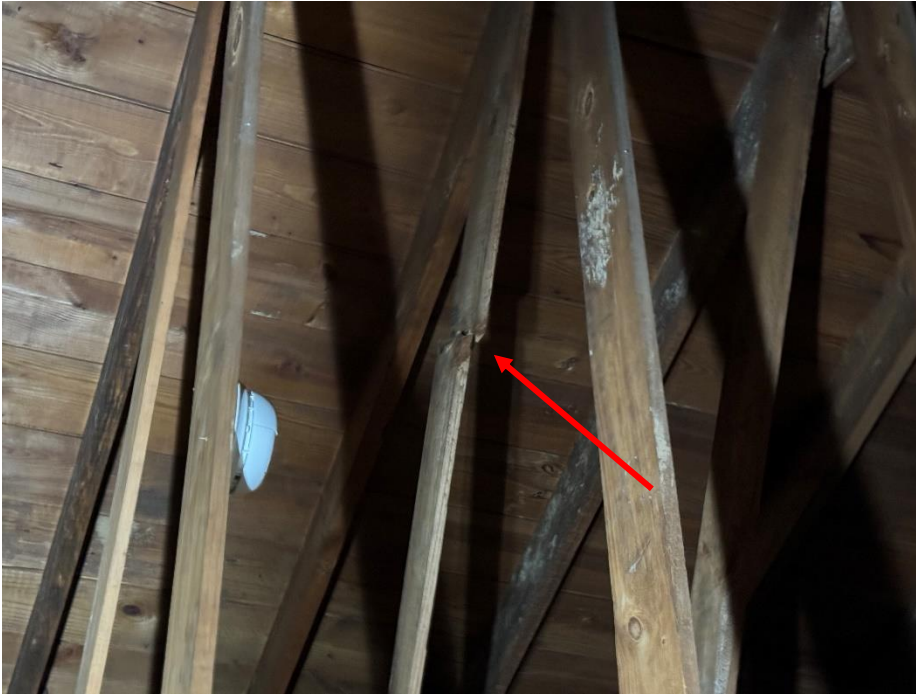
Photo 8. Bldg. 953 – Unit 1500: Red arrow pointing to damaged web chord of roof truss. Yellow arrow pointing to missing web chord of roof truss.

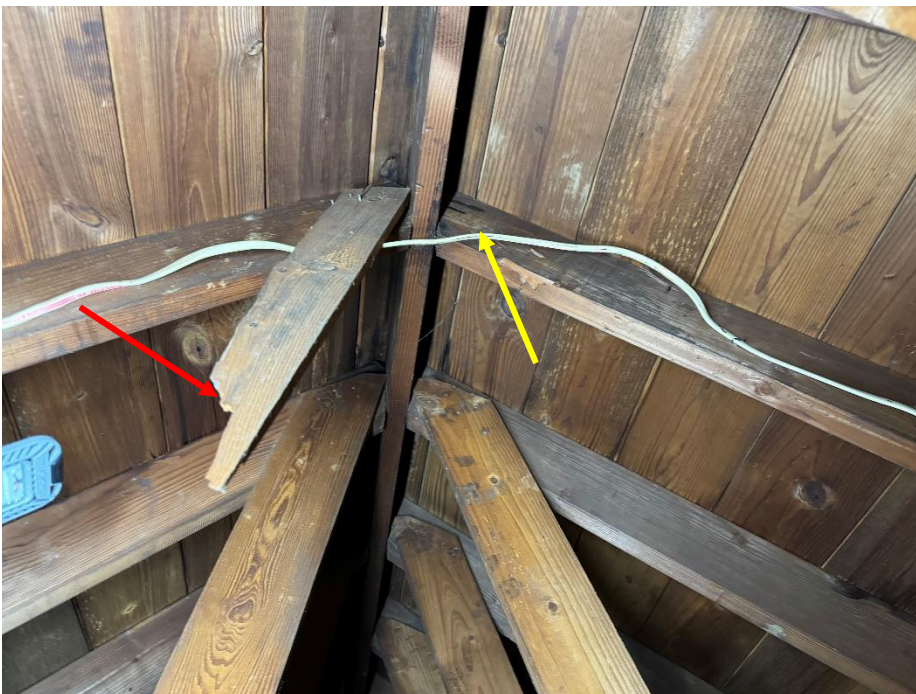
Photo 9. Bldg. 510 – Unit 3708: Red arrow pointing to missing web chord of roof truss.

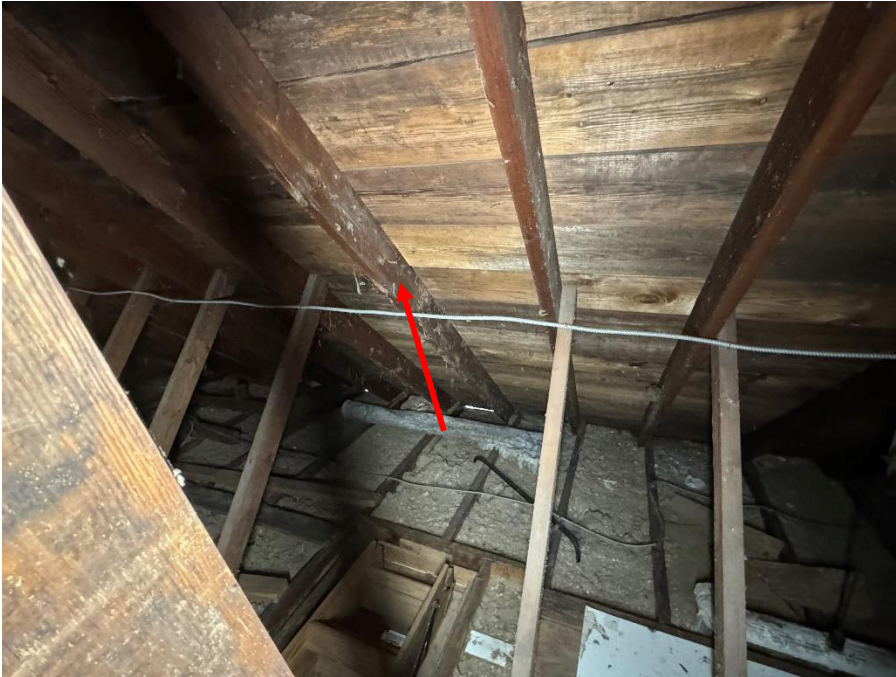
Photo 10. Bldg. 305 – Unit 3578: Web chord member of roof truss replaced with PVC trim.

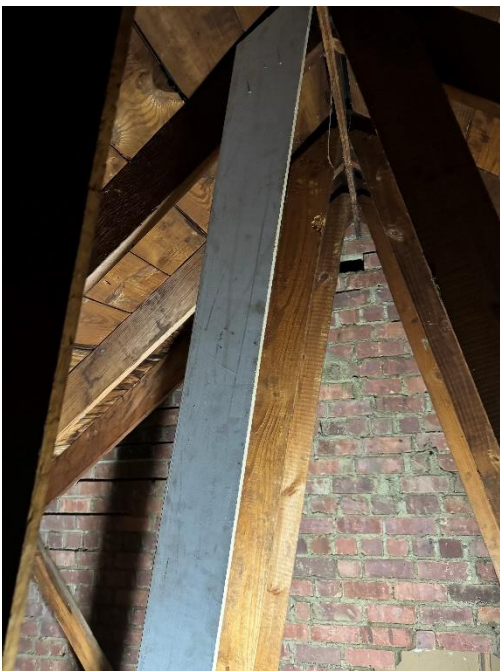
Photo 11. Bldg. 403 – Unit 1429: Red arrow pointing to section loss in roof sheathing.

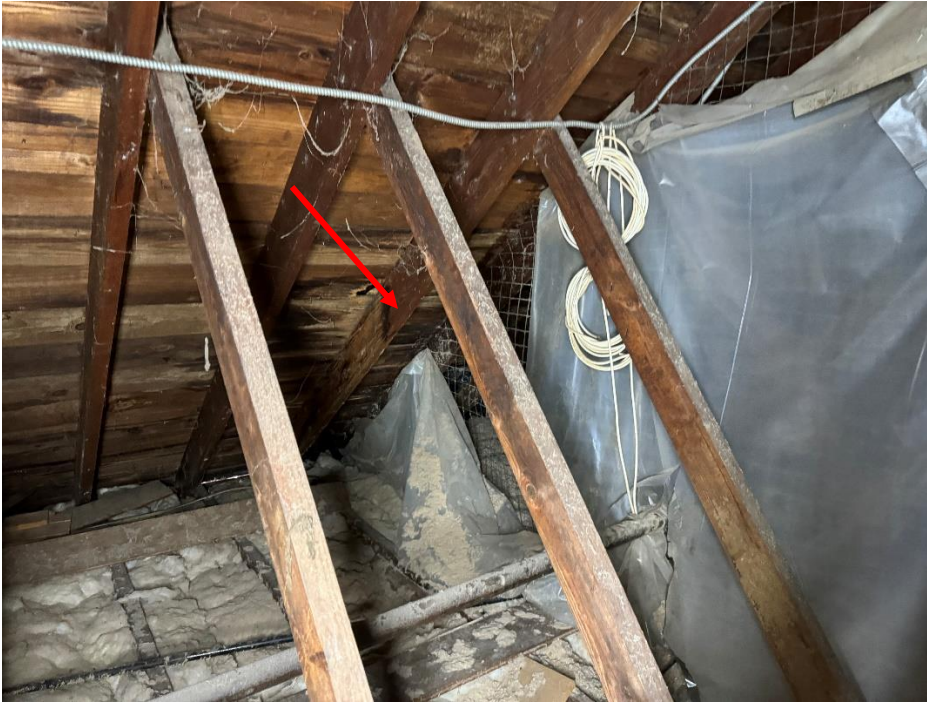
Photo 14. Bldg. 827 – Unit 3339: Previous repair to web chord of roof truss.

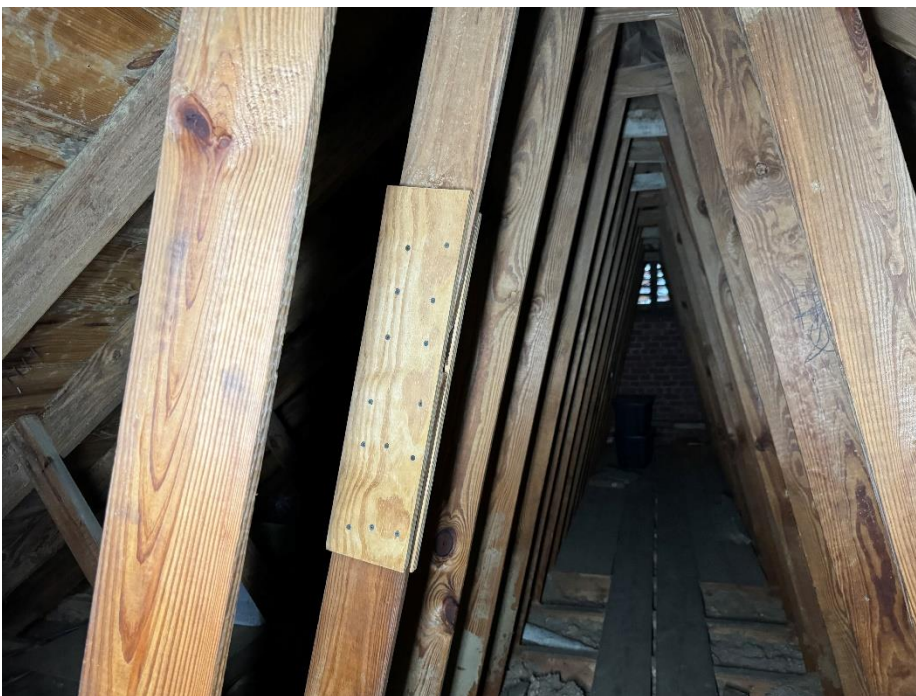
Photo 13. Bldg. 849 – Unit 3229: Step away of region where white staining was observed.

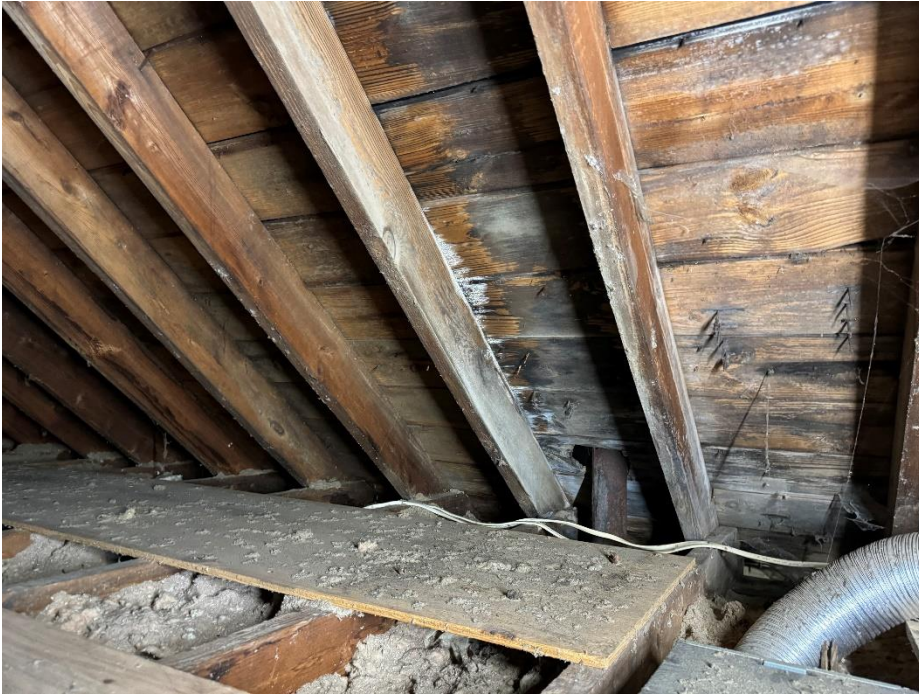
Photo 14. Bldg. 849 – Unit 3229: Moisture observed where white staining was encountered.

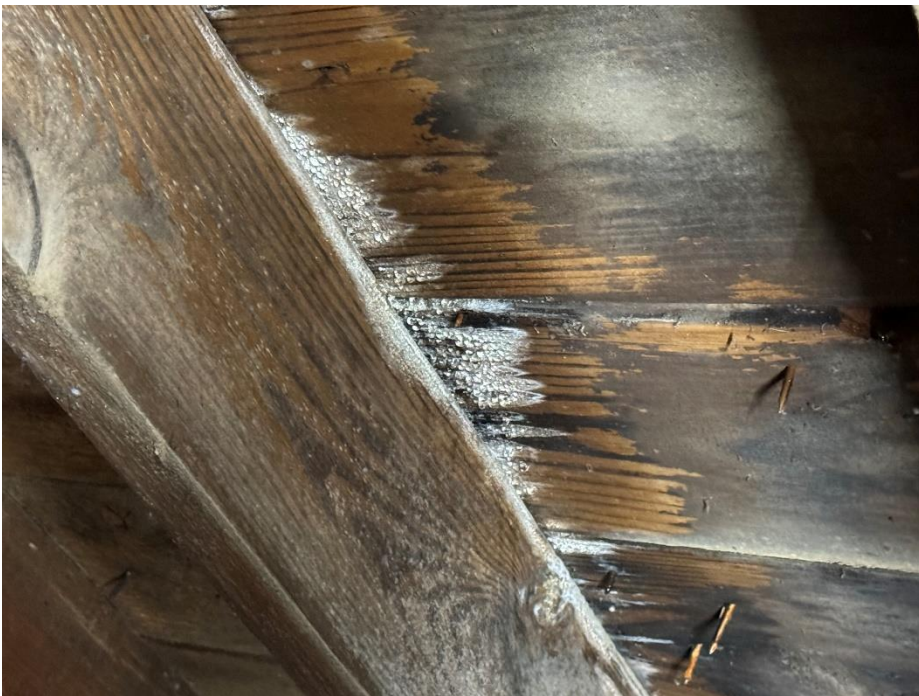
Photo 15. Bldg. 849 – Unit 3229: Red arrow pointing to deteriorated roof sheathing.

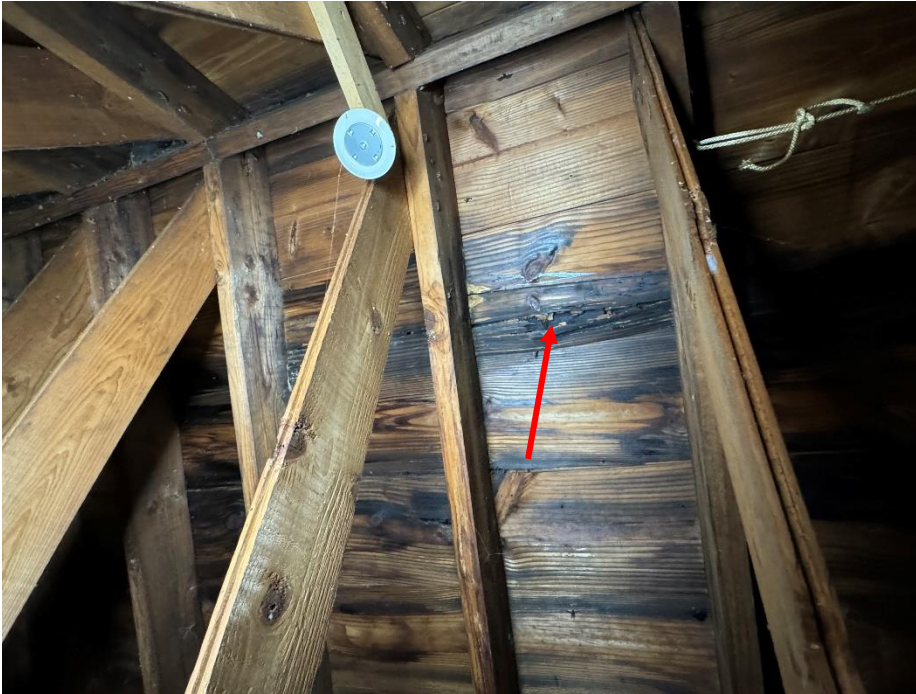
Photo 16. Bldg. 953: Cupola provides air flow for the attics of Units 1500 and 1501.

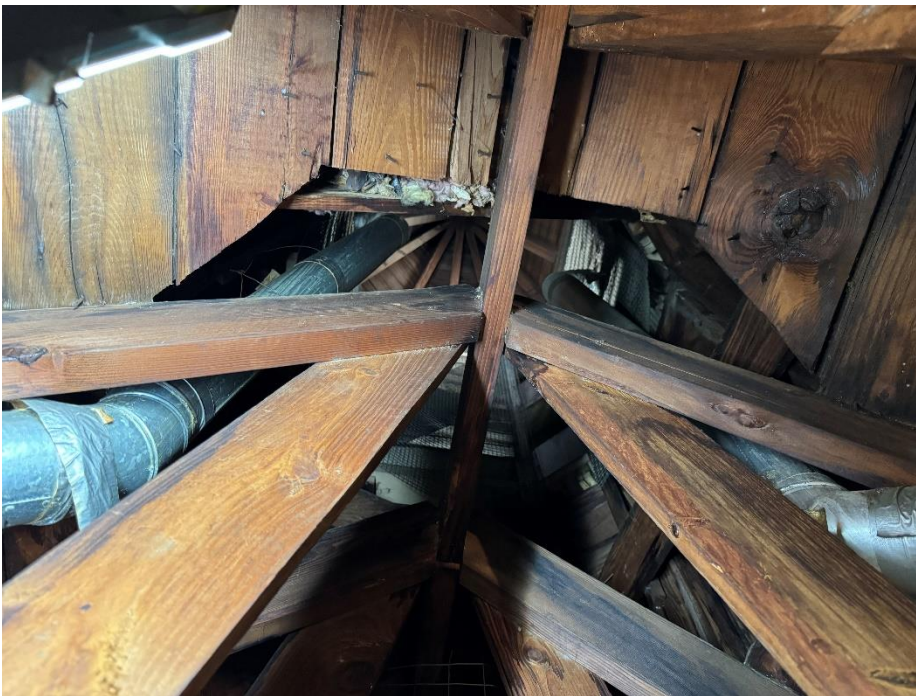
Photo 17. Bldg. 953: Red arrows pointing to moisture staining on framing for Cupola.

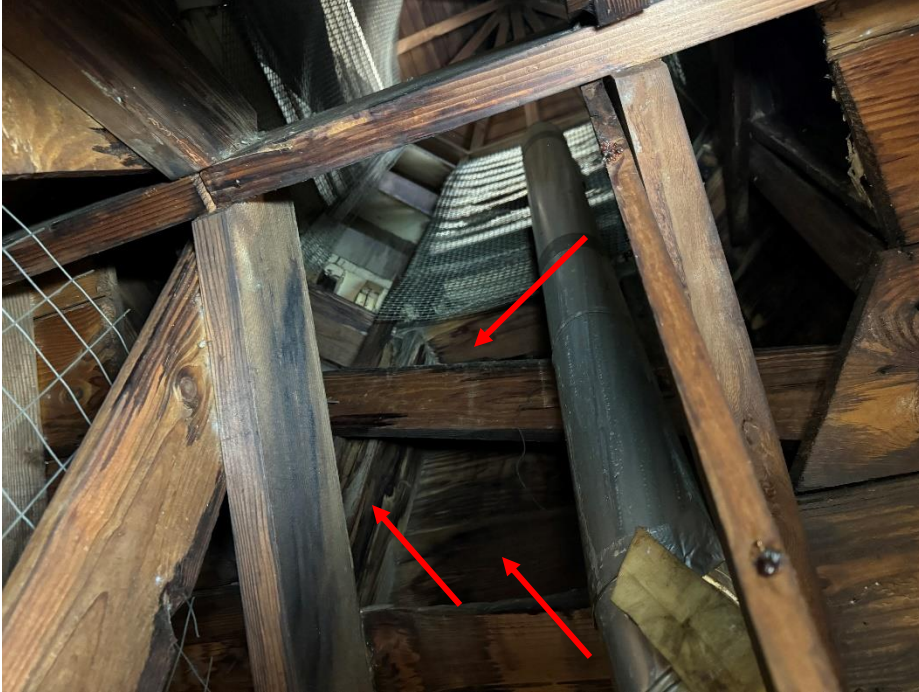
Photo 18. Bldg. 510 – Unit 3708: Red arrow pointing to dark staining on sheathing suggesting moisture intrusion. Yellow arrow pointing to nail punctures through roof sheathing.

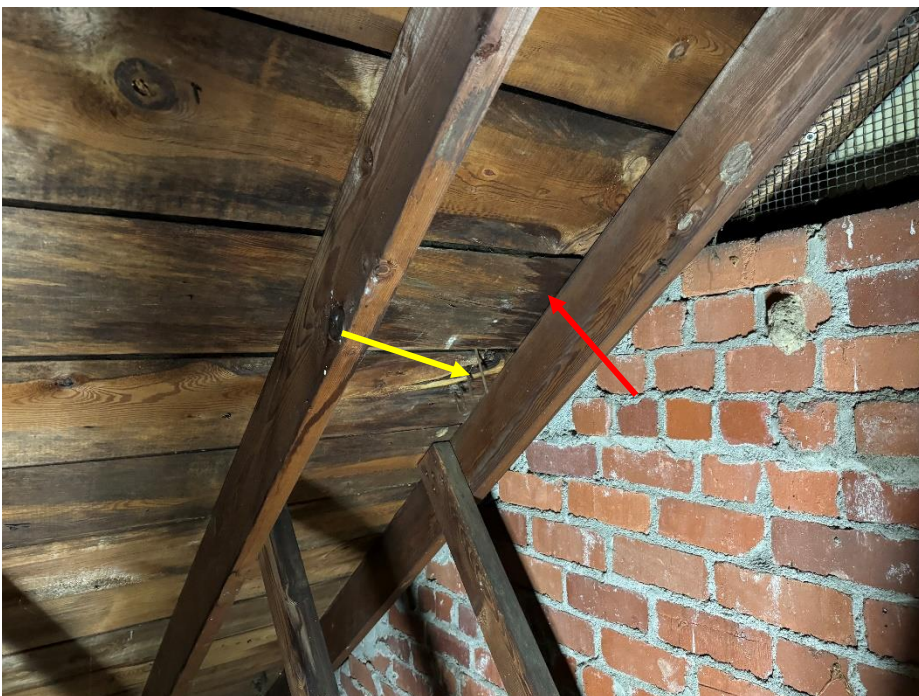
Photo 19. Bldg. 403 – Unit 1427: Red arrow pointing to crack in roof sheathing.

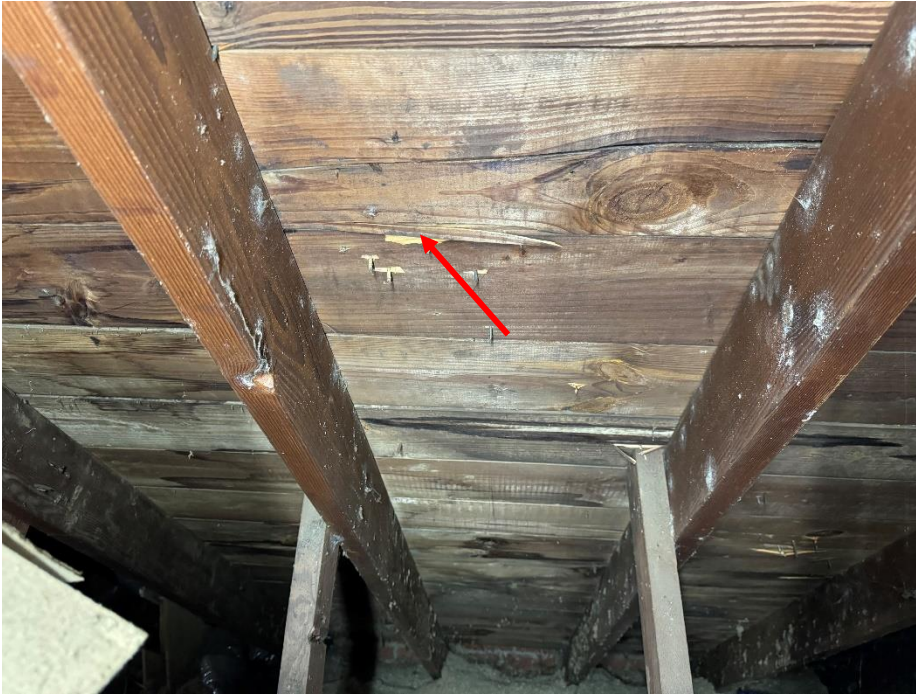
Photo 20. Bldg. 403 – Unit 1427: Red arrows pointing to coating applied on roof sheathing. Evidence of moisture intrusion on roof truss adjacent to applied coating.

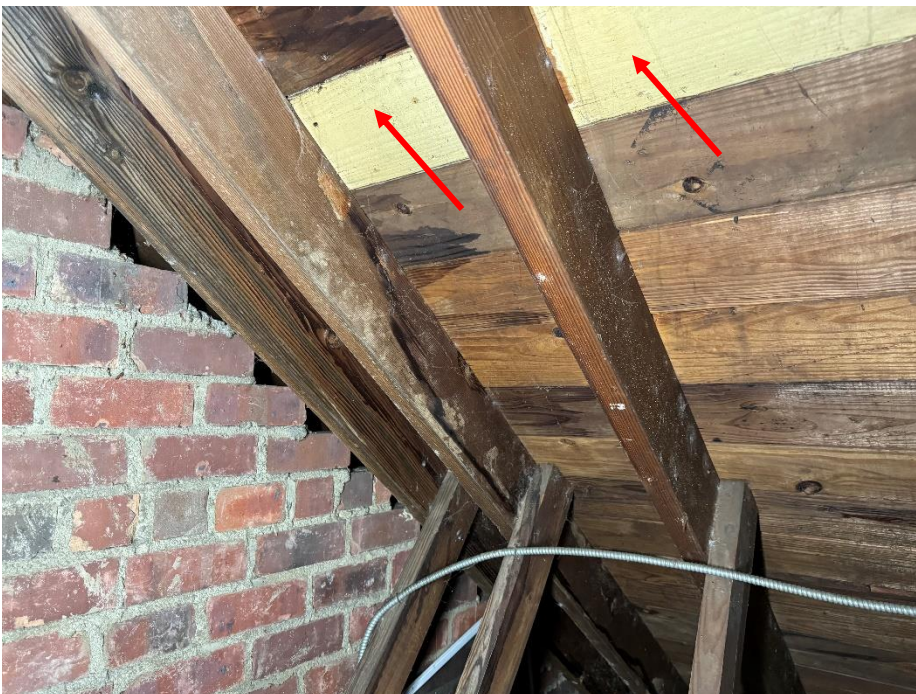
Photo 21. Bldg. 403 – Unit 1427: Red arrow pointing to coating applied on roof sheathing.
