# Building 919 Patio Repair Resolution Worksheet

September 10, 2024

Re: *Letter Summary for Building 919 Foundation Wall Assessment  
Parkfairfax Condominium  
1656 – 1670 Fitzgerald Lane (Building 919)  
Alexandria, VA 22303  
Walker Consultants Project #22-001530.00*

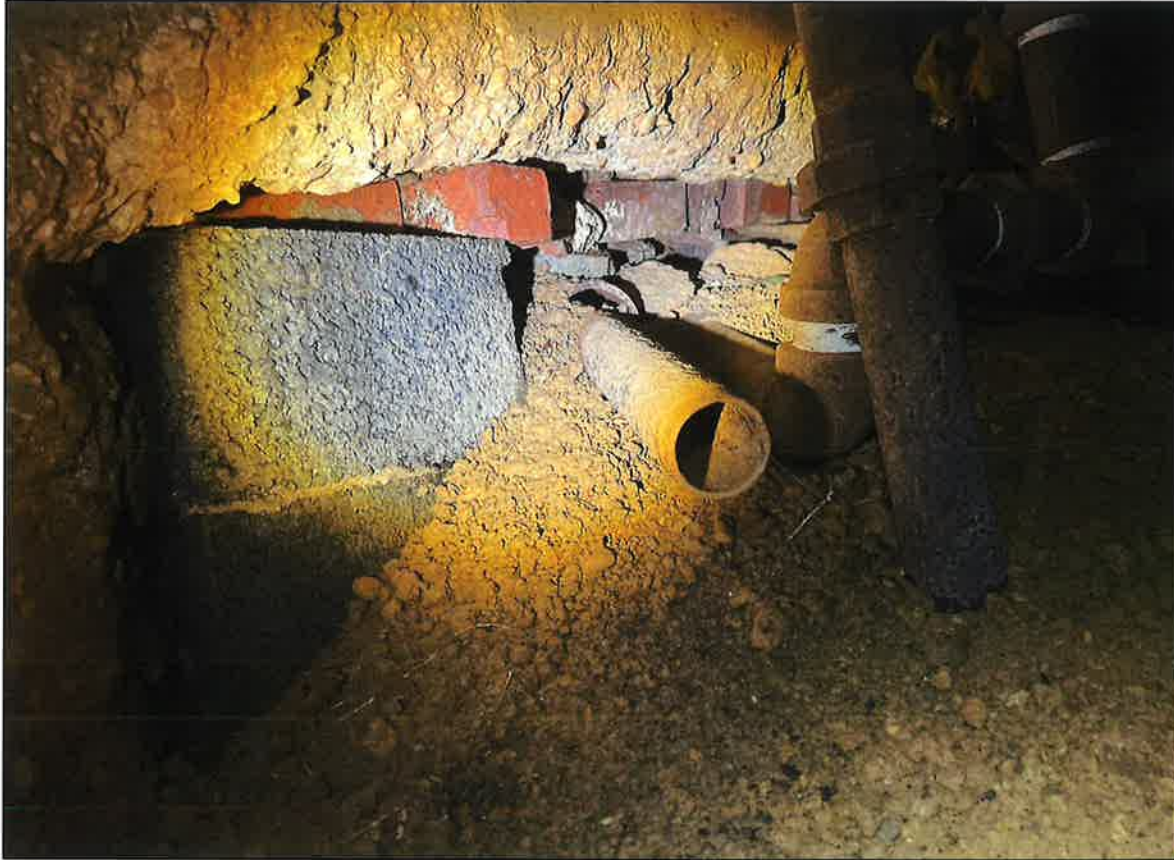
Upon entering the crawl space at the rear of Building 919, Walker observed sections/areas of the concrete foundation wall were previously cut out and filled with an infill material (CMU blocks) at three locations. At the rear elevation (Refer to Photo #1 in Appendix B) the CMU blocks are not adequate for the opening. There is also visible backfill from outside the building entering the opening in the foundation wall and into the crawl space. Along the side elevation, (Refer to Photos 2 and 3 in Appendix B) penetrations have been created for conduit and piping. The penetration shown in Photo #3 of Appendix B has been filled with miscellaneous materials.

Photo 1. Demolished foundation wall at the rear of Unit 1670's foundation wall.

1. Excavate along the rear and side elevations of Unit 1670 to expose the foundation walls and footings.
2. Perform concrete infill repairs at the three locations where the CMU was installed.

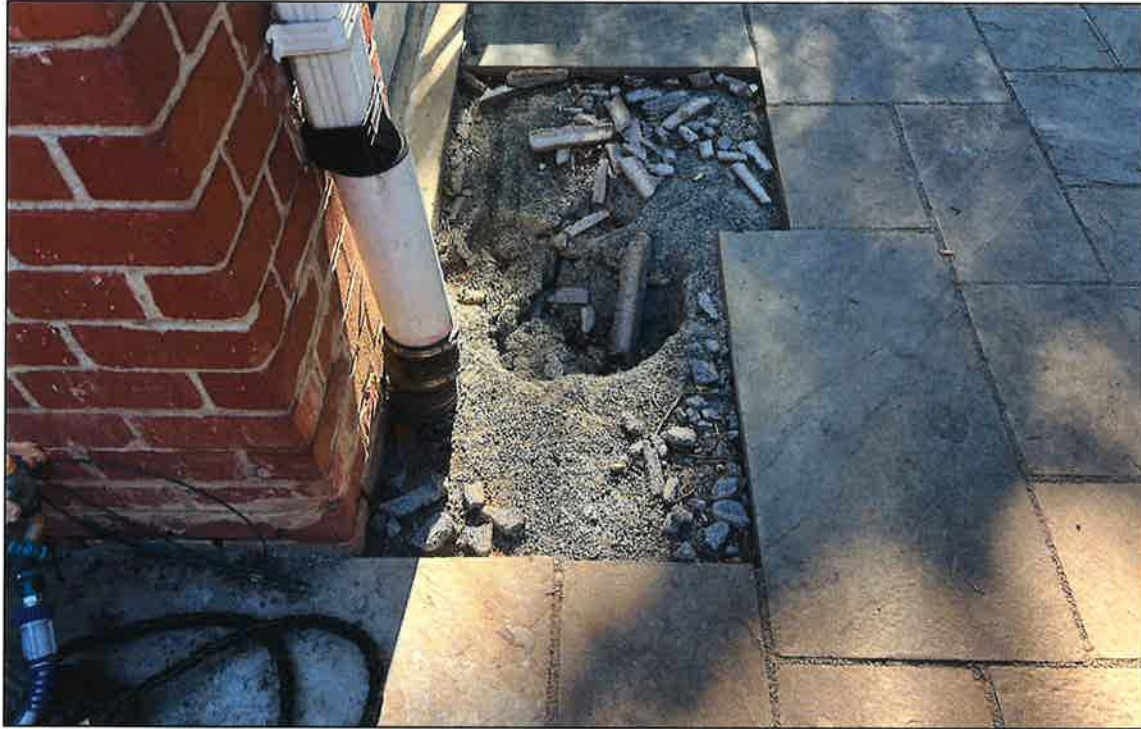
At the request of Parkfairfax Condominium, (the Condominium) Walker Consultants (Walker) performed a visual assessment of the visually and physically acceptable (Walker) portions of the foundation walls below Unit 1670 of Building 919 (the subject building). Walker was asked to perform this assessment due to reported differential movement of the patio (see Photo #4 in Appendix B) of Unit 1670 that is located at the rear elevation of the subject building.

1. The patio for Unit 1670 is experiencing differential movement due to moisture from the downspout being discharged into the ground at/adjacent to the patio.
2. The infills within the concrete foundation walls are inadequate to help support the loads from the soil acting on the foundation walls and are also allowing moisture to enter into the crawlspace. Since Walker could not locate the discharge end of the below grade downspout line, there is the possibility the downspout is providing a source of moisture that enters the crawlspace through the inadequate infills in addition to the moisture within the soil adjacent to the foundation walls.

Photo 4. Rear porch of Unit 1670 sinking towards the building.

In order to perform the repair work outlined above, the patio for Unit --- will have to be fully removed for the work to be performed. By removing the entire patio, the entire area of soil that the patio will bear on can be backfilled and compacted per Walker's construction documents.
