# Building 919 Patio Repair Resolution Worksheet

Re: *Letter Summary for Building 919 Foundation Wall Assessment  
Parkfairfax Condominium  
1656 – 1670 Fitzgerald Lane (Building 919)  
Alexandria, VA 22303  
Walker Consultants Project #22-001530.00*

# PARKFAIRFAX CONDOMINIUM BUILDING 919 FOUNDATION REPAIRS

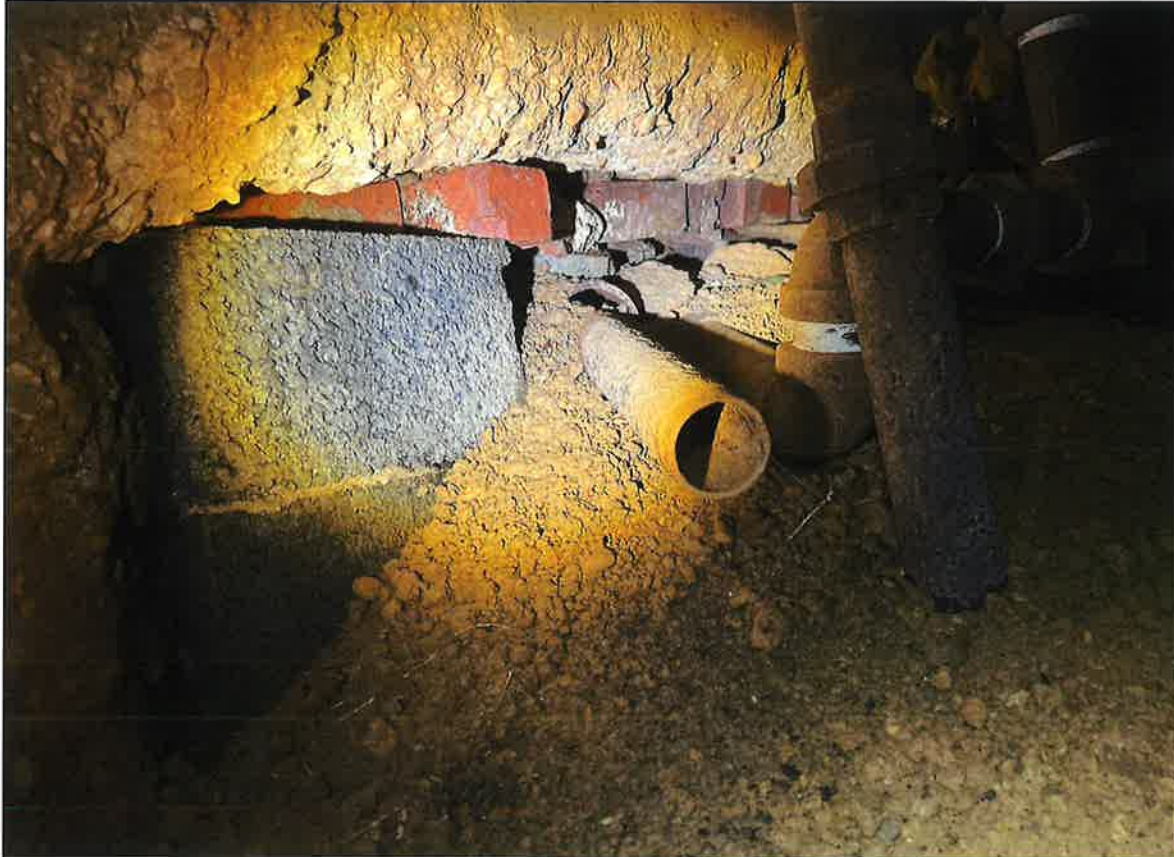
Upon entering the crawl space at the rear of Building 919, Walker observed sections/areas of the concrete foundation wall were previously cut out and filled with an infill material (CMU blocks) at three locations. At the rear elevation (Refer to Photo #1 in Appendix B) the CMU blocks are not adequate for the opening. There is also visible backfill from outside the building entering the opening in the foundation wall and into the crawl space. Along the side elevation, (Refer to Photos 2 and 3 in Appendix B) penetrations have been created for conduit and piping. The penetration shown in Photo #3 of Appendix B has been filled with miscellaneous materials.

Photo 1. Demolished foundation wall at the rear of Unit 1670's foundation wall.

1. Excavate along the rear and side elevations of Unit 1670 to expose the foundation walls and footings.
2. Perform concrete infill repairs at the three locations where the CMU was installed.

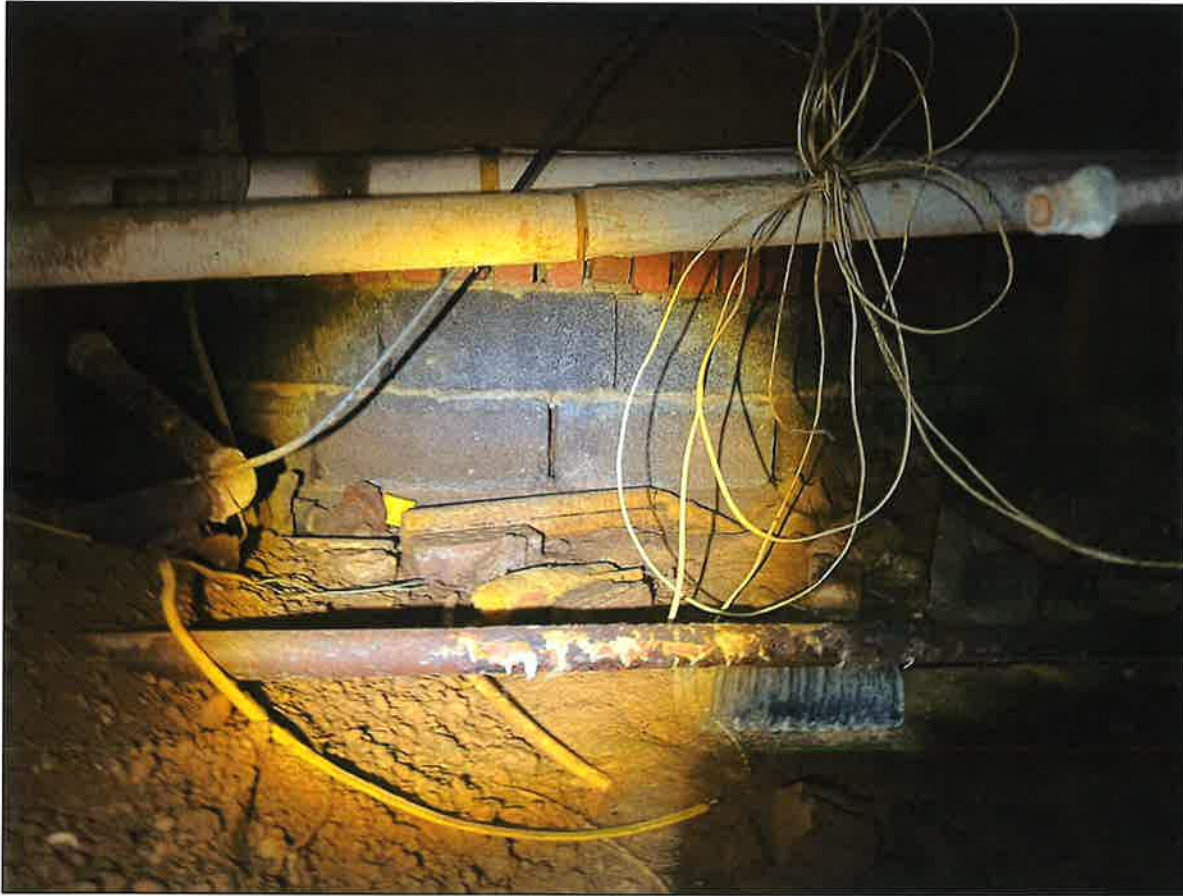
Photo 2. CMU infill at the side elevation of Unit 1670.

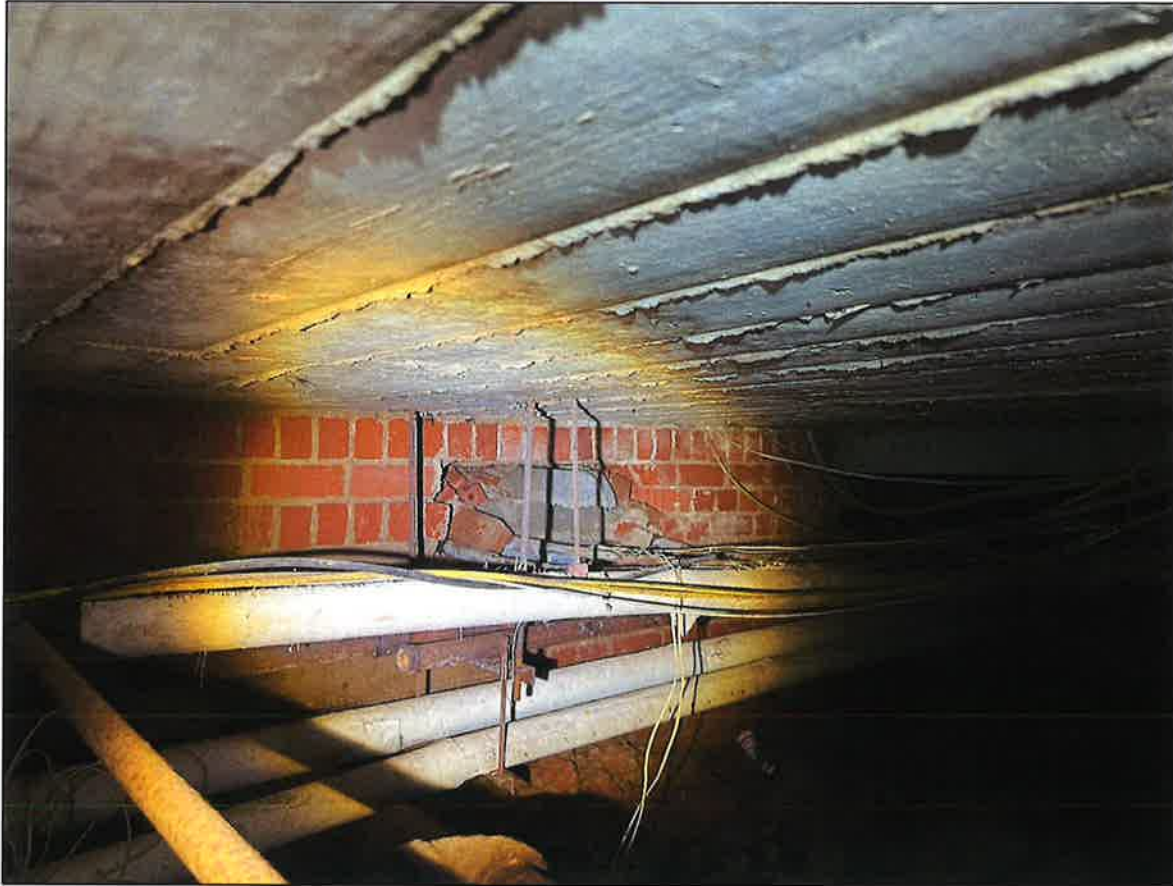
Photo 3. Opening in the side elevation foundation wall.
