Building 919 Patio Repair Resolution Worksheet

Letter Summary for Building 919 Foundation Wall Assessment Parkfairfax Condominium 1656 – 1670 Fitzgerald Lane (Building 919) Alexandria, VA 22303 Walker Consultants Project #22-001530.00

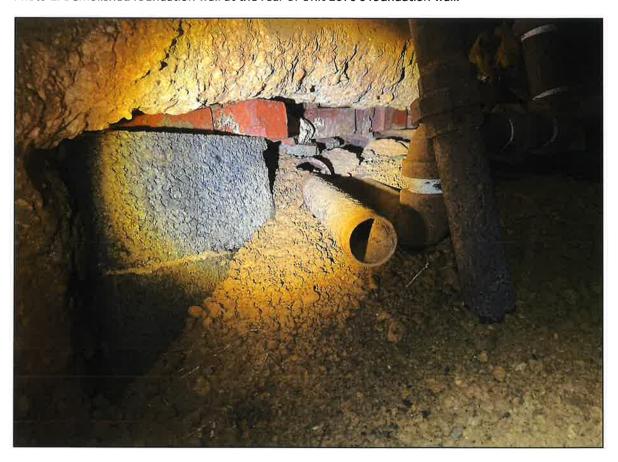
Upon entering the crawl space at the rear of Building 919, Walker observed sections/areas of the concrete foundation wall were previously cut out and filled with an infill material (CMU blocks) at three locations. At the rear elevation (Refer to Photo #1 in Appendix B) the CMU blocks are not adequate for the opening. There is also visible backfill from outside the building entering the opening in the foundation wall and into the crawl space. Along the side elevation, (Refer to Photos 2 and 3 in Appendix B) penetrations have been created for conduit and piping. The penetration shown in Photo #3 of Appendix B has been filled with miscellaneous materials.

Photo 2. CMU infill at the side elevation of Unit 1670.

- 1. Excavate along the rear and side elevations of Unit 1670 to expose the foundation walls and footings.
- 2. Perform concrete infill repairs at the three locations where the CMU was installed.

- 3. Install a steel lintel at the elevated repair location on the foundation wall along the side elevation of unit 1670.
- 4. Install a cementitious parge coating, cold-applied waterproofing, and drainage board with filter fabric.

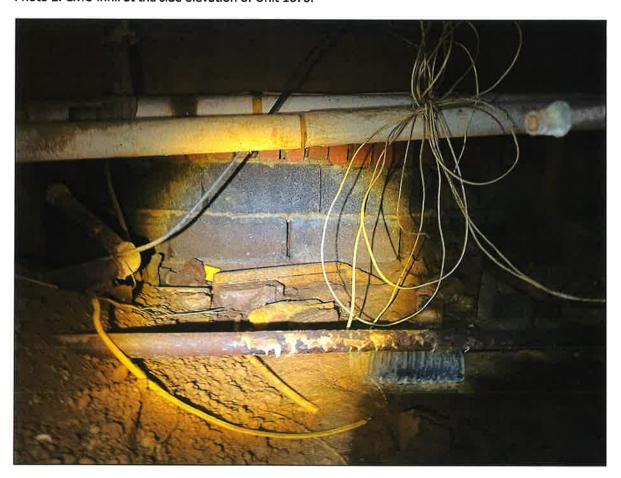
Photo 3. Opening in the side elevation foundation wall.
