**Landscaping Approach to 1631
Ripon Place**

BLDG 843

1631 RIPON PLACE
PARTIAL LANDSCAPE PLAN REAR TERRACE
1"=10' MARCH 2020

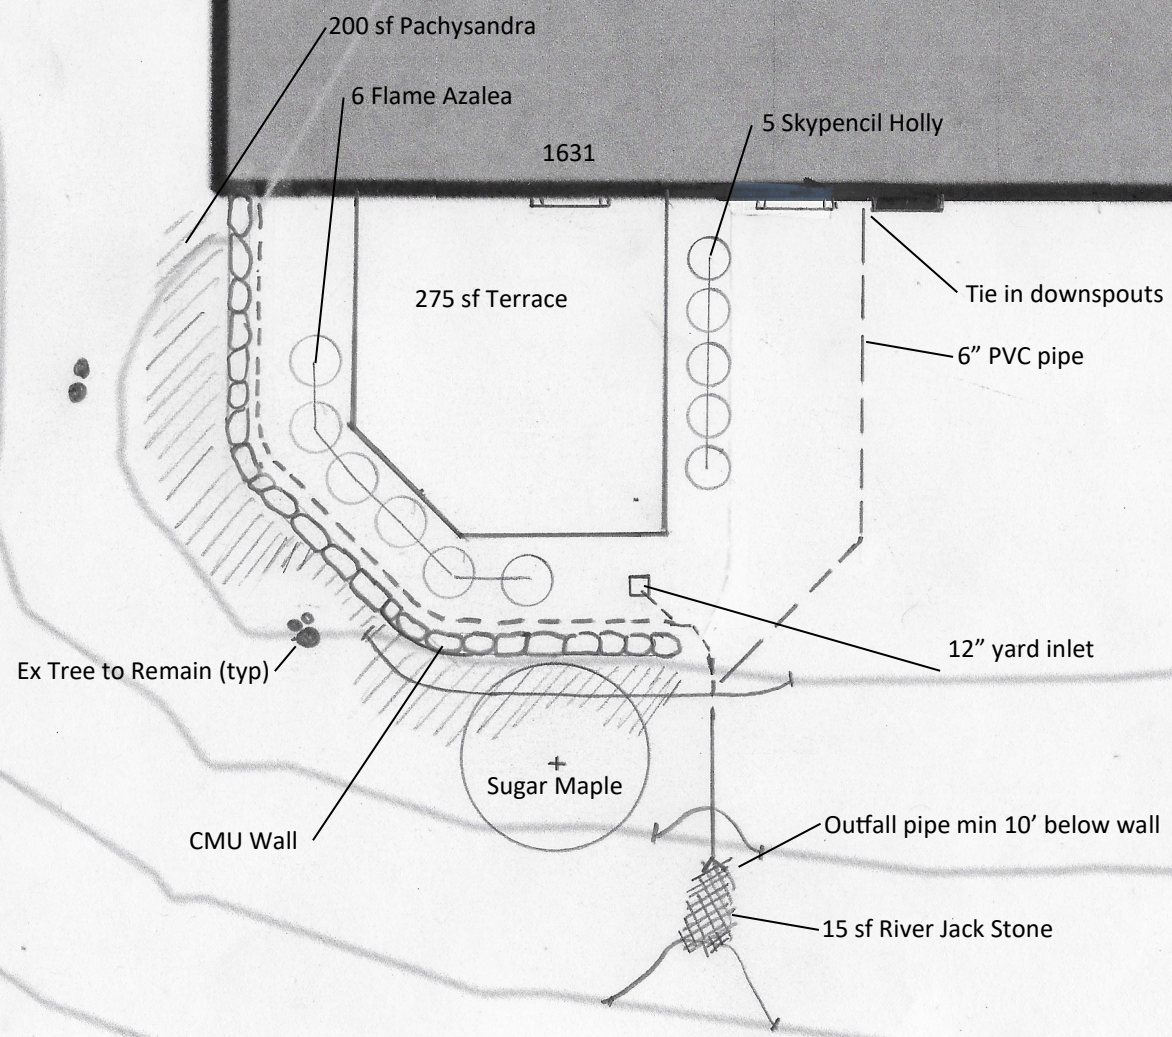
Our assessment is similar to that of the landscape architects. The resident's patio appears to have settled and the stone retaining wall appears to have moved as well. However, the building distress did not appear to be significant enough to warrant geotechnical involvement. We observed settlement cracks at the back-right corner of the building which may or may not be related to the slope. The corner wall appeared to be planar so we do not have cause for immediate concerns related to the building structure. We recommend repointing the cracks at the back corner and monitor for re-cracking.

We discovered a soaker hose on the top of the patio in the dirt area directly above the stack stone. The influx of water may have contributed to the soil behind the stone washing away causing some of the slump or creep.....the opposite end of the building has the same wall construction although the elevation is different it has no noted issues.

1. Prior to the construction of the proposed ledgerstone wall, the existing flagstone terrace should be removed. Any sound flagstone material removed may be set aside for use in the construction of a new terrace. Construction of any new terrace or other site features in place of the terrace to be removed should be delayed until the new ledgerstone wall is completed, other site grading is completed, and all drainage elements are in place.

2. Any new terrace should not exceed the footprint or square footage shown on the plan such that grading and drainage can be facilitated.
3. Existing tree(s) are to be removed prior to the construction of the proposed wall.

4. Proposed cmu wall is to be Techo Bloc Mini-Creta Stone in Shale Grey (or equal).
5. Proposed cmu wall is to be constructed immediately in front of the existing wall, but far enough in front of the existing wall such that a footer trench can be dug 18" wide and 18" deep.

6. Footer trench is to be compacted and then filled with concrete.
7. Existing wall stone should be carefully removed no more than 3 "courses" at a time so as to minimize soil (backfill) disturbance. Existing wall should be taken down to the level where the geo-grid (if required) for the cmu wall will be placed.

8. Proposed wall is to be back-filled with gravel and 6" drainage pipe per manufacturer standards.
9. Area between the proposed wall and any proposed terrace should be a minimum of 5' wide and be graded so as to promote positive drainage away from the building and toward the proposed yard inlet and end of the proposed wall. The area between 1631 and 1633 is to be similarly graded.
