May 2021 Reserve Expenditures Resolution Worksheet

May 2021 Reserve Expenditures Reported in June 2021

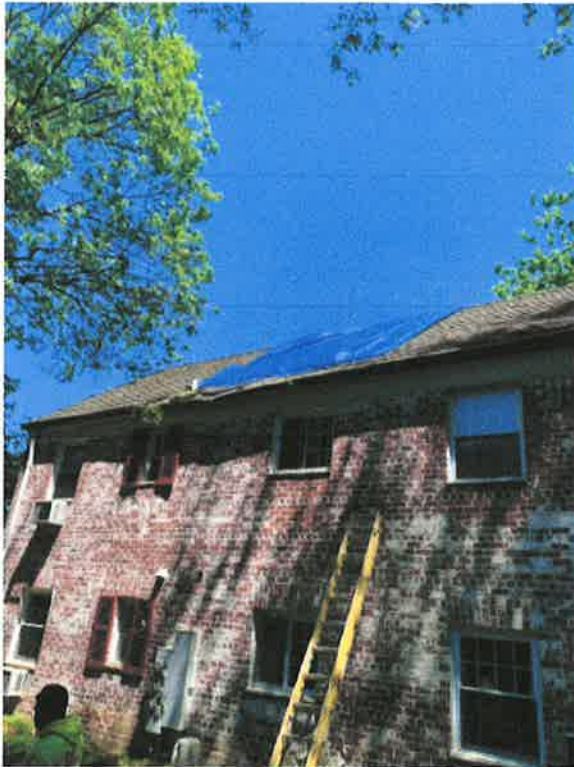
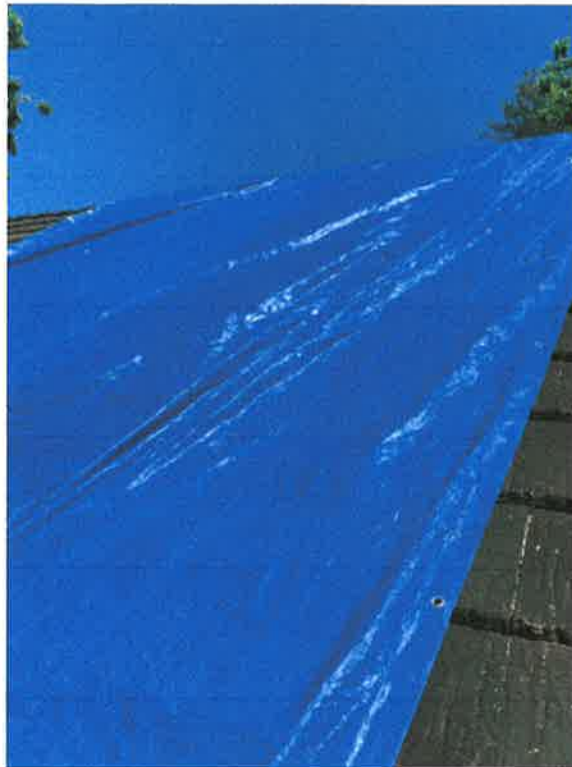
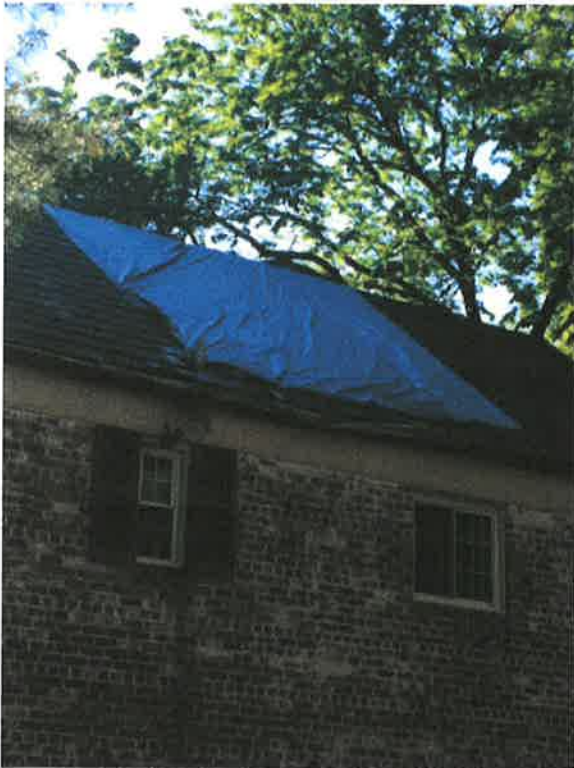
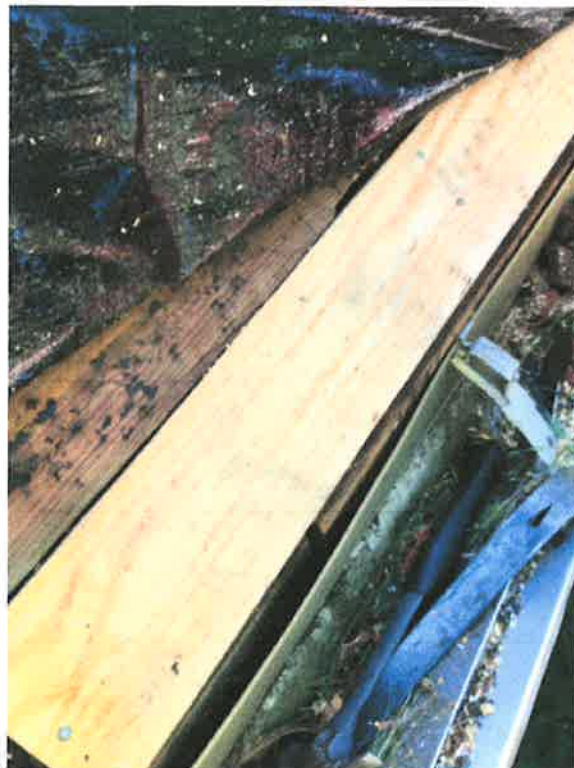
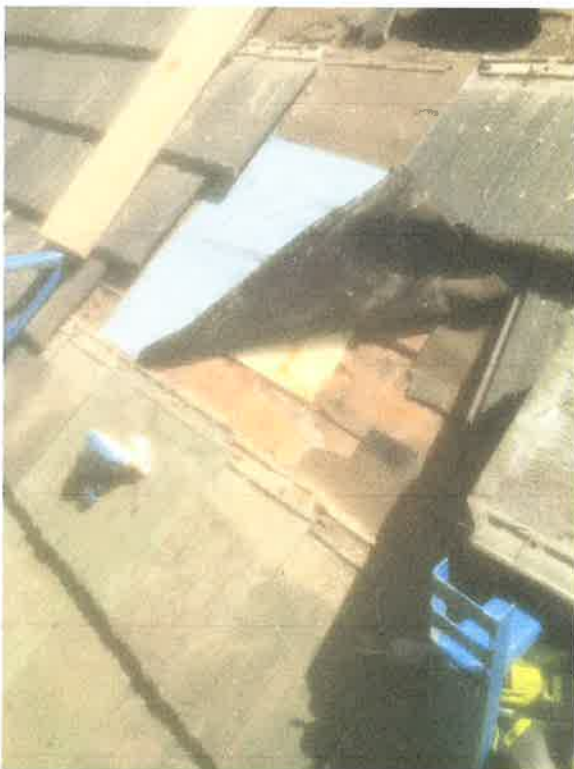
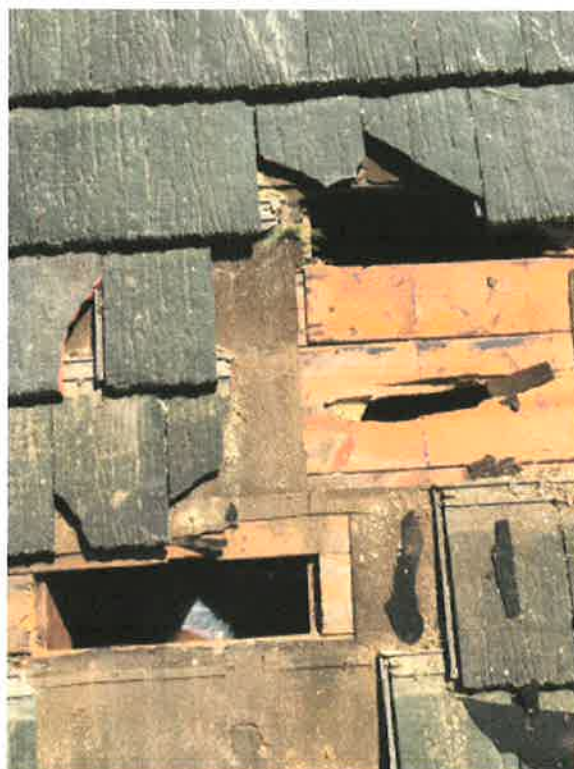
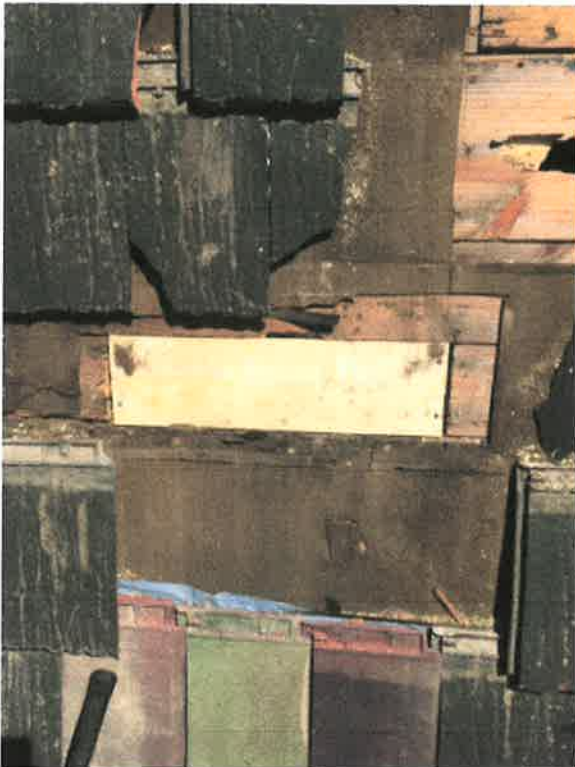
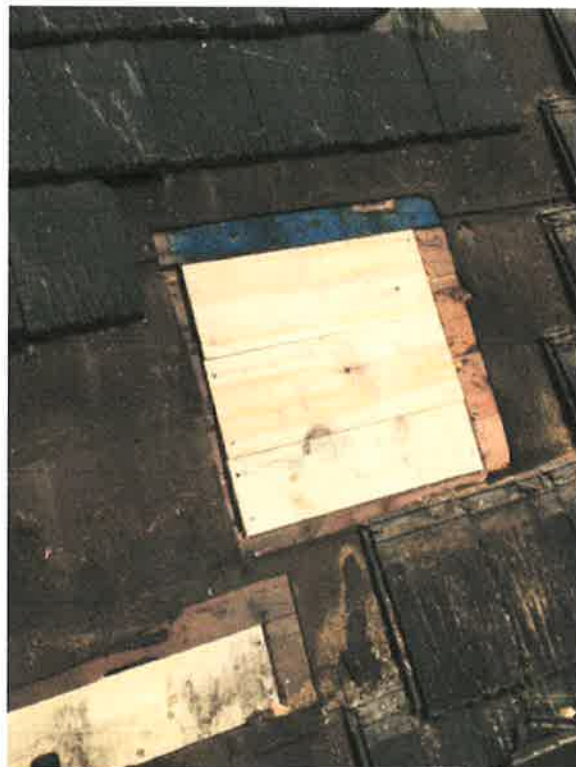
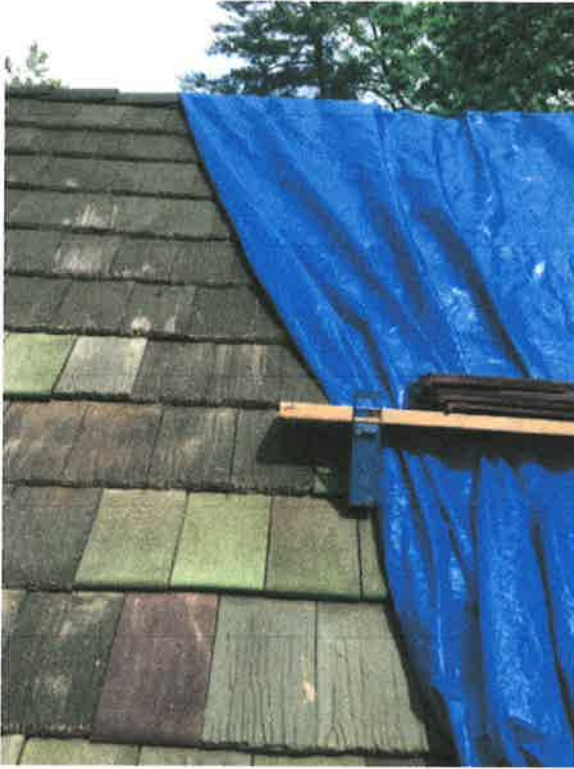
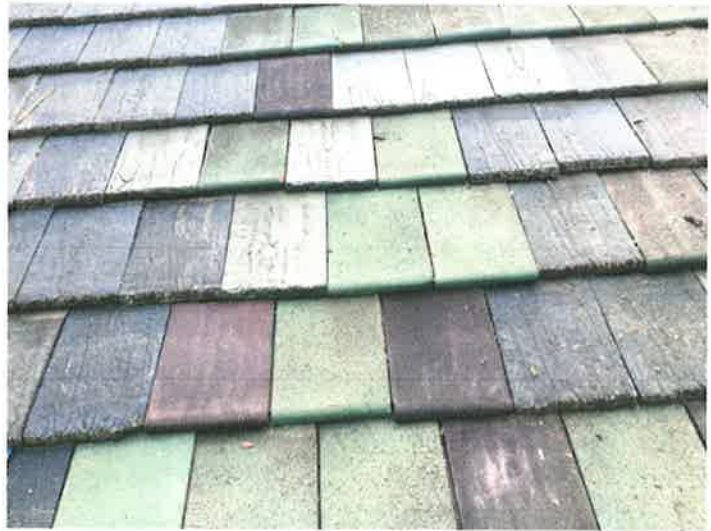
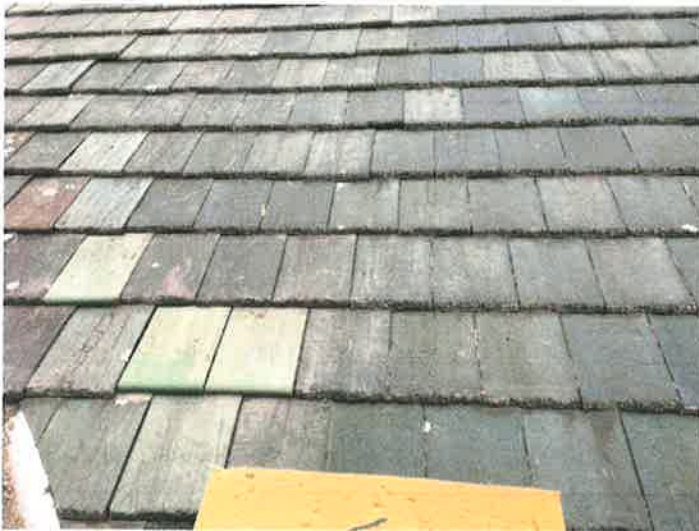
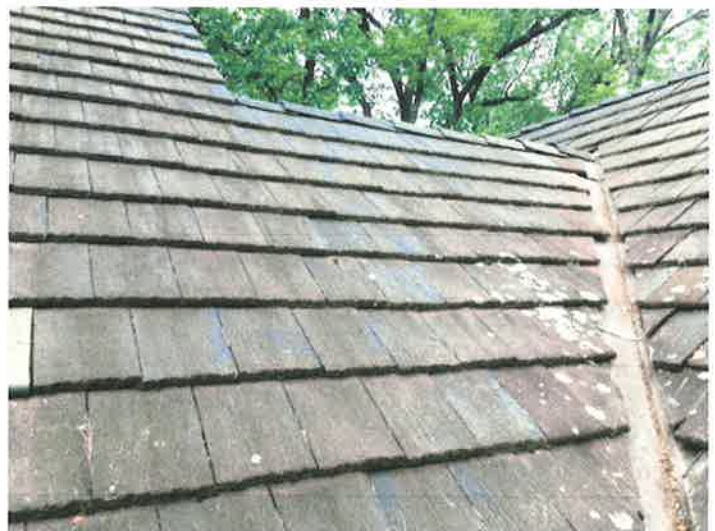
1124 Valley

- 1124/1136 Valley Dr: The crew started on the tree damage. Replacing 40+ tiles, 40' of decking, and installing new underlayment.

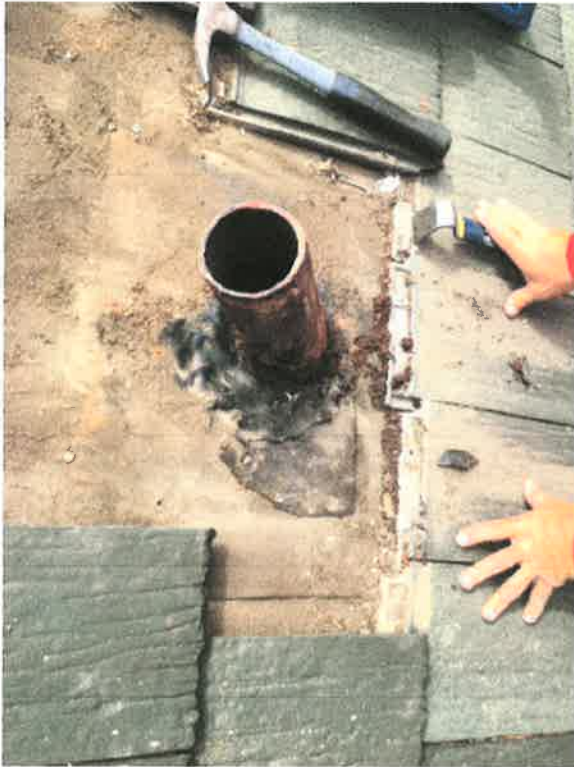
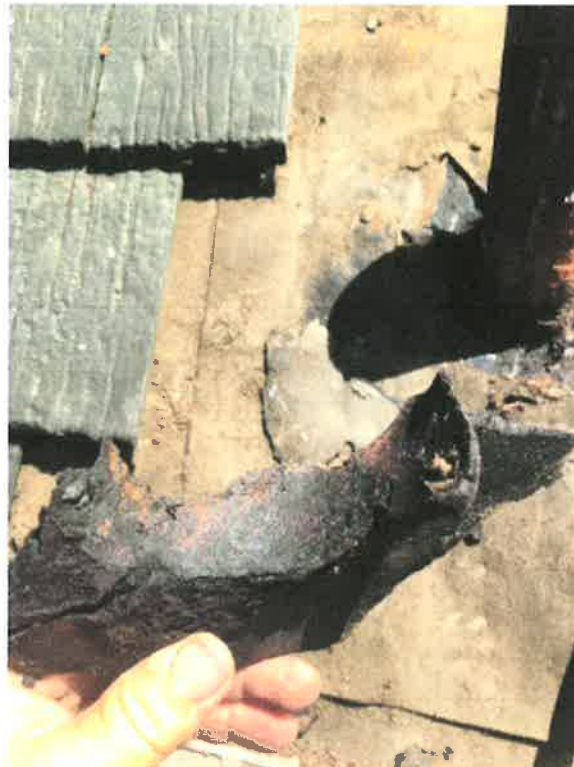
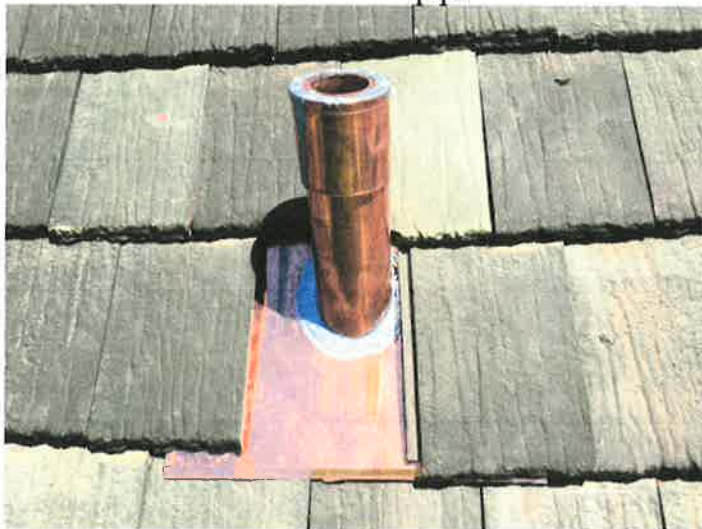
3771 Gunston pipe

- 1801 Preston: Replaced copper flashing and measured the front porch roof which is failing. We will have pricing over for this shortly.
- 3767 Gunston: Replaced nine tiles.
- 3771 Gunston: Replaced a pipe collar with copper and new underlayment to surround it.
