PARKFAIRFAX UNIT OWNERS ASSOCIATION
Board of Directors Meeting and Budget Workshop
9:00 am, Saturday, January 24, 2026

The Parkfairfax Transportation and Land Use Committee (TLUC) launched an initiative to examine all buildings and common element areas in all five wards to identify and prioritize potential safety hazards. Nearly 300 issues were identified, the majority being common element exterior steps lacking handrails as well as uneven common element walkways and flagstones. TLUC members and outstanding community volunteers performed the inspections in October 2022.

SUMMARY

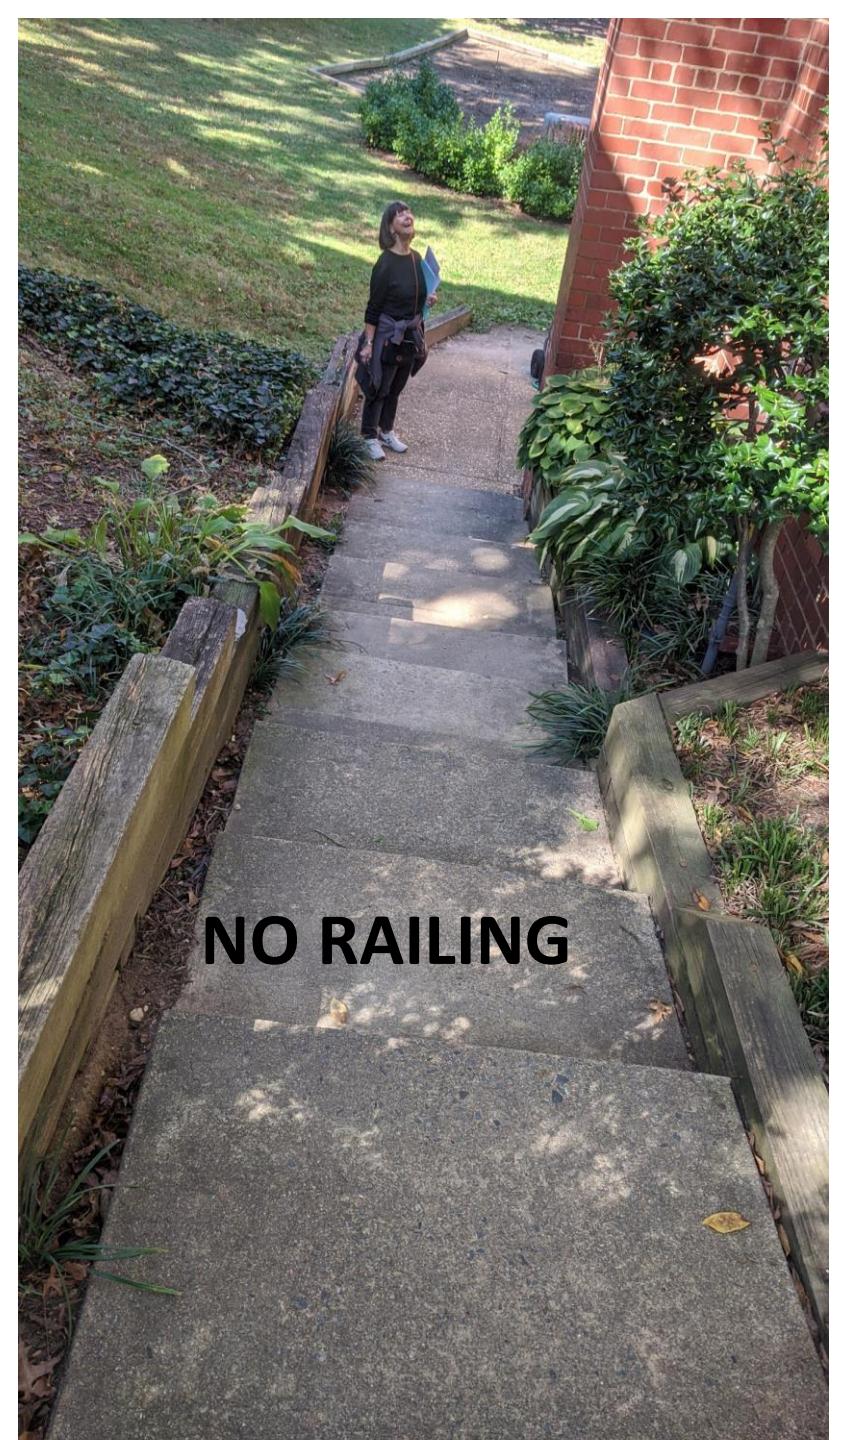
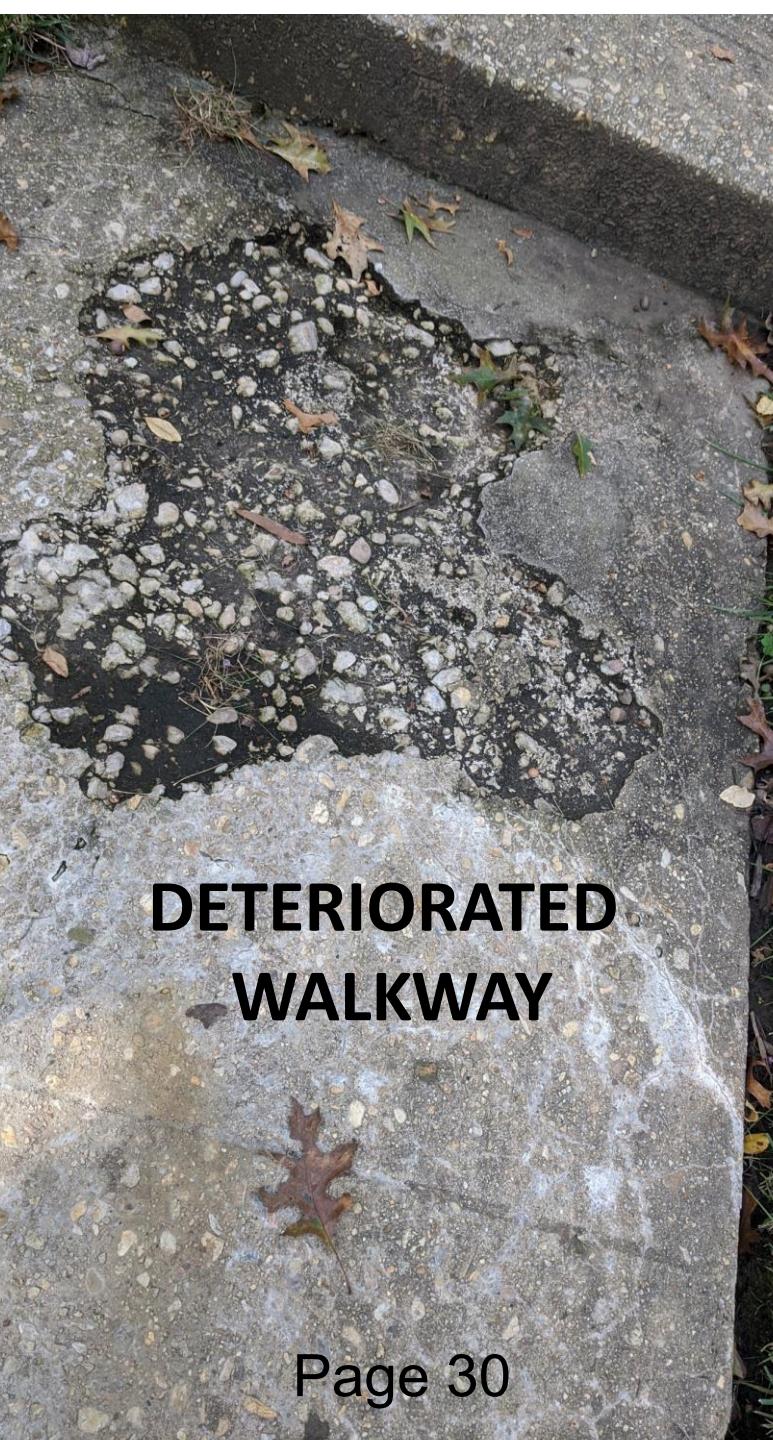
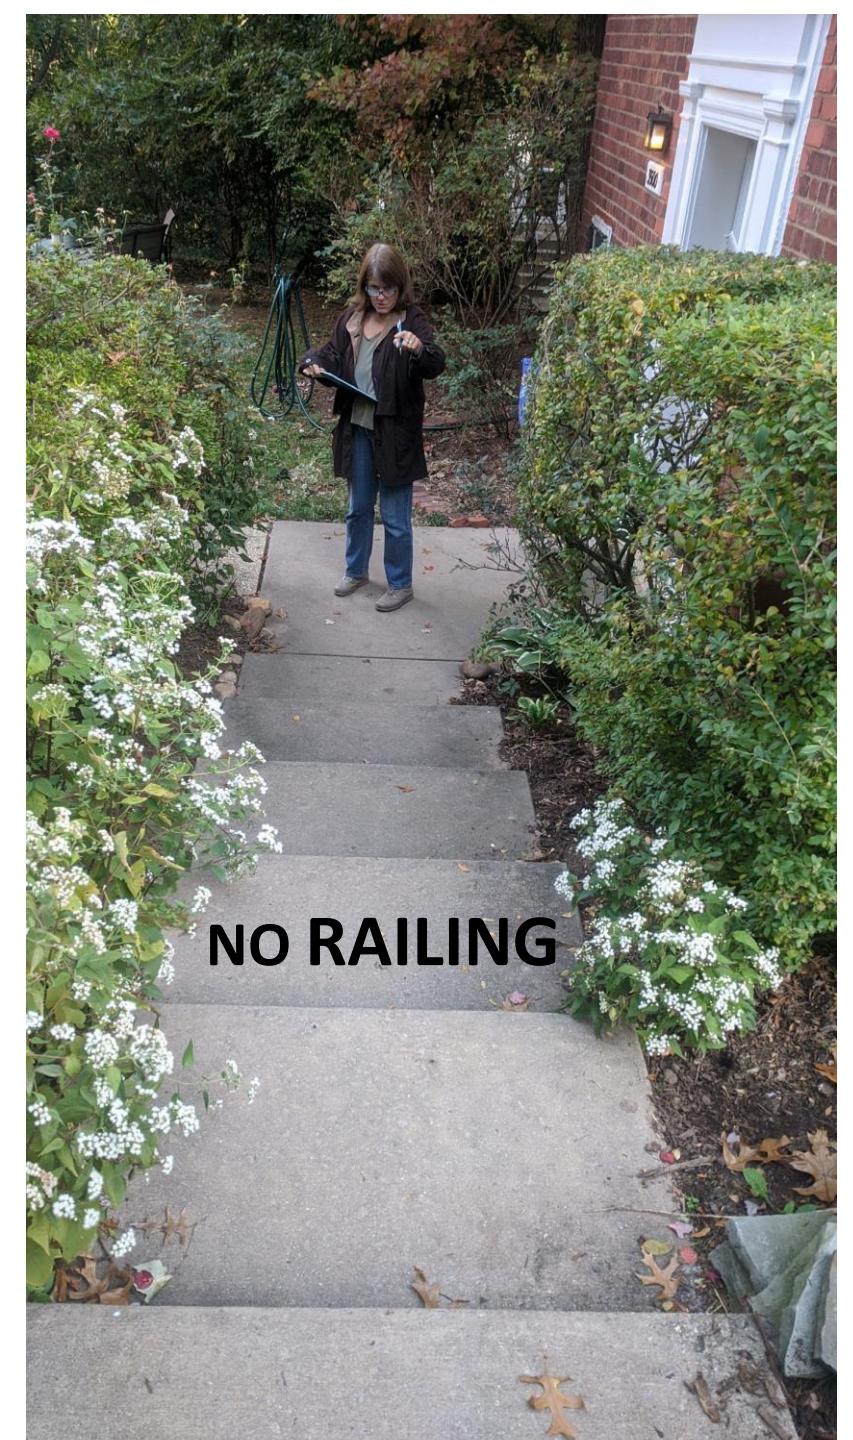
Following an organizational meeting and “dry run” walkthrough, inspectors examined every building and surrounding common element areas recording and photographing observed hazards and noting their severity. Six representative photographs are attached and photographs of specific areas of concern are available upon request.

**UNEVEN
WALKWAY**

**TRICK
STEPS
(no railing)**

As Parkfairfax prepares a multi-year budget, the TLUC recommends a phased approach to correcting the discrepancies noted in this report. Attached are two spreadsheets documenting the findings, one sorted by ward and the other sorted by priority. As noted above, the priorities were assigned by the individual volunteer inspectors and opinions may differ. A professional review is recommended prior to developing a work package for remedial action.

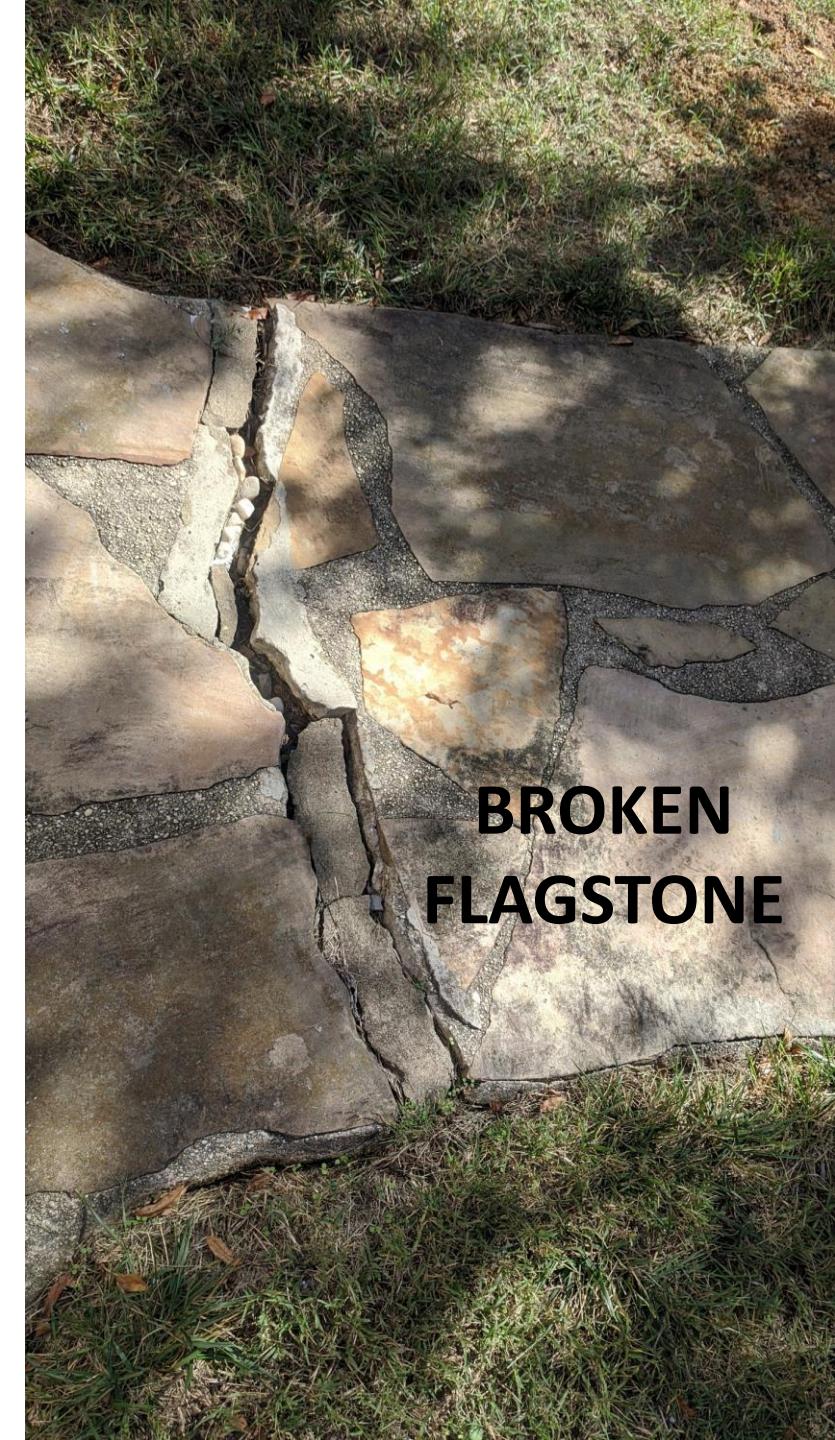
**BROKEN
FLAGSTONE**

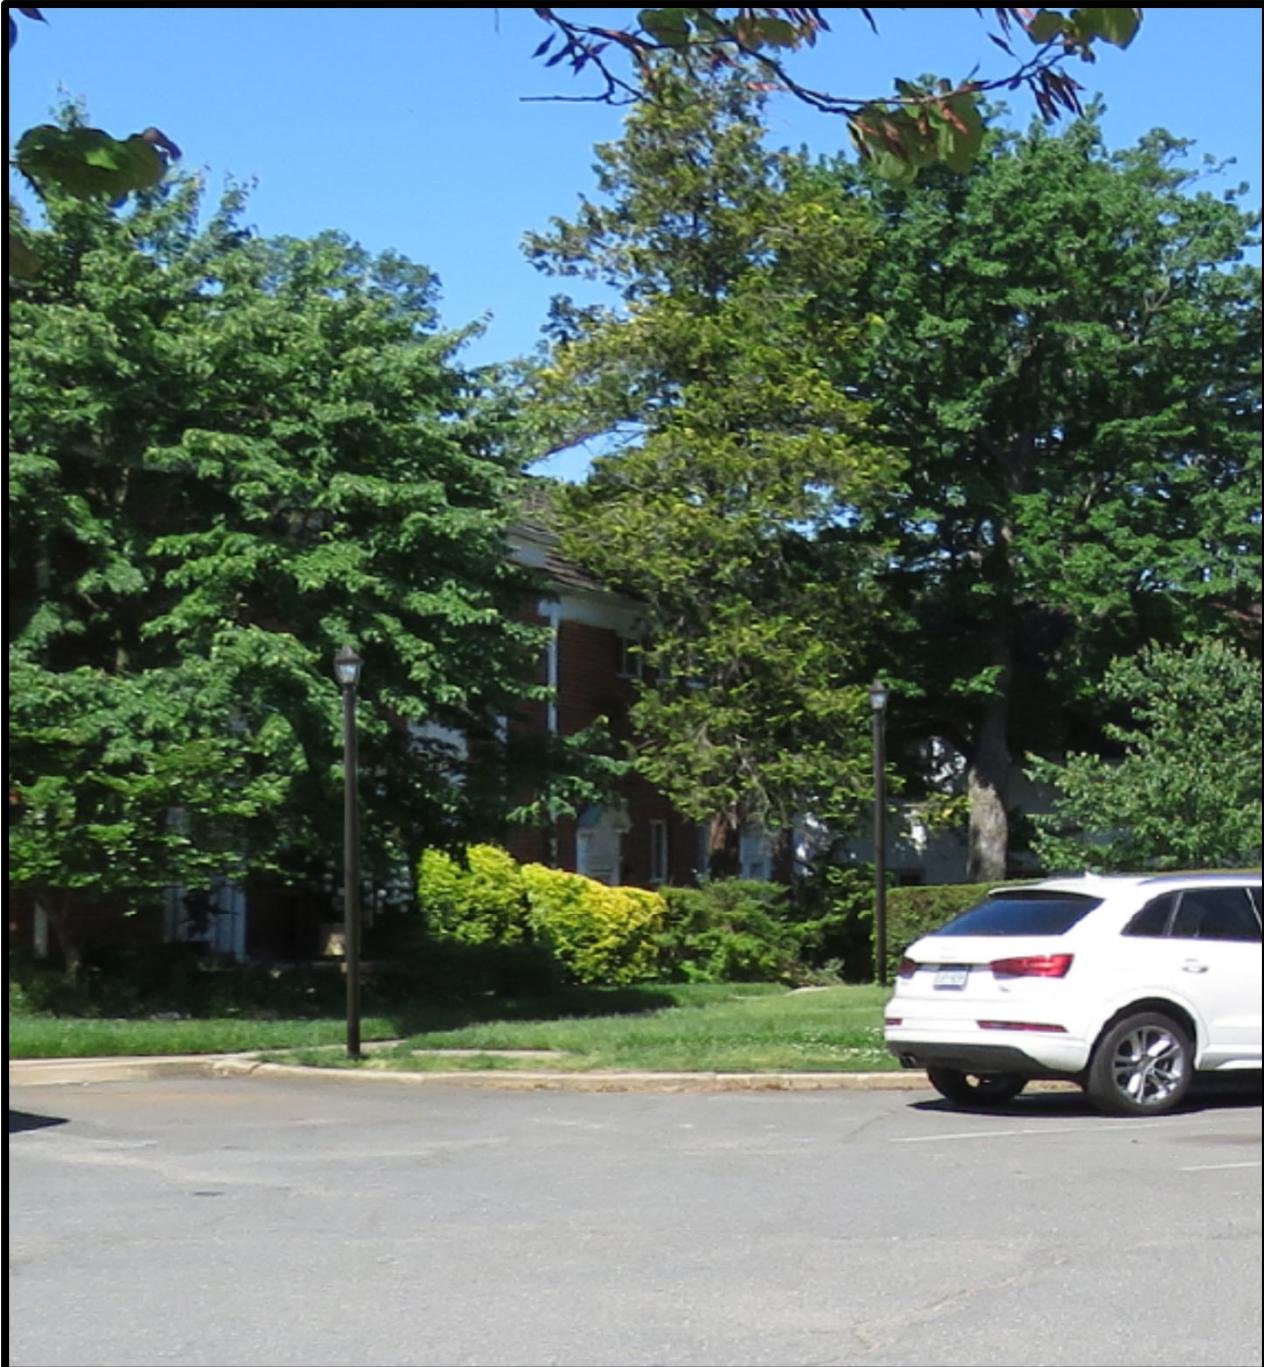
The photo below is a similar look at what the Classic 1 fixture would look like installed in the walkways from the parking lots to between the buildings.

This is the NLS Classic 1 fixture that we recommend as an option to getting better light levels throughout the walkways on the property. We would need to get confirmation that power would be able to be provided before we start specifying locations for them. These are priced at \$745 per fixture, along with about \$600 per pole. The next page is a glimpse at what it would possibly look like with these installed in the walkways between buildings.

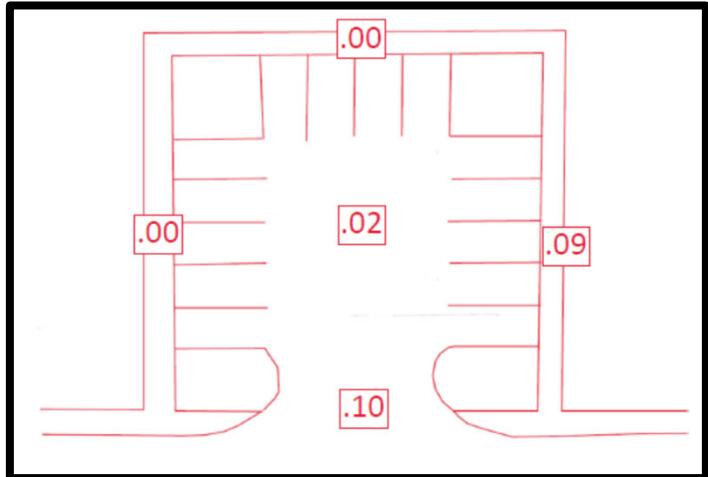
Parking Area # 1

Footcandle Readings Found

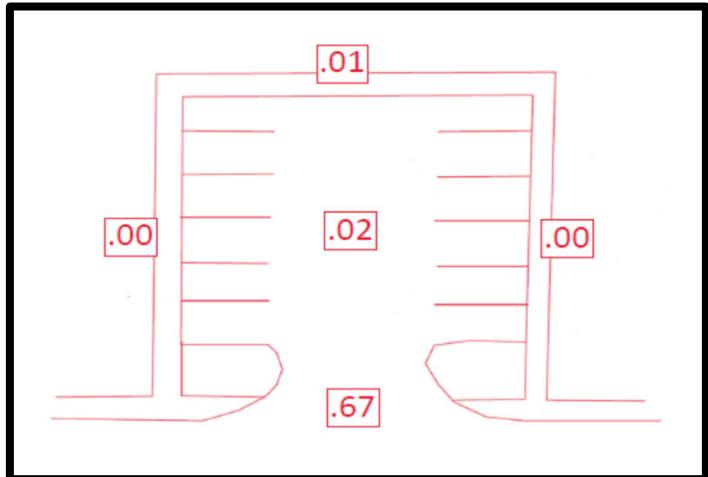
Parking Area # 2

Footcandle Readings Found

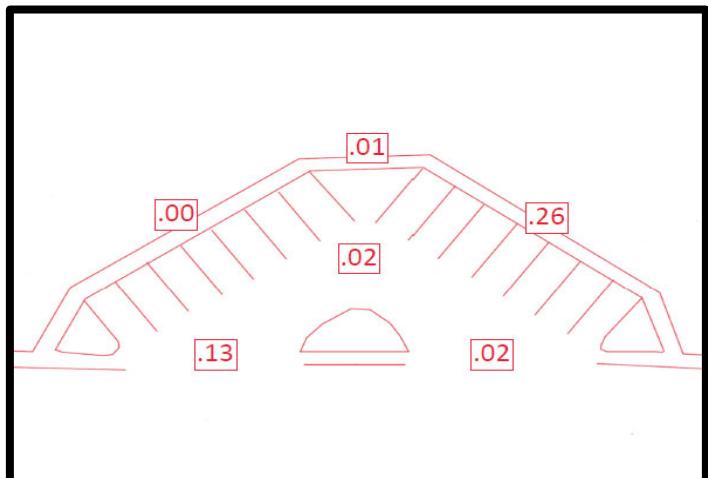
Parking Area # 3

Footcandle Readings Found

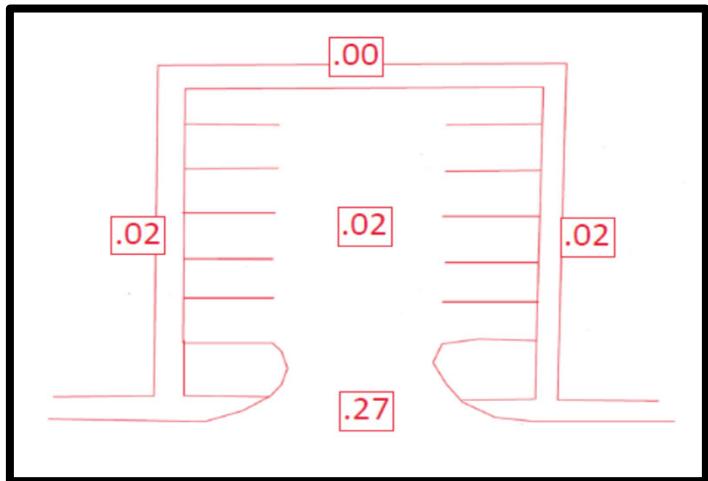
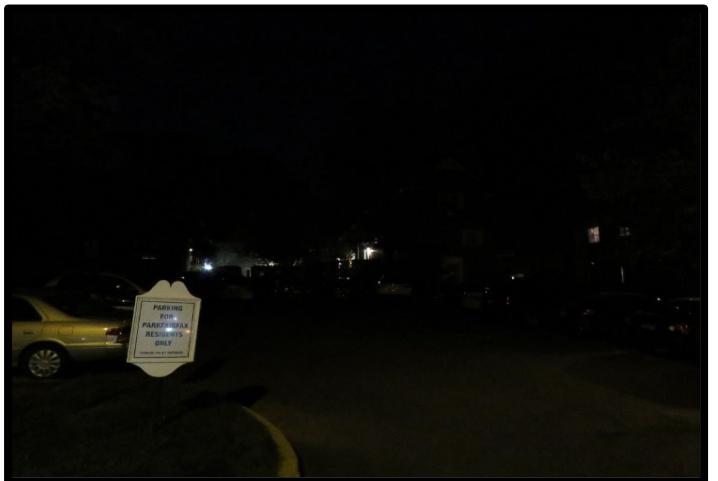
Parking Area # 4

Footcandle Readings Found

Night Photo

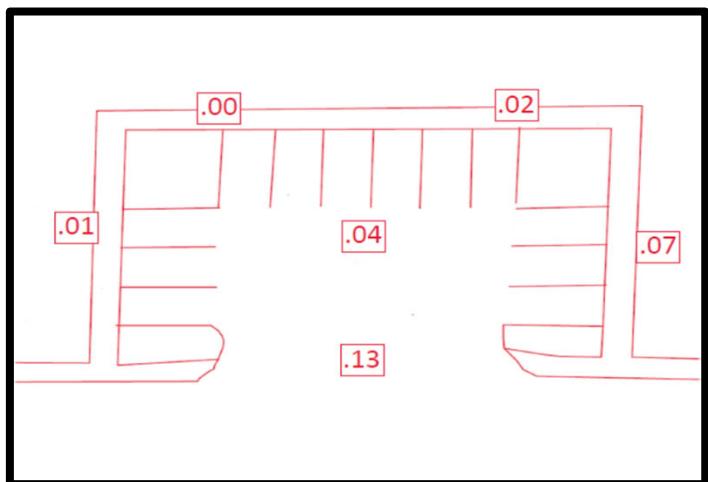
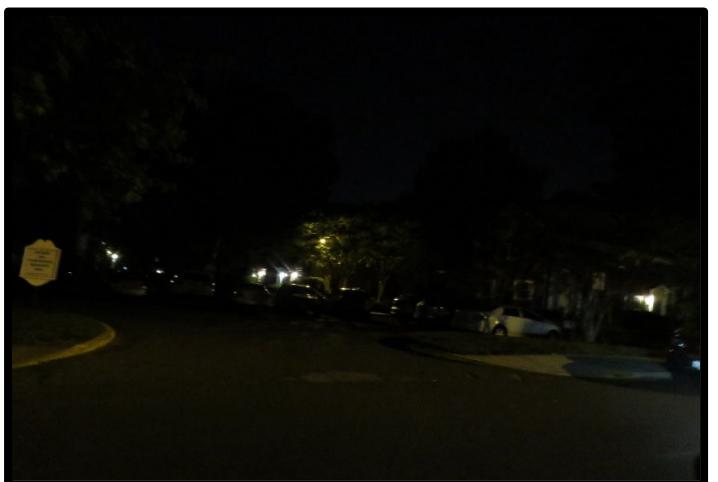
Parking Area # 5

Footcandle Readings Found

Night Photo

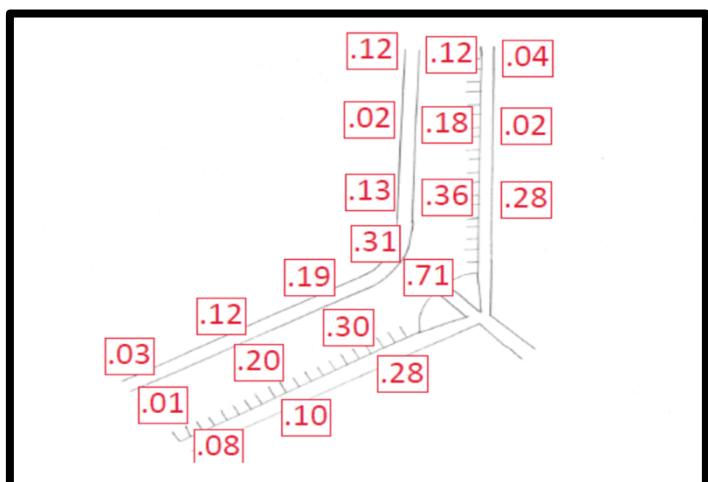
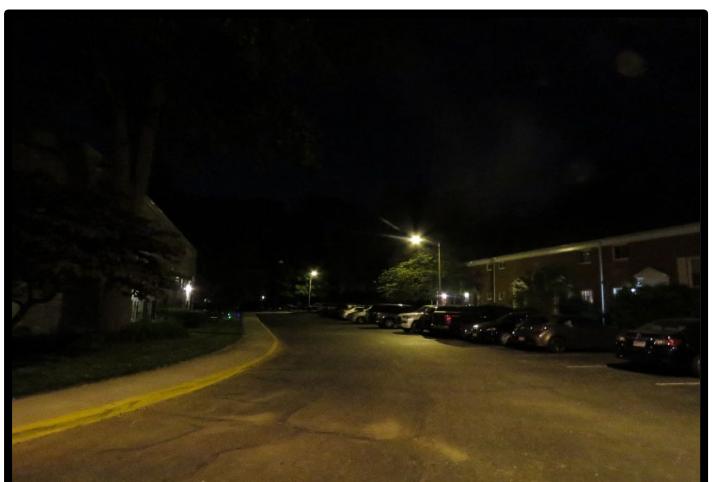
Parking Area # 6

Footcandle Readings Found

Night Photo

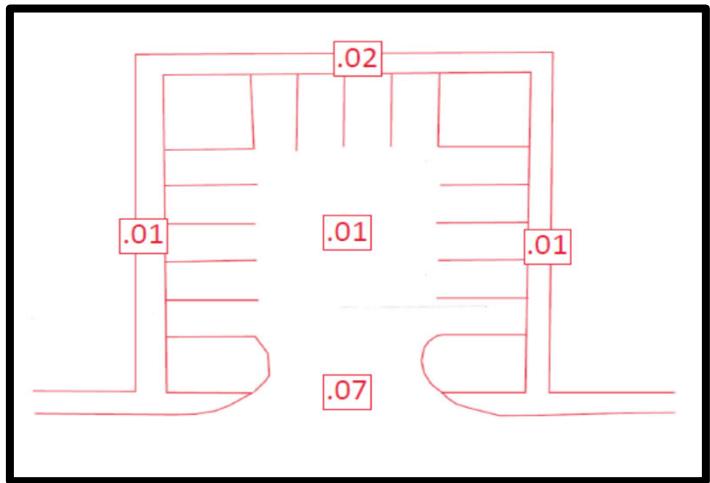
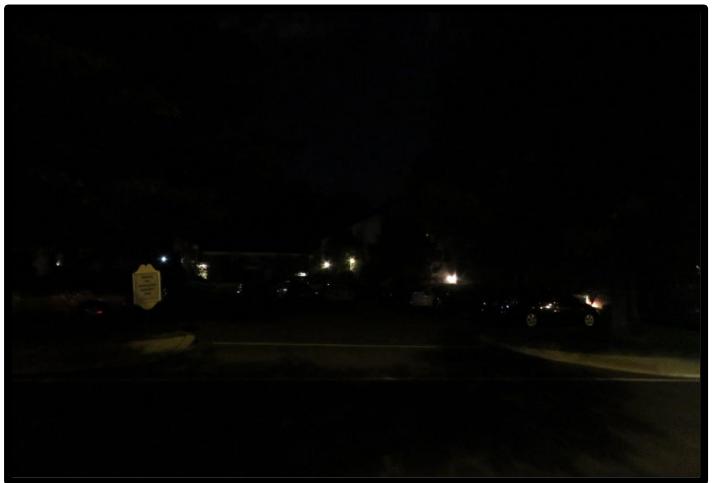
Parking Area # 7

Footcandle Readings Found

Night Photo

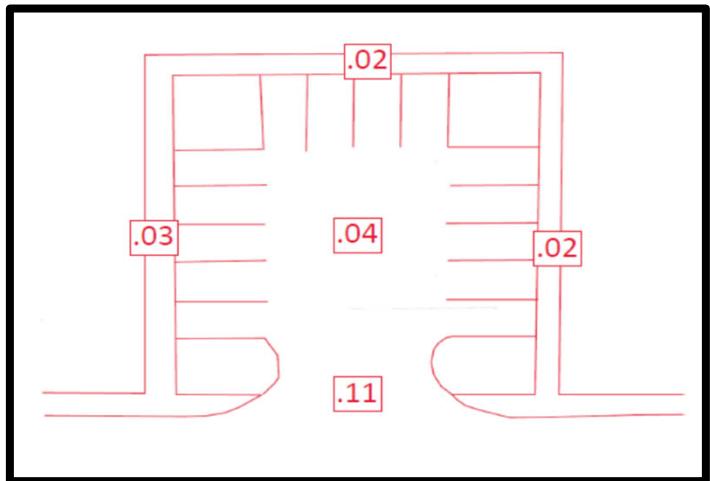
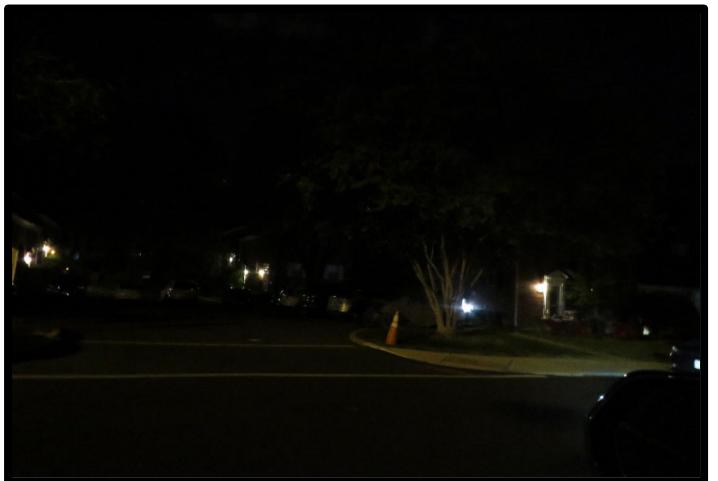
Parking Area # 8

Footcandle Readings Found

Night Photo

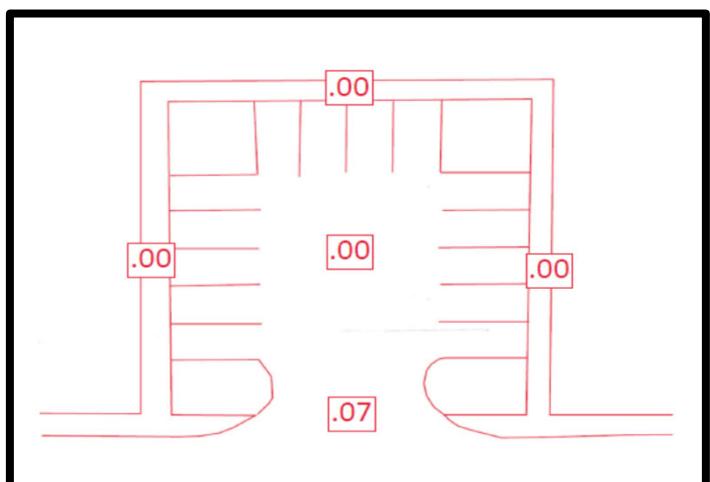
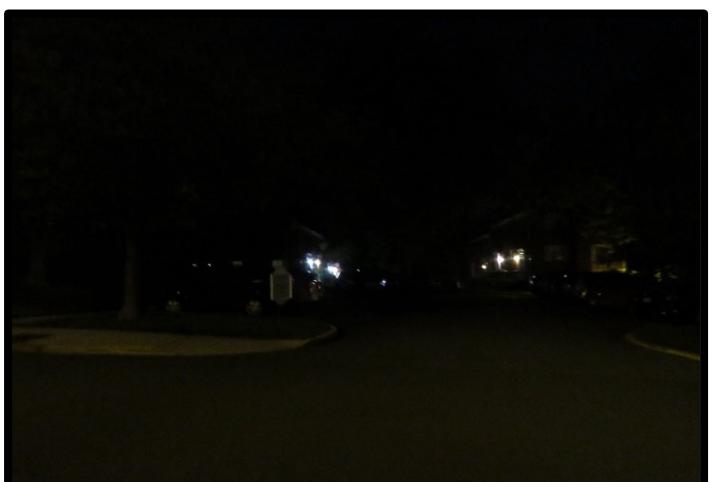
Parking Area # 9

Footcandle Readings Found

Night Photo

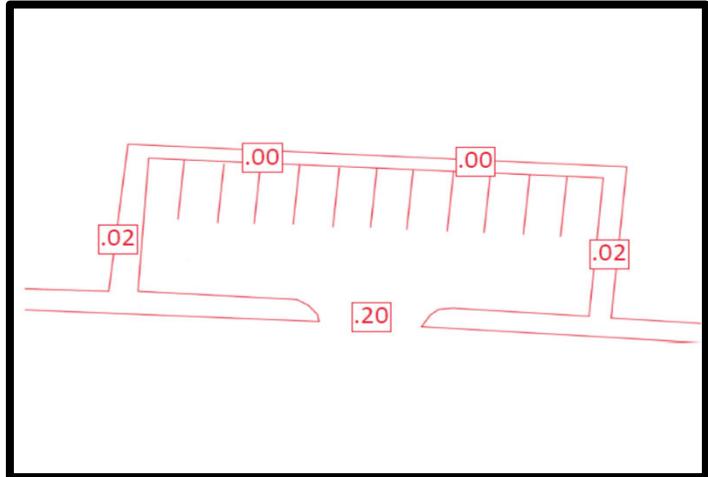
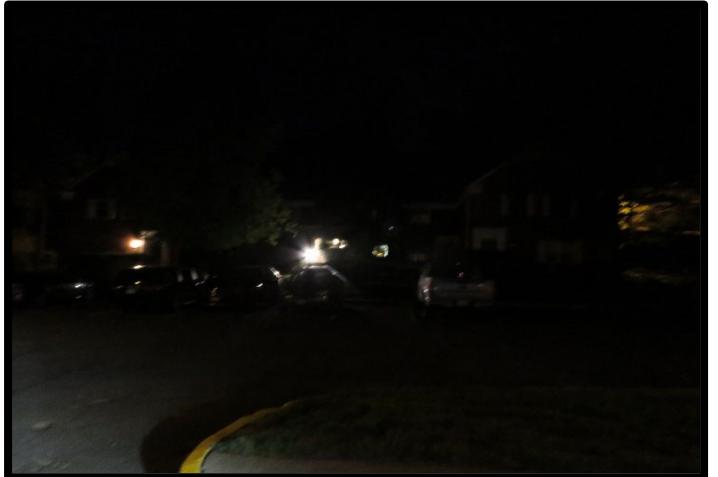
Parking Area # 10

Footcandle Readings Found

Night Photo

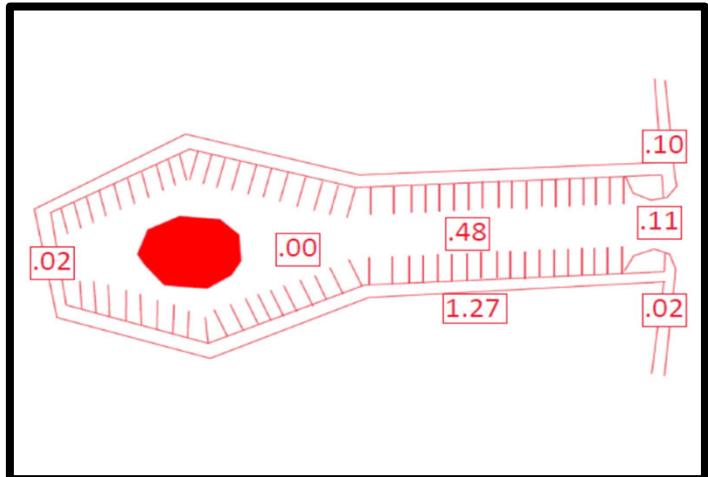
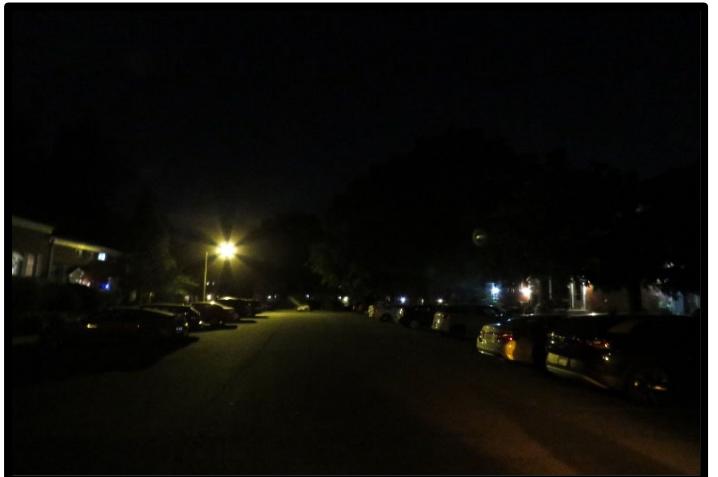
Parking Area # 11

Footcandle Readings Found

Night Photo

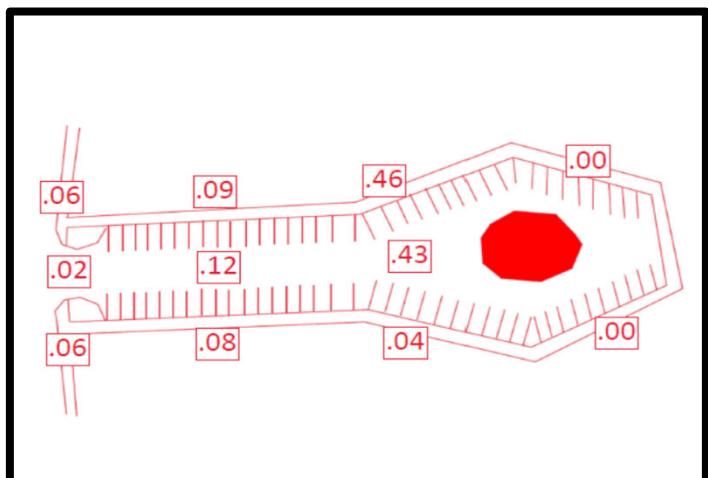
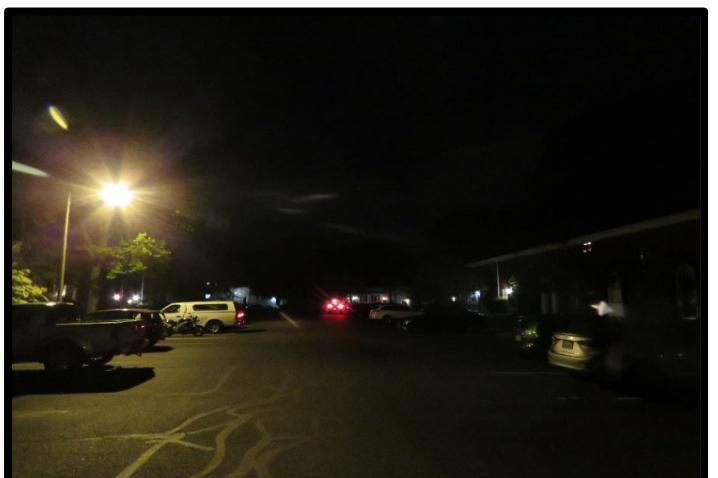
Parking Area # 12

Footcandle Readings Found

Night Photo

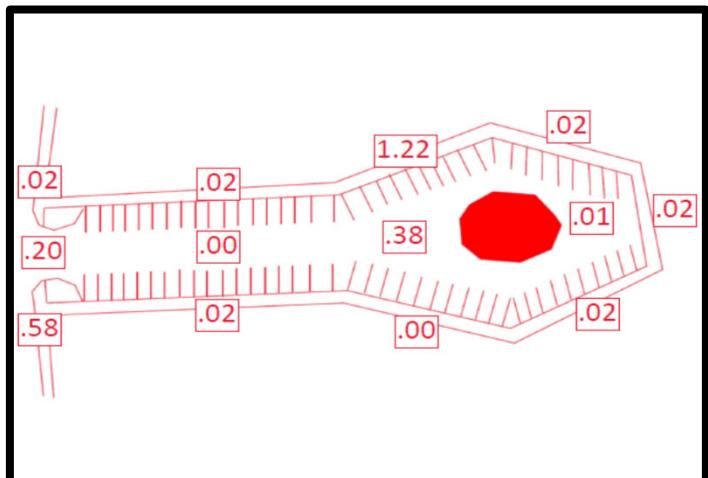
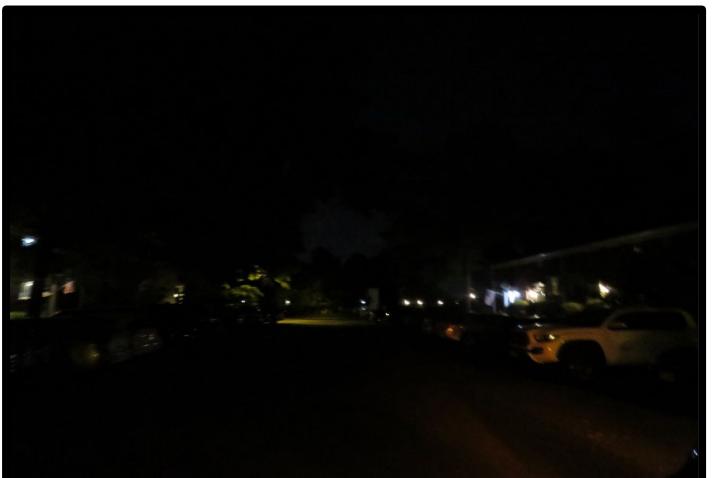
Parking Area # 15

Footcandle Readings Found

Night Photo

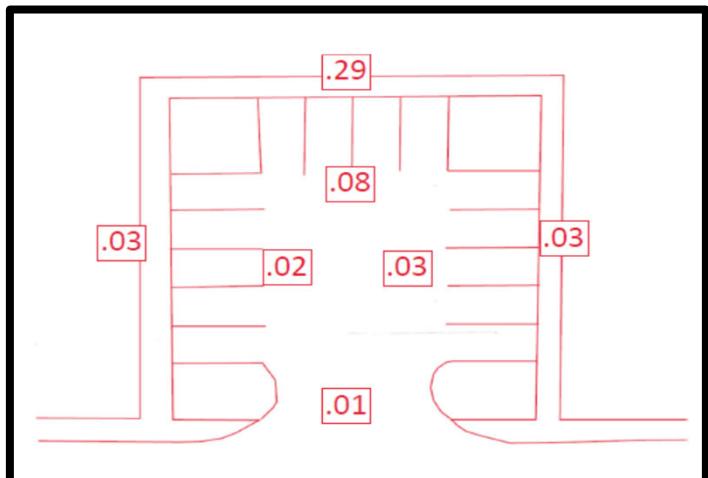
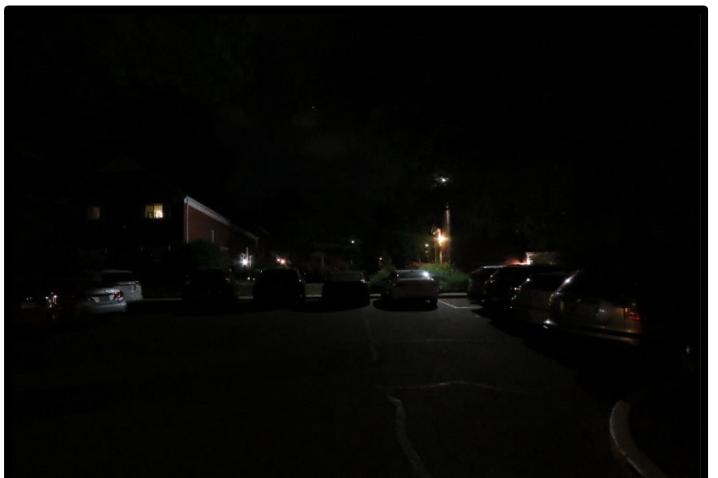
Parking Area # 18

Footcandle Readings Found

Night Photo

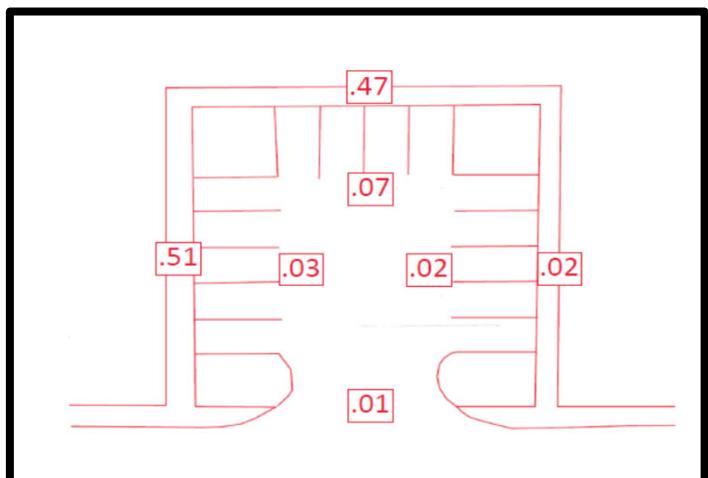
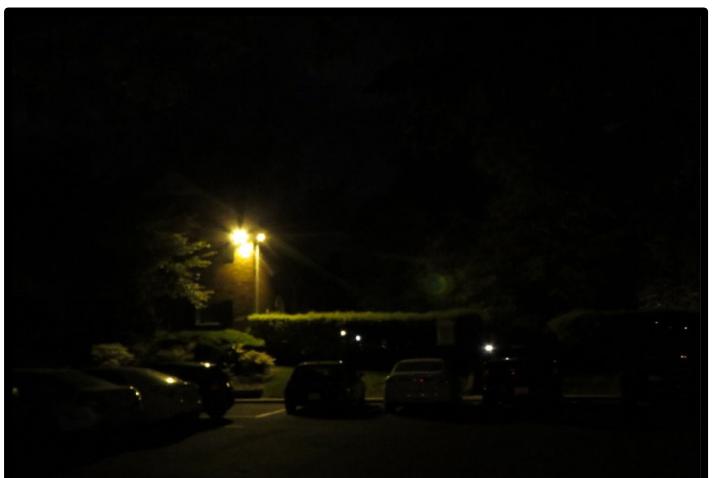
Parking Area # 21

Footcandle Readings Found

Night Photo

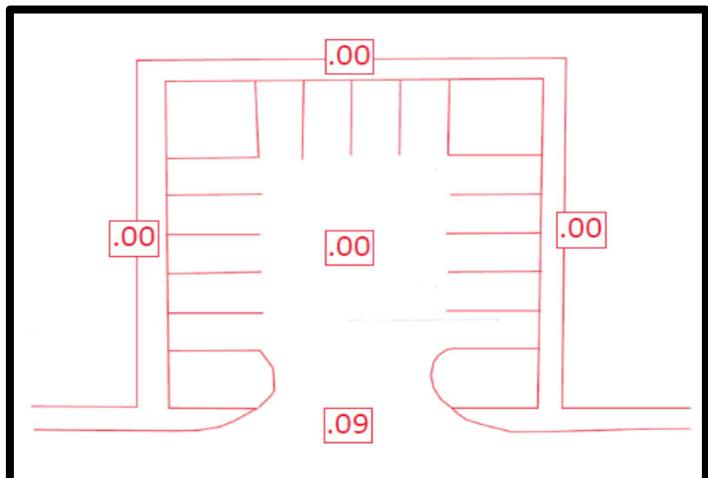
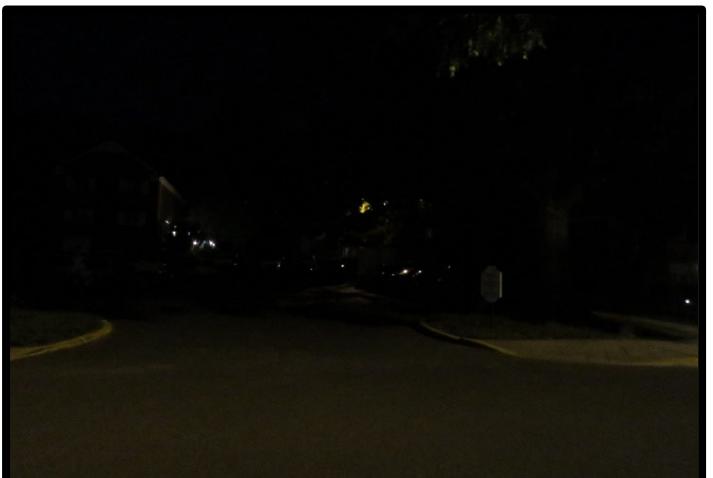
Parking Area # 24

Footcandle Readings Found

Night Photo

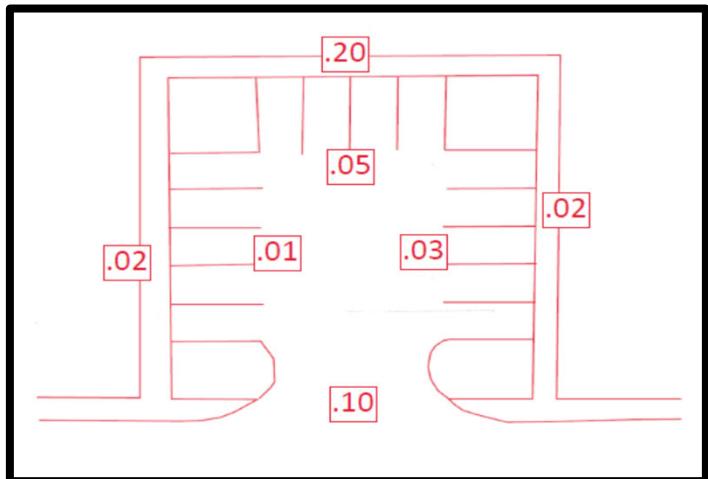
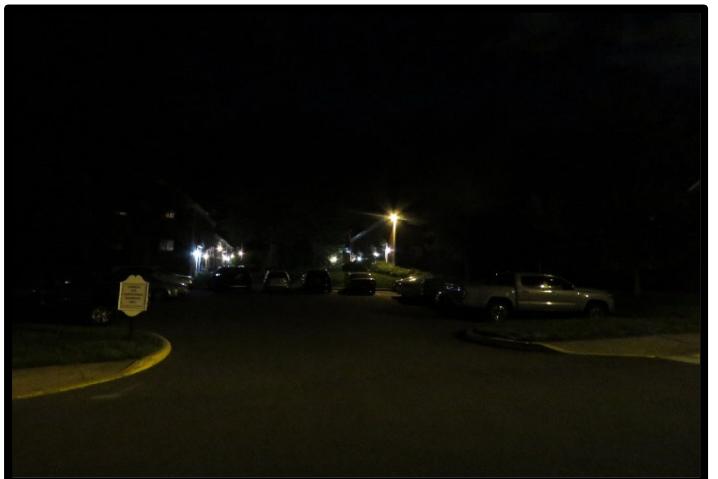
Parking Area # 25

Footcandle Readings Found

Night Photo

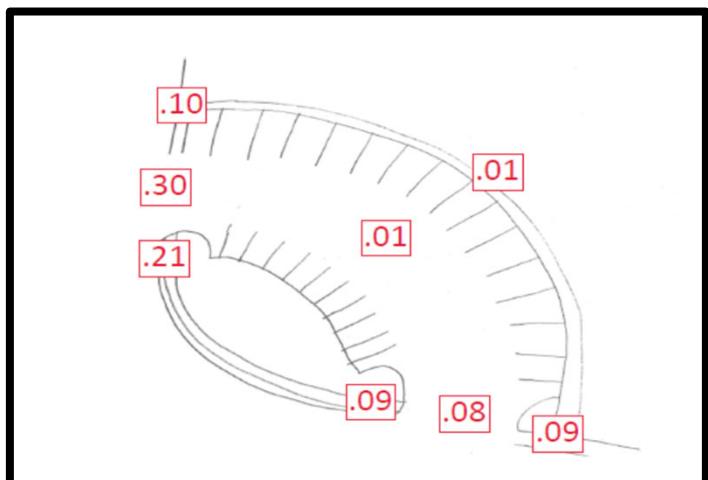
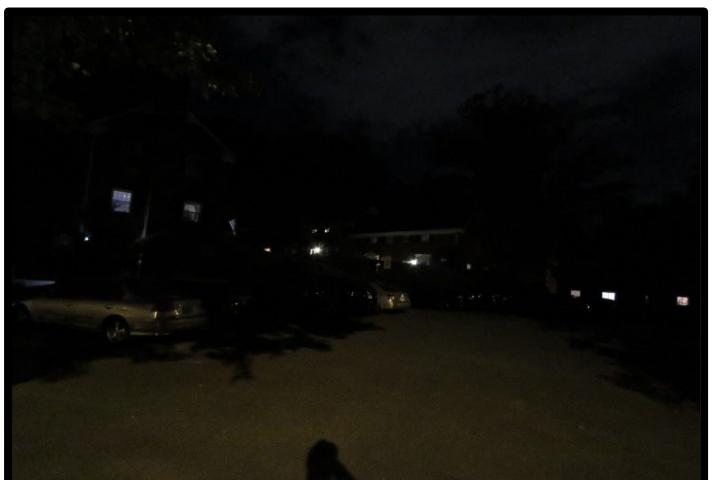
Parking Area # 26

Footcandle Readings Found

Night Photo

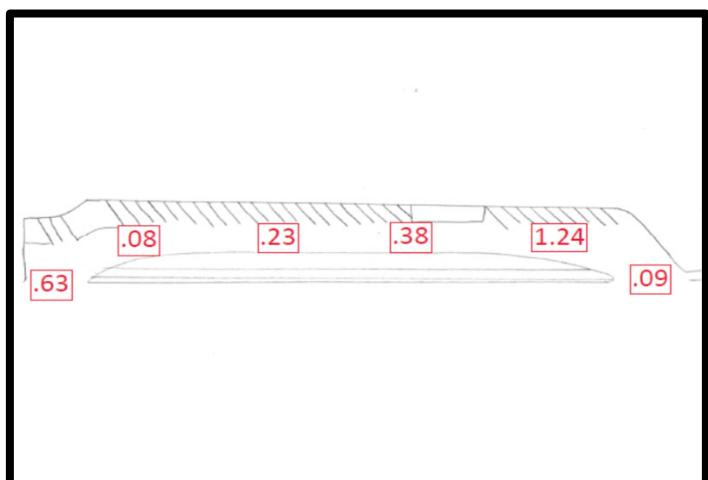
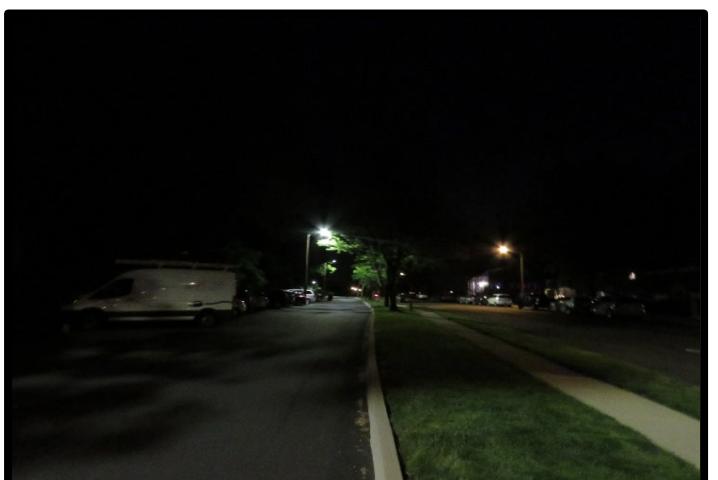
Parking Area # 27

Footcandle Readings Found

Night Photo

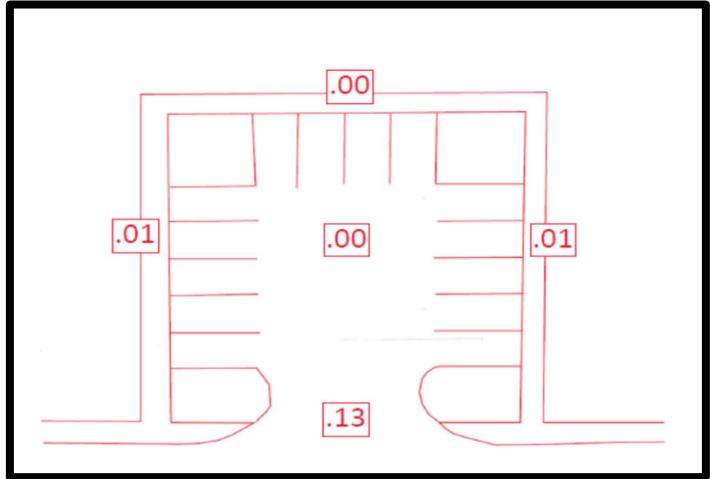
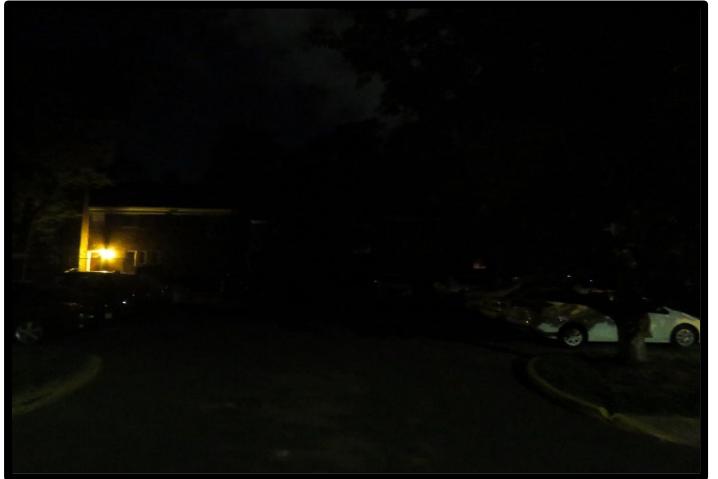
Parking Area # 28

Footcandle Readings Found

Night Photo

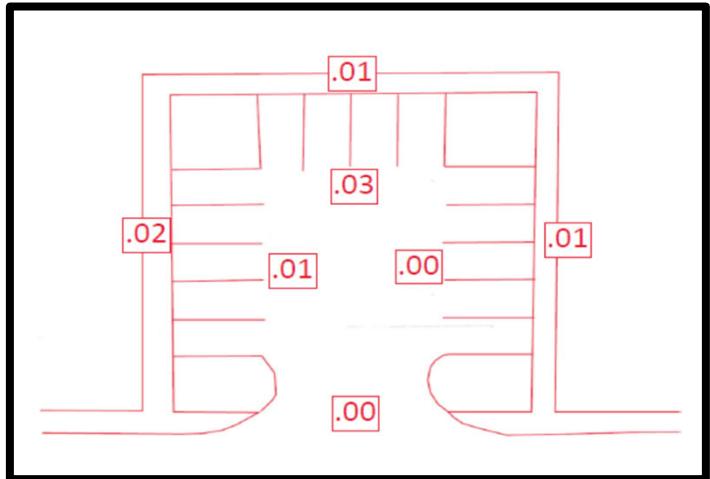
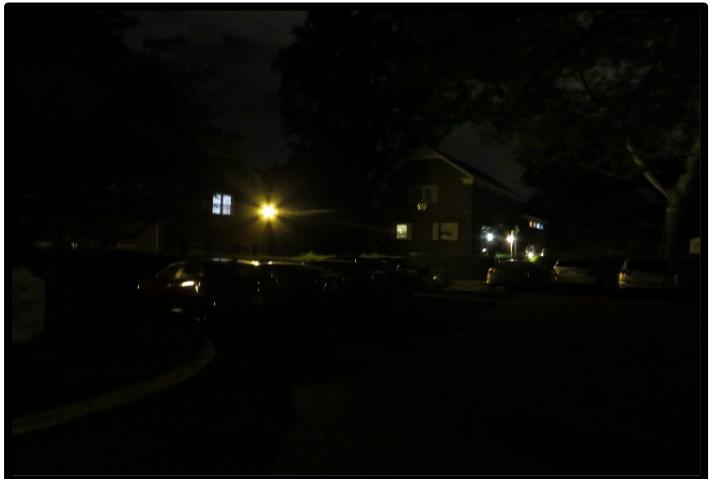
Parking Area # 29

Footcandle Readings Found

Night Photo

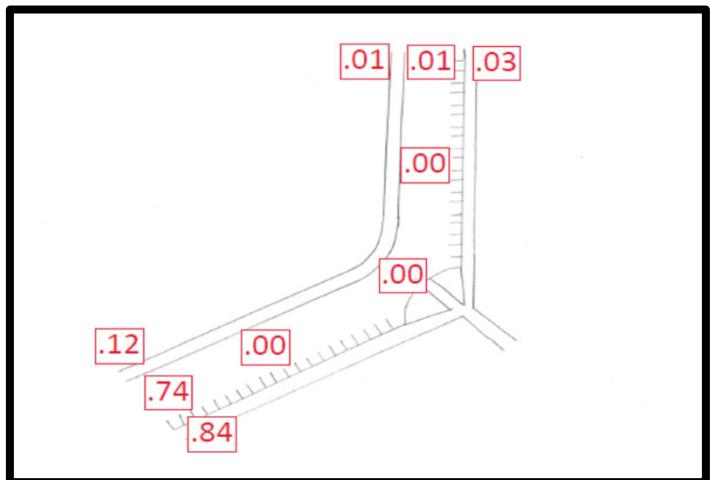
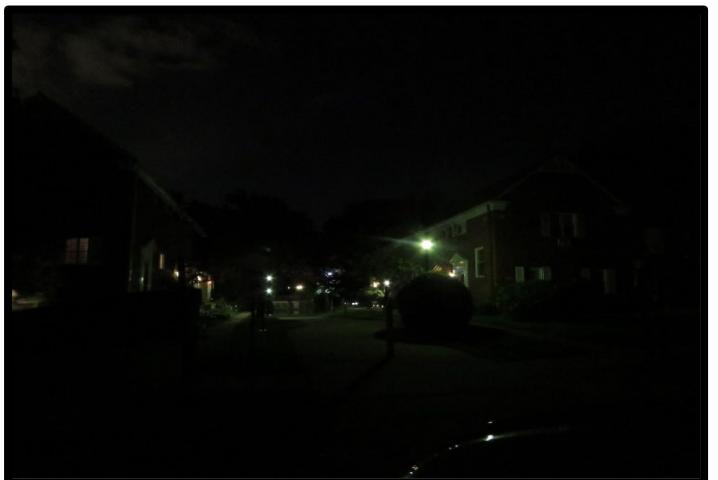
Parking Area # 30

Footcandle Readings Found

Night Photo

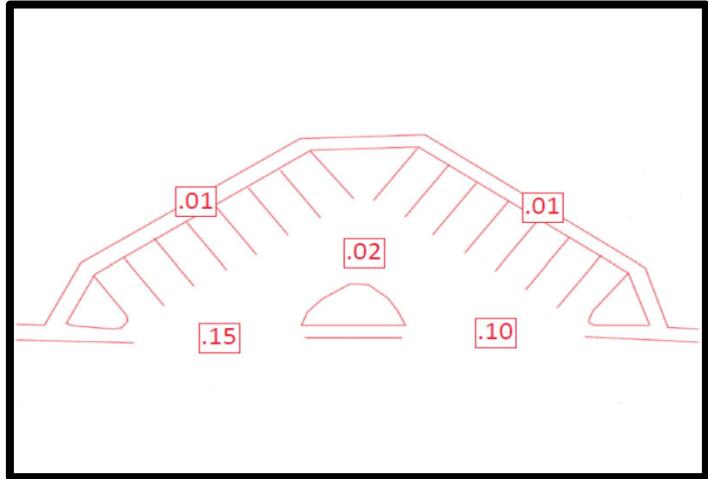
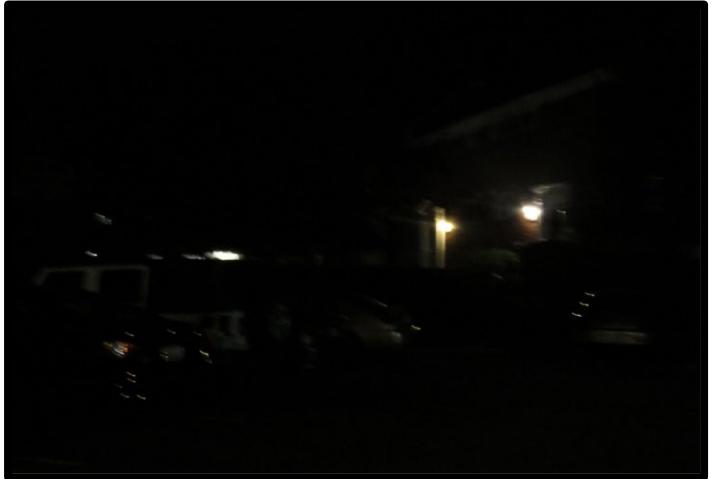
Parking Area # 34

Footcandle Readings Found

Night Photo

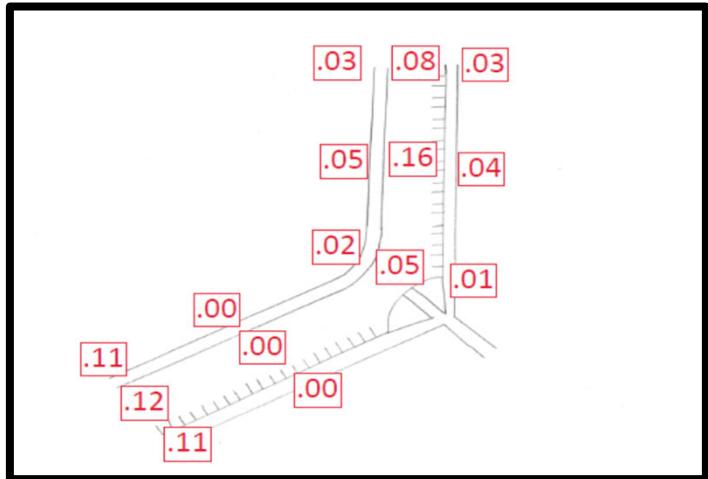
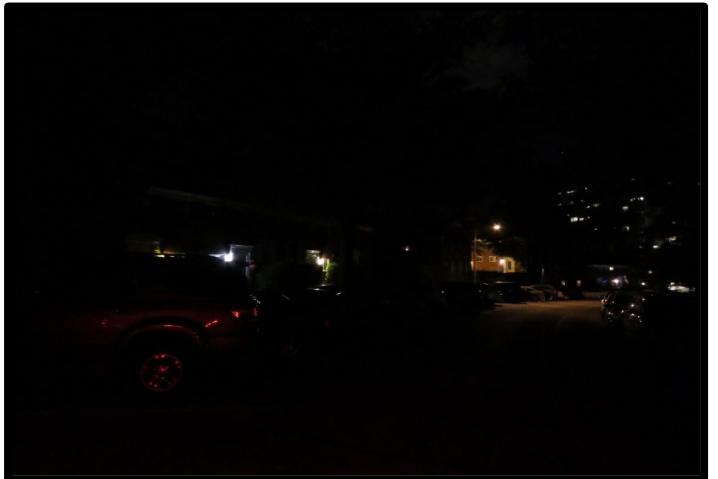
Parking Area # 35

Footcandle Readings Found

Night Photo
