PARKFAIRFAX UNIT OWNERS ASSOCIATION
Board of Directors Meeting and Budget Workshop
9:00 am, Saturday, January 24, 2026

The Parkfairfax Transportation and Land Use Committee (TLUC) launched an initiative to examine all buildings and common element areas in all five wards to identify and prioritize potential safety hazards. Nearly 300 issues were identified, the majority being common element exterior steps lacking handrails as well as uneven common element walkways and flagstones. TLUC members and outstanding community volunteers performed the inspections in October 2022.

SUMMARY

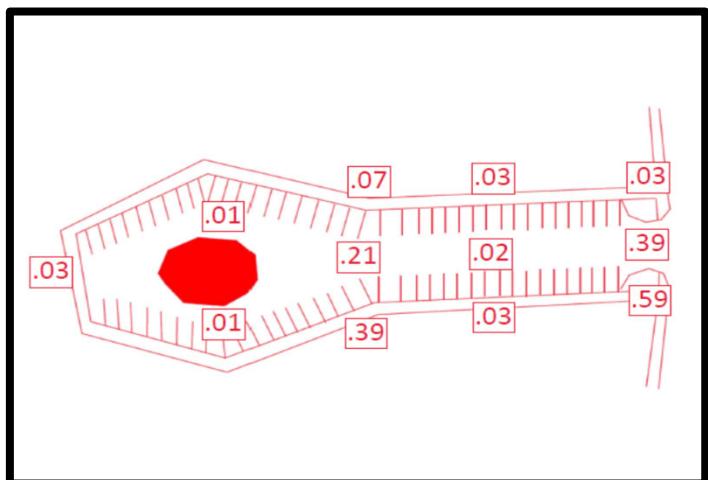
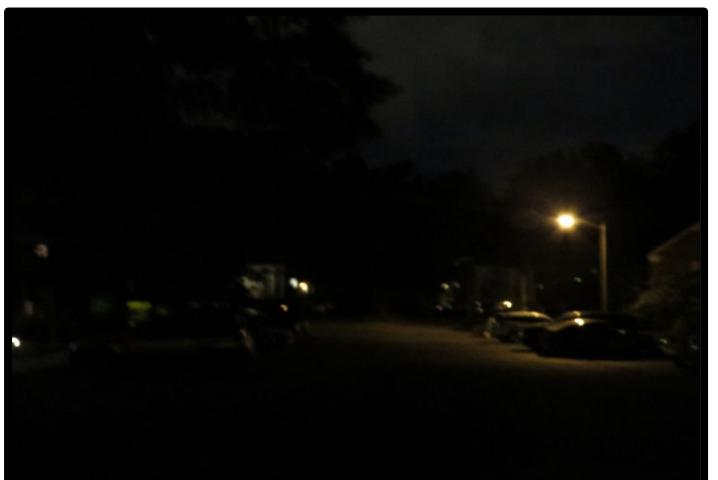
Parking Area # 37

Footcandle Readings Found

Night Photo

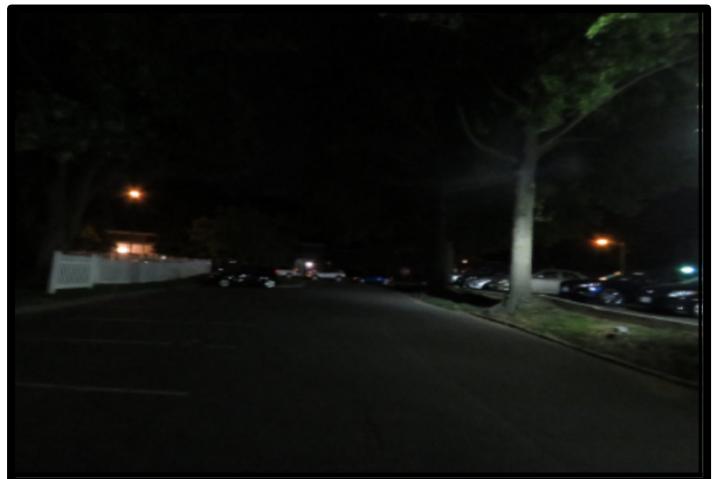
Parking Area # 36

Footcandle Readings Found

Night Photo
