# Building 919 Patio Repair Resolution Worksheet

September 10, 2024

Re: *Letter Summary for Building 919 Foundation Wall Assessment  
Parkfairfax Condominium  
1656 – 1670 Fitzgerald Lane (Building 919)  
Alexandria, VA 22303  
Walker Consultants Project #22-001530.00*

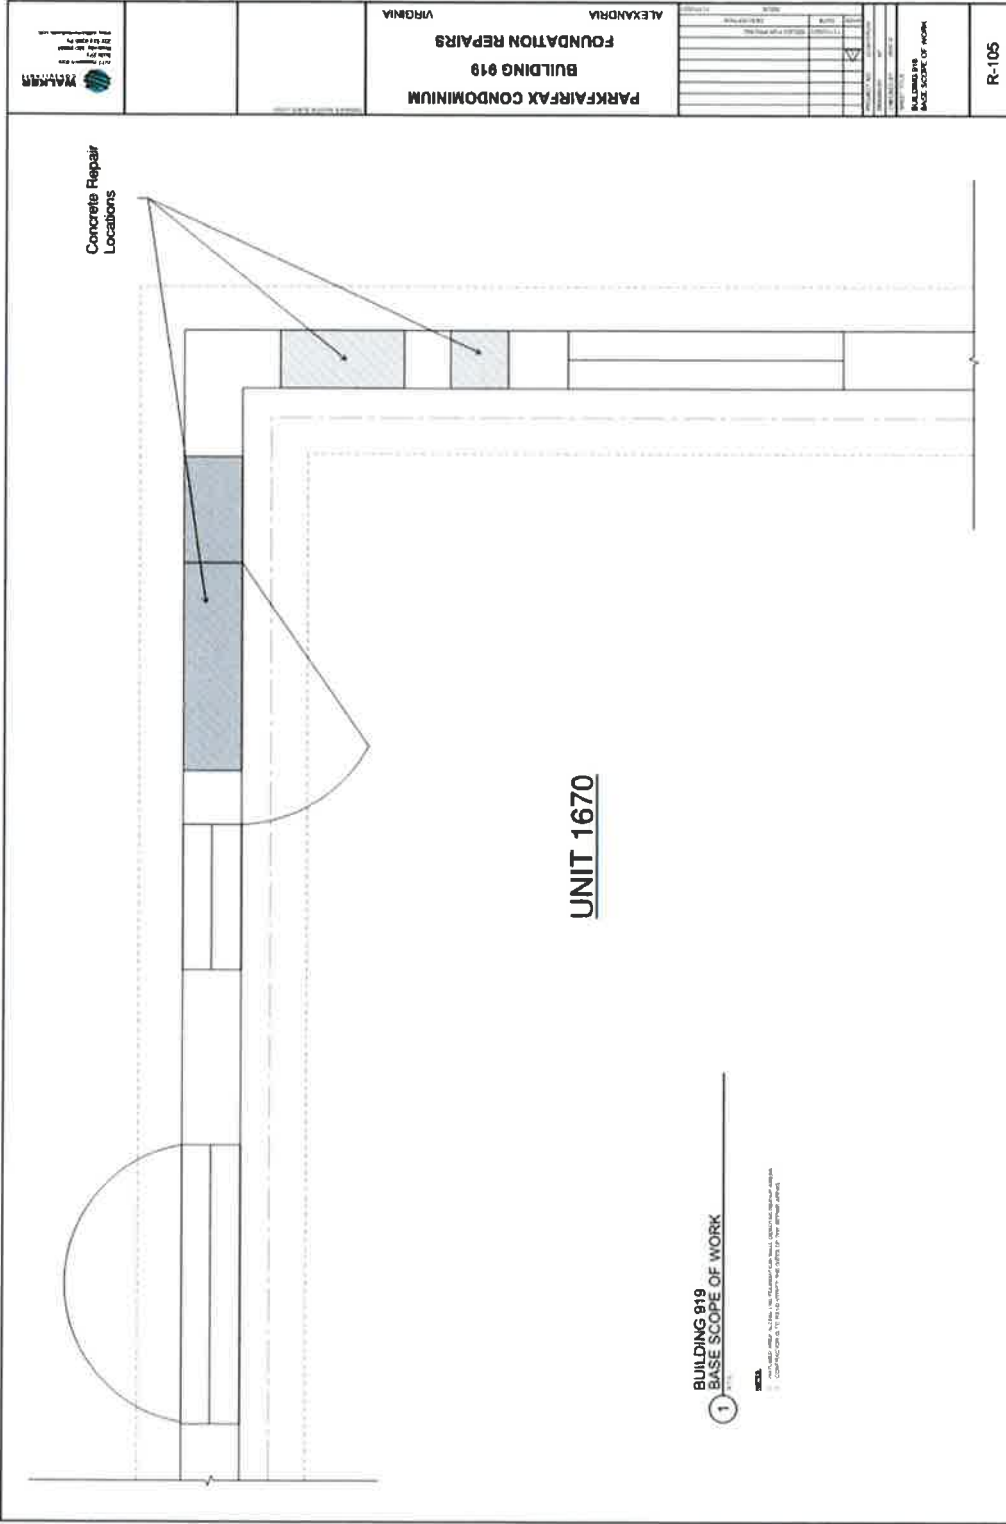
<b>PARKFAIRFAX CONDOMINIUM</b> <b>BUILDING 919</b> <b>FOUNDATION REPAIRS</b> ALEXANDRIA VIRGINIA	SHEET NO. 1670-01 DATE: 08/20/24 DRAWN BY: [Name] CHECKED BY: [Name]
	PROJECT NO. [Number] CLIENT: [Name]	SCALE: [Scale] PROJECT LOCATION: [Address]

UNIT 1670

**BUILDING 919**  
**BASE SCOPE OF WORK**
