547- Drainage study and concept plan.

# Parkfairfax 547

## Drainage Analysis

Project No. 21261.001.00  
September 21, 2021

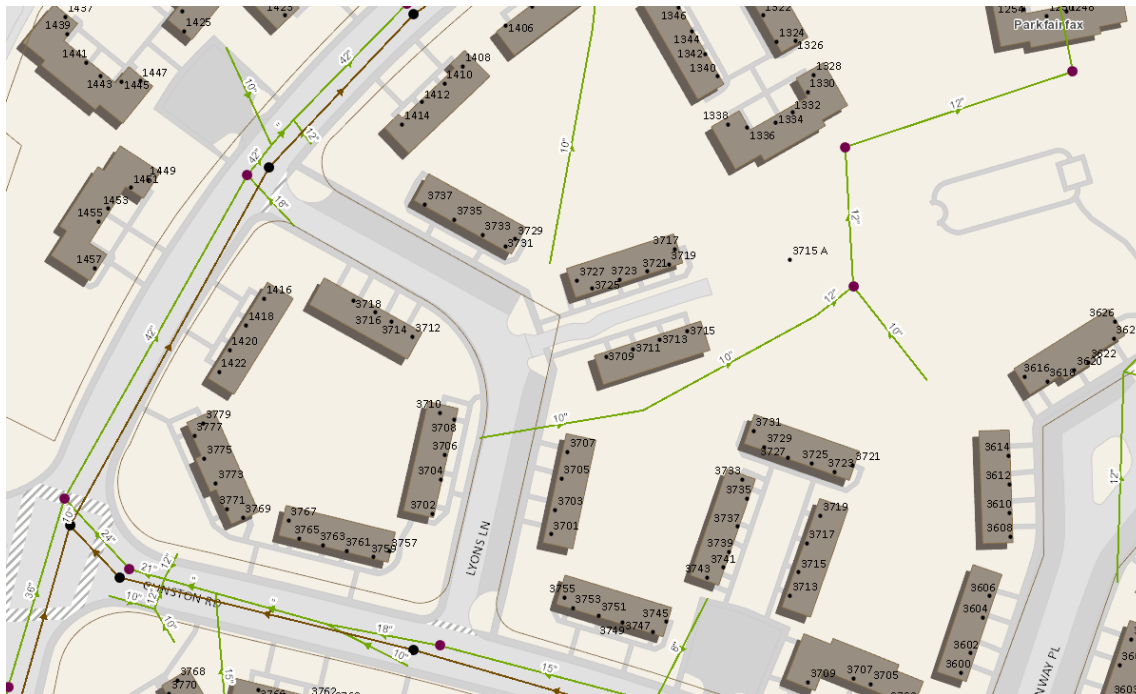
SITE 547

We also utilized our topographic survey (Exhibit 2) and the City of Alexandria GIS maps to analyze the storm sewer system.

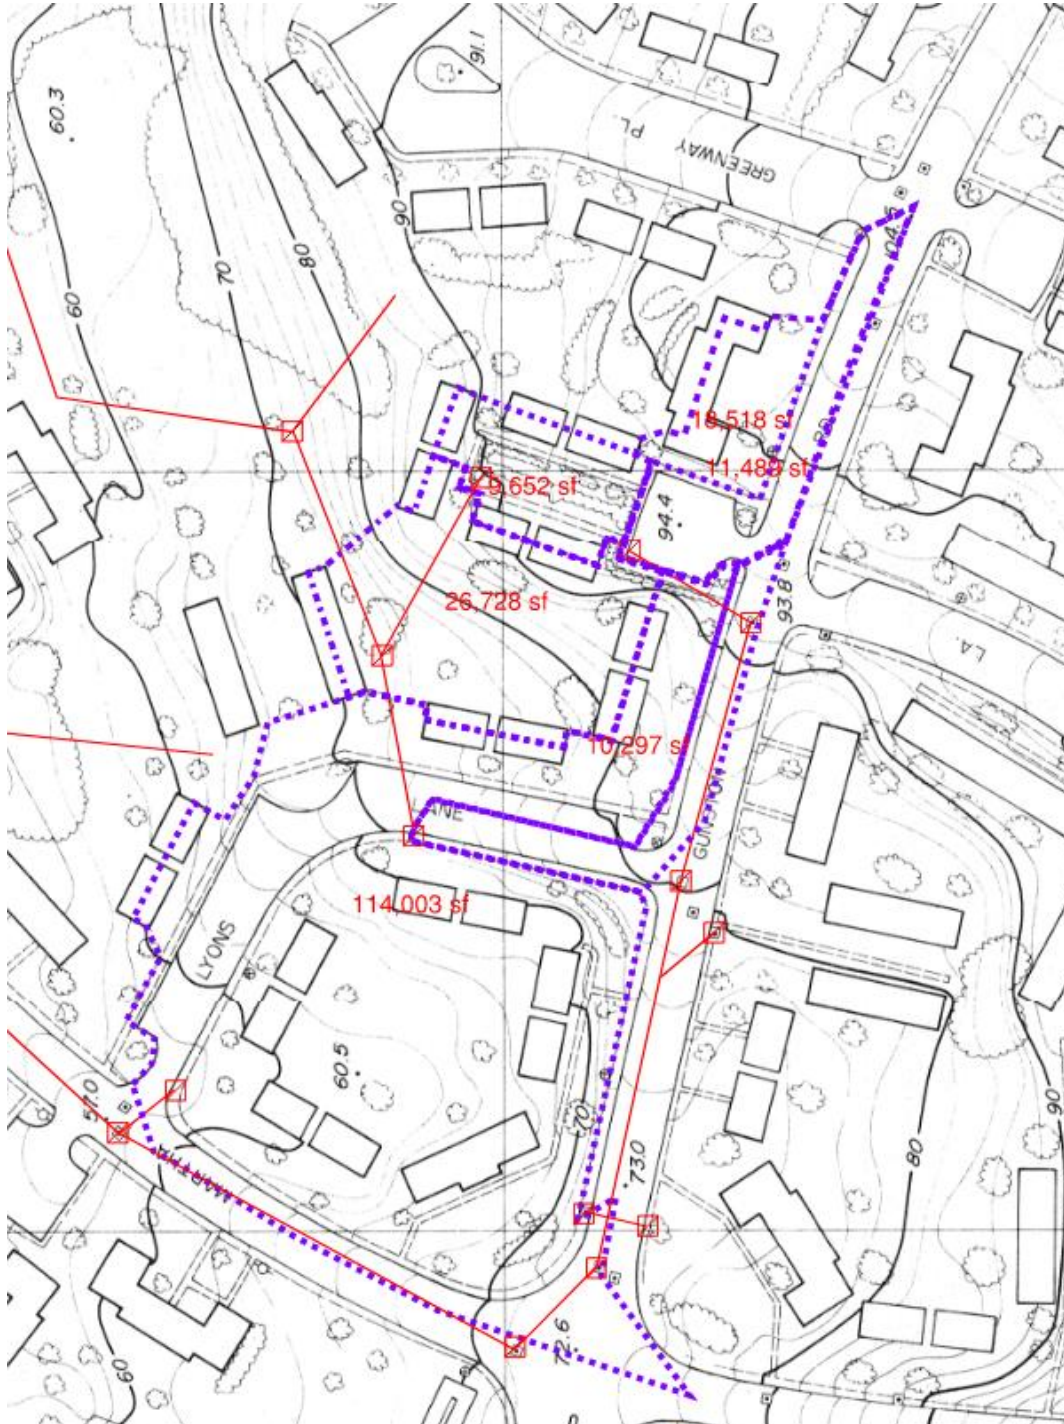
### *Drainage Divides*

Below are this the drainage divides for the storm sewer system in the area. This information was used to analyze the inlets and storm sewer system in this area.

The drainage area to storm structure #1010 is 0.62 Ac with a weighted c value of 0.61. The drainage area to storm structure #1100 is 0.22 Ac with a weighted c value of 0.62. The drainage area to storm structure #21 is 2.62 Ac with a weighted c value of 0.66. Below are the inlet and storm sewer calculations. The storm sewer and inlet at structure #21 are inadequate.
