Slope Stabilization Feedback and Recommendations Resolution Worksheet

Management Recommendations Slope Stabilization Building(s) 833-835

Parkfairfax, Bldg 833 Common Area Slope Stabilization

RE: Response to Revised Plan

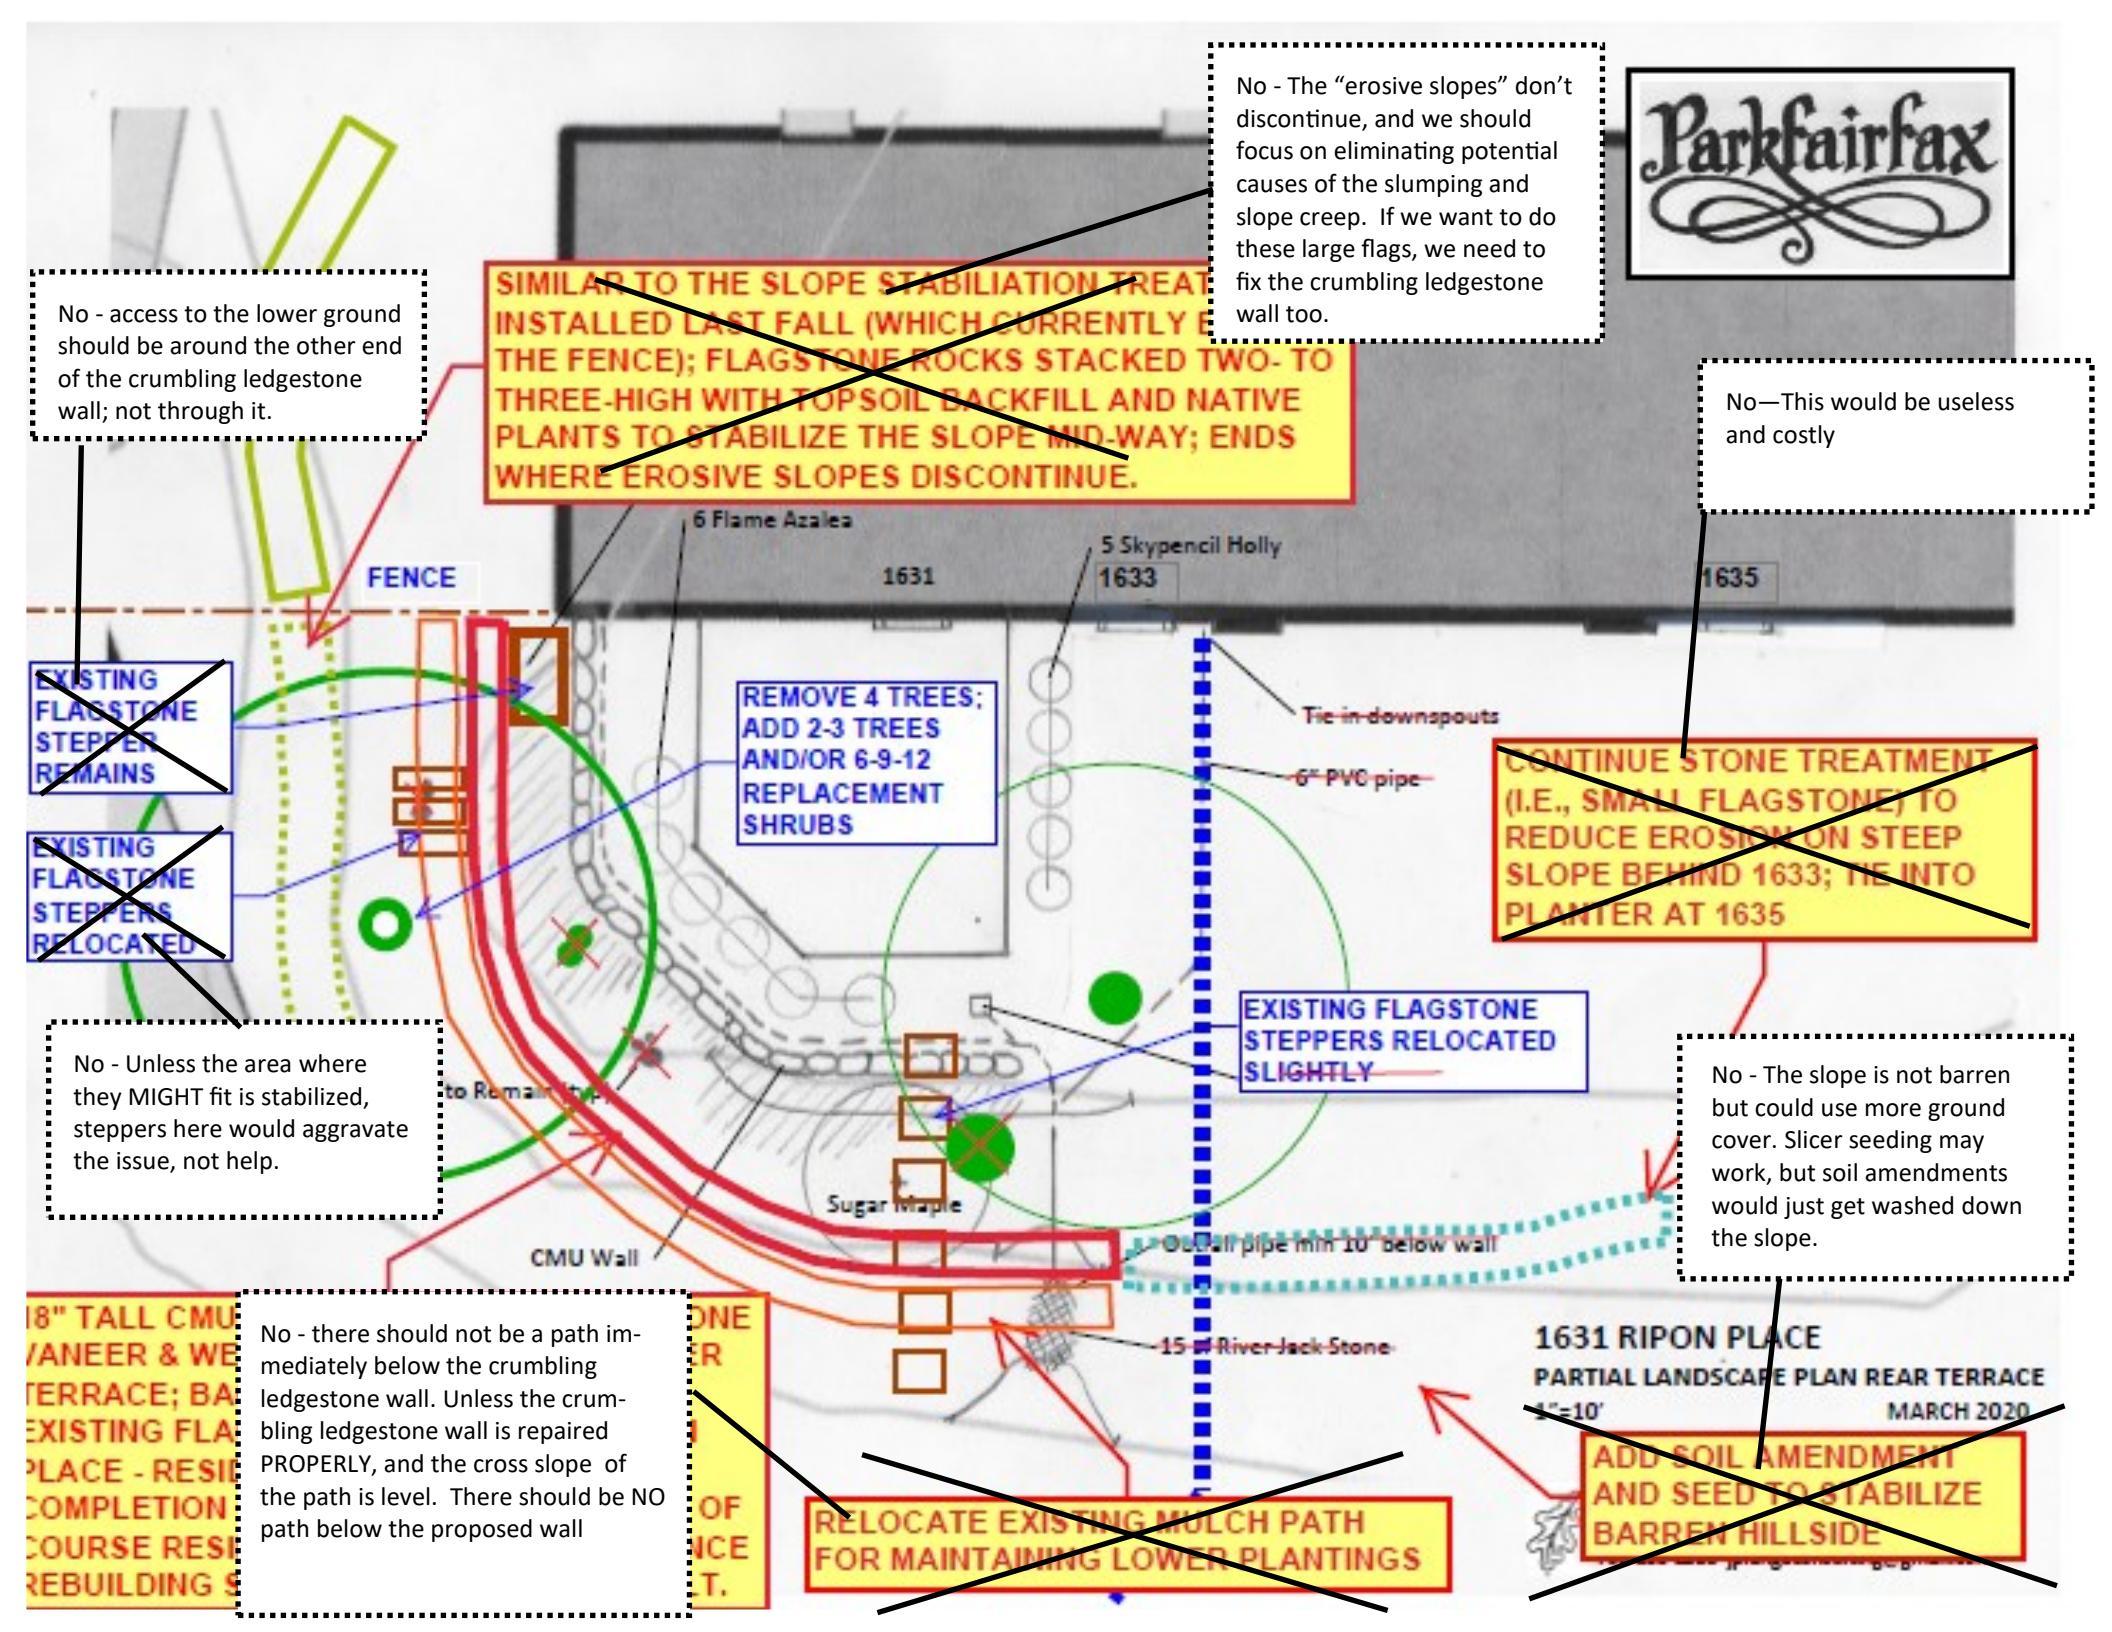
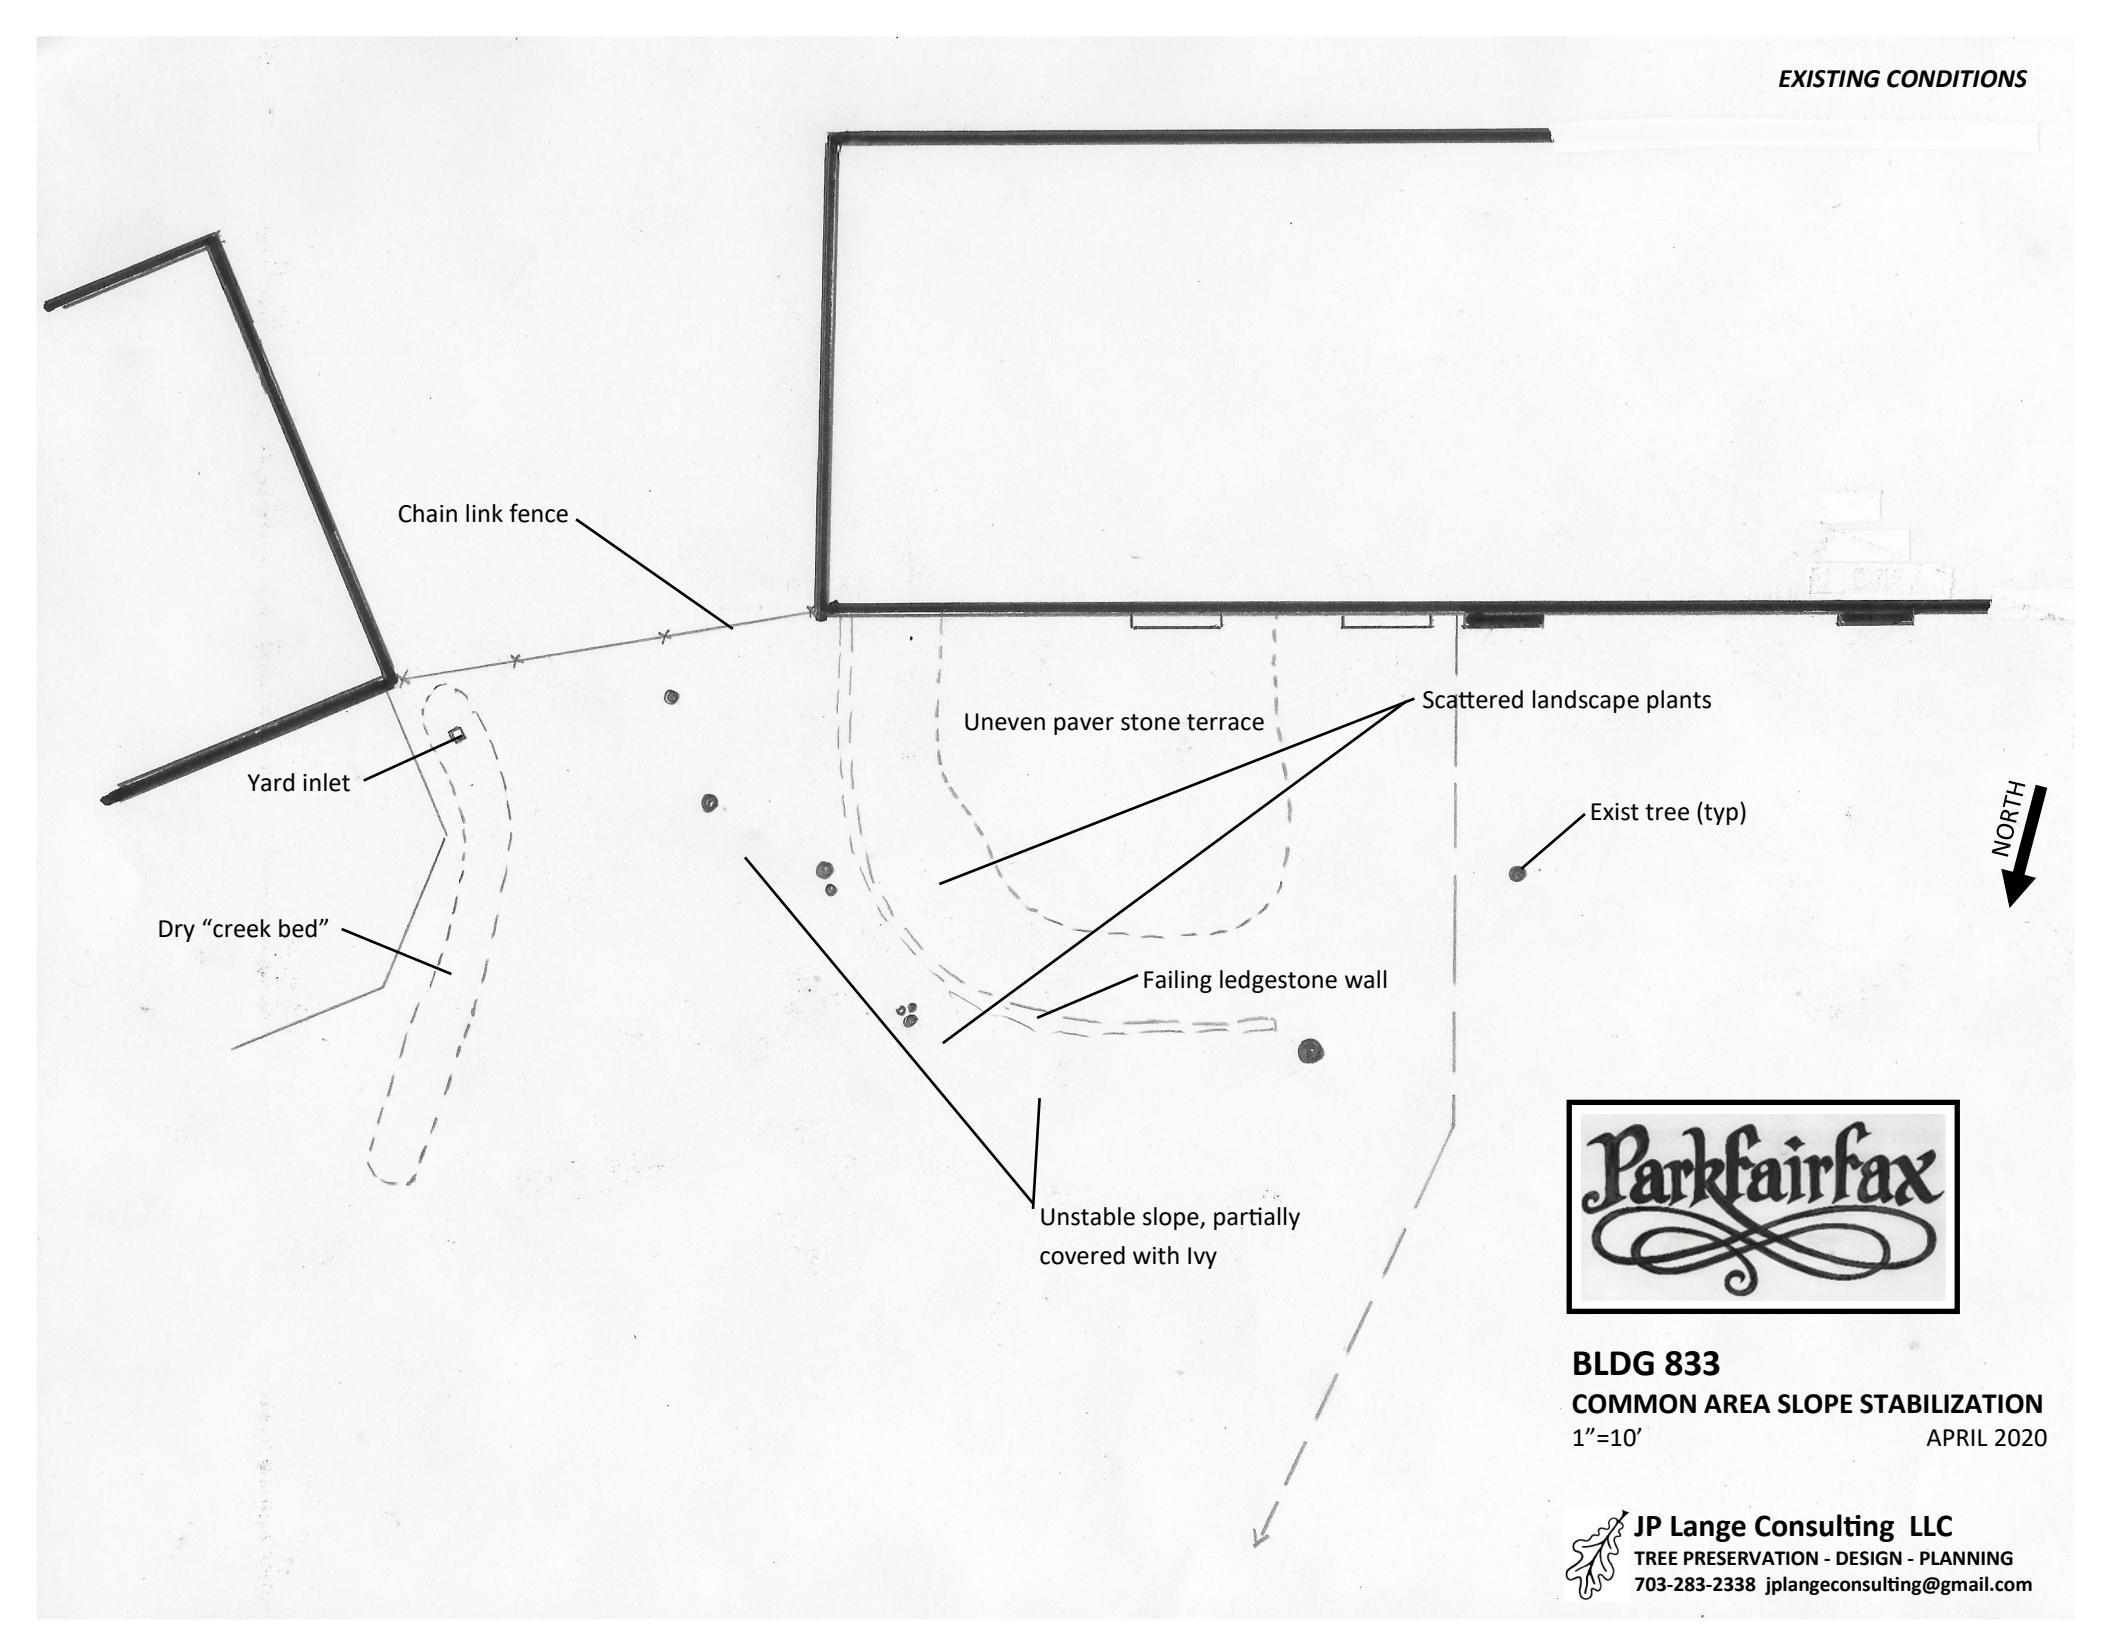
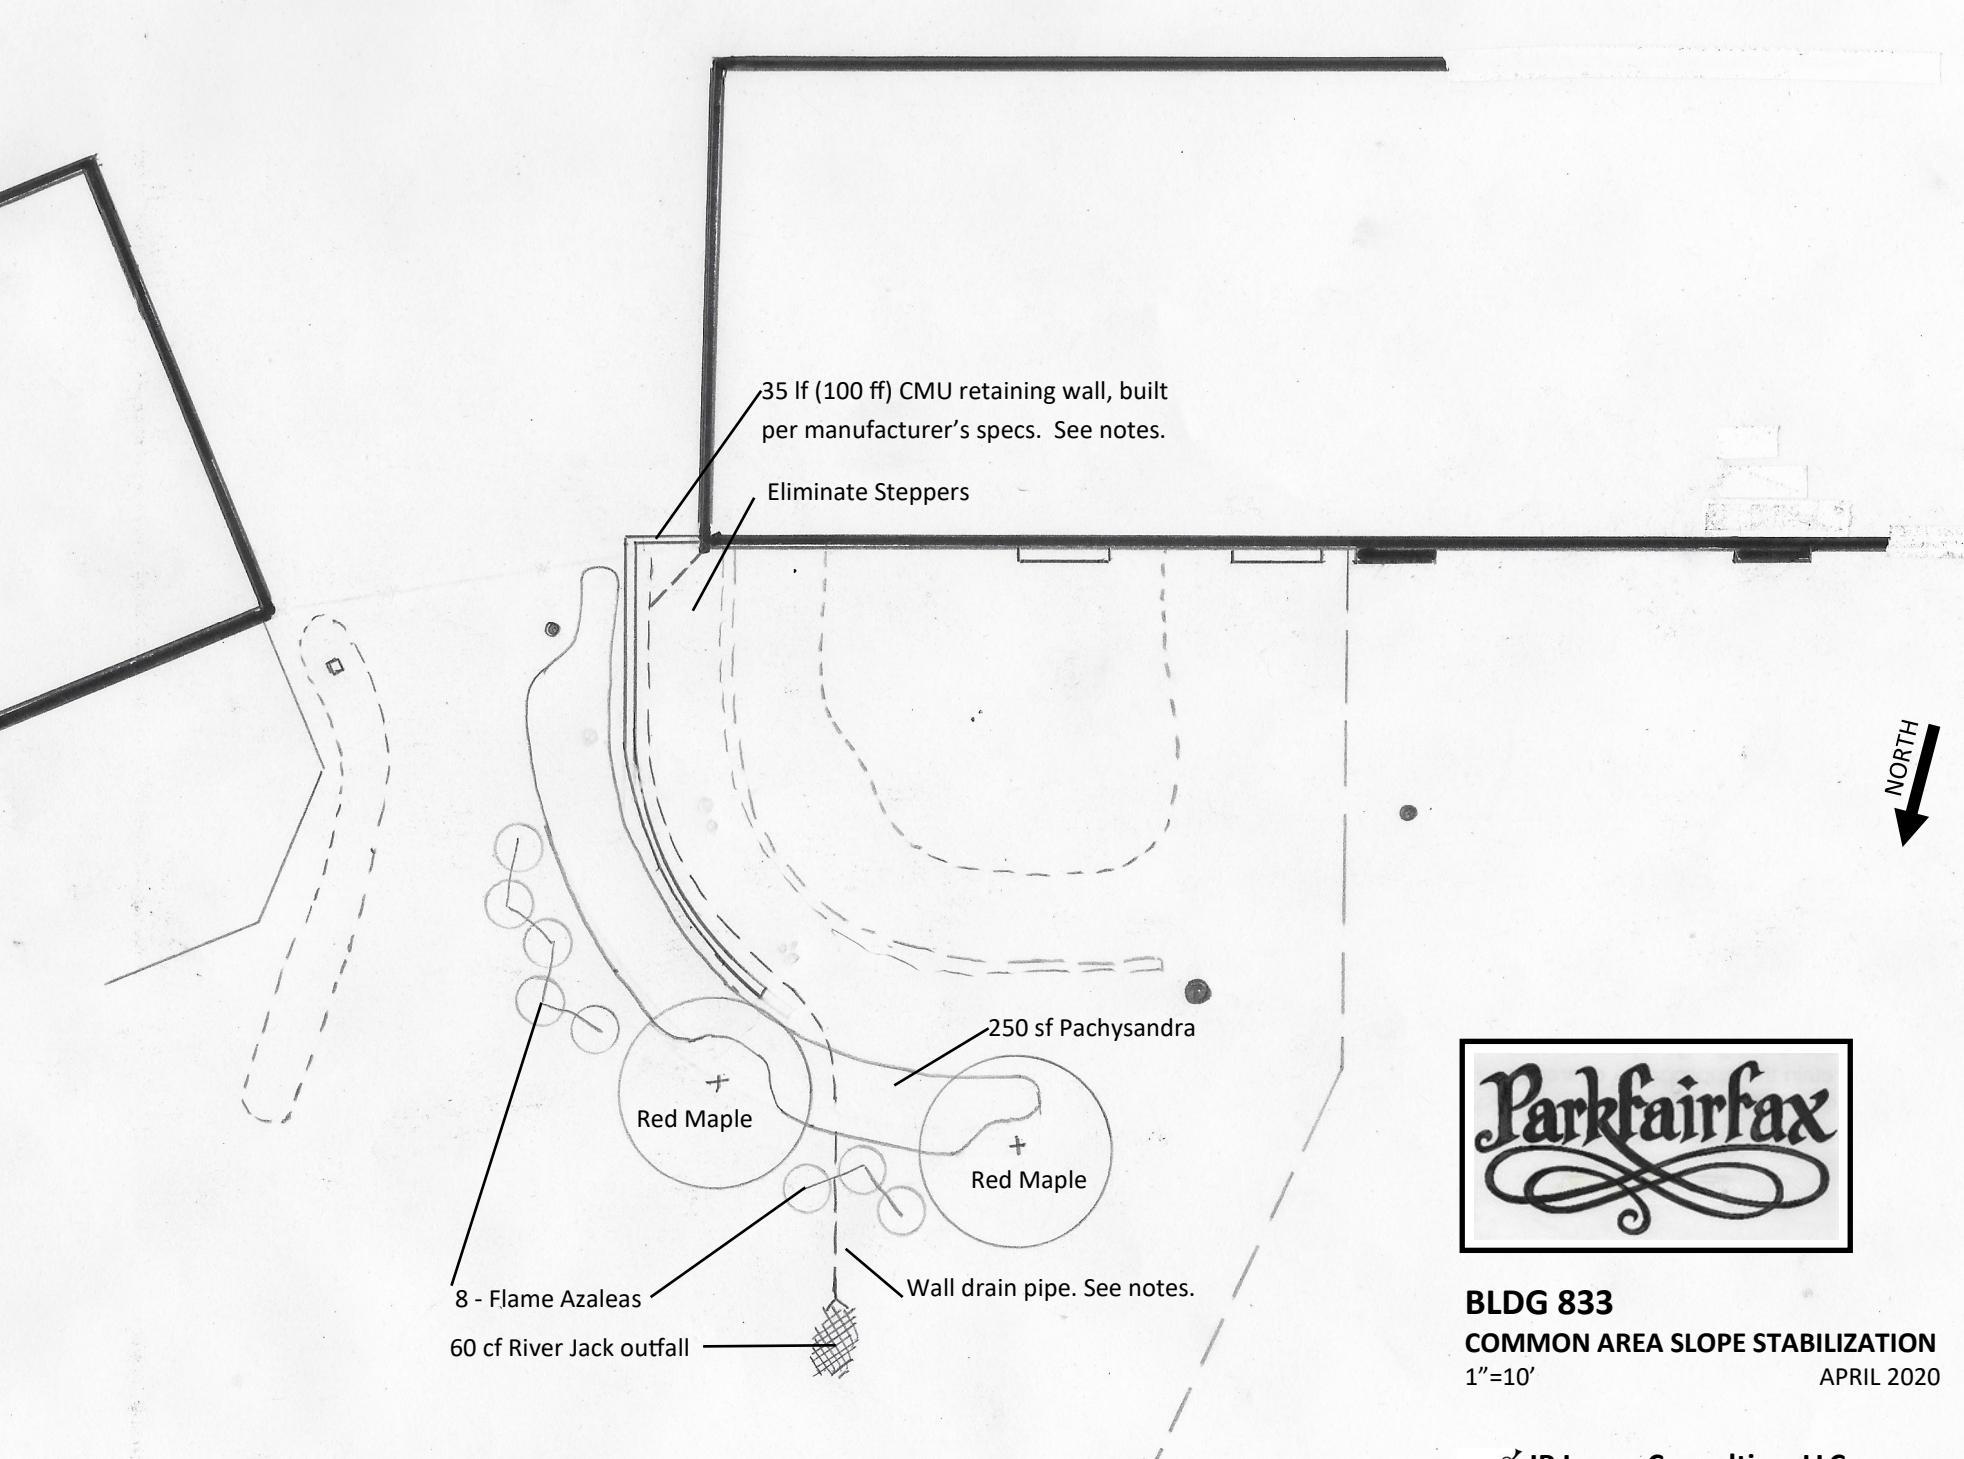
CONSTRUCTION NOTES

- All hardscape and landscape materials from the bottom of the existing failing ledgestone wall to the limits of the work zone should be removed. The limits of the work zone will be established in the field. Any existing perennials and shrubs that can be re-used may be set aside and replanted after the work is completed. The chain link fence between buildings 833 and 835 should be removed and discarded.

- 2. Existing trees shown as to be removed are to be removed prior to the construction of the proposed wall. Stumps should be ground out or otherwise removed within the work zone.

- 3. Proposed cmu wall is to be Techo Bloc Mini-Creta Stone in Shale Grey (or equal).
- 4. Proposed cmu wall is to be constructed per the layout shown, but minimally such that a footer trench can be dug 18" wide and 18" deep. As possible, the wall should meet the building corner flush with the rear face of the building, and may be pinned or otherwise attached to the building foundation as per cmu manufacturer's specs.

- 5. New wall will be approximately 100 ff exposed, with approximately ¾ of the base course buried as foundation/footer. Proposed wall is approximately 30" tall. The wall shall start at the building corner and step down 4' away and perpendicular to the side building face, turn 90 degrees and be approximately 30 above grade until near the proposed end of the wall. It may step down as necessary to meet grade at the proposed end point.

- 6. Footer trench is to be compacted and then filled with 57A stone or according to cmu manufacturer's specs.
- 7. Proposed wall is to be back-filled with gravel and 6" drainage pipe per manufacturer standards.

- 8. As practical, the downspout extension nearest the proposed wall should be routed so as to avoid the fill behind the proposed wall as much as possible. The River Jack outfall should be downhill from (outside) the work zone in undisturbed earth.

- 9. Area between the proposed wall and the bottom of the failing ledgestone wall should be a minimum of 4' wide and be graded so as to promote positive drainage away from the building. No hardscape materials not shown on the proposed layout should be installed between the existing wall and the proposed wall.

- 10. All proposed plant material should be kept away from the building foundation; a minimum of 6" for goundcovers and perennials, and a minimum of 4' for shrubs. Any planting between the failing ledgestone wall and the top of the proposed wall should receive prior approval.

- See attached plan and proposed scope of work.
- Discussion centered around the positioning of the proposed wall and how it will affect the slumping or creep of the slope. There was some disagreement to both the plan and interpretation of the causes of the conditions.

- As such management is in agreement with the new recommended plan as submitted on May the 4th for JP Lange Consulting.

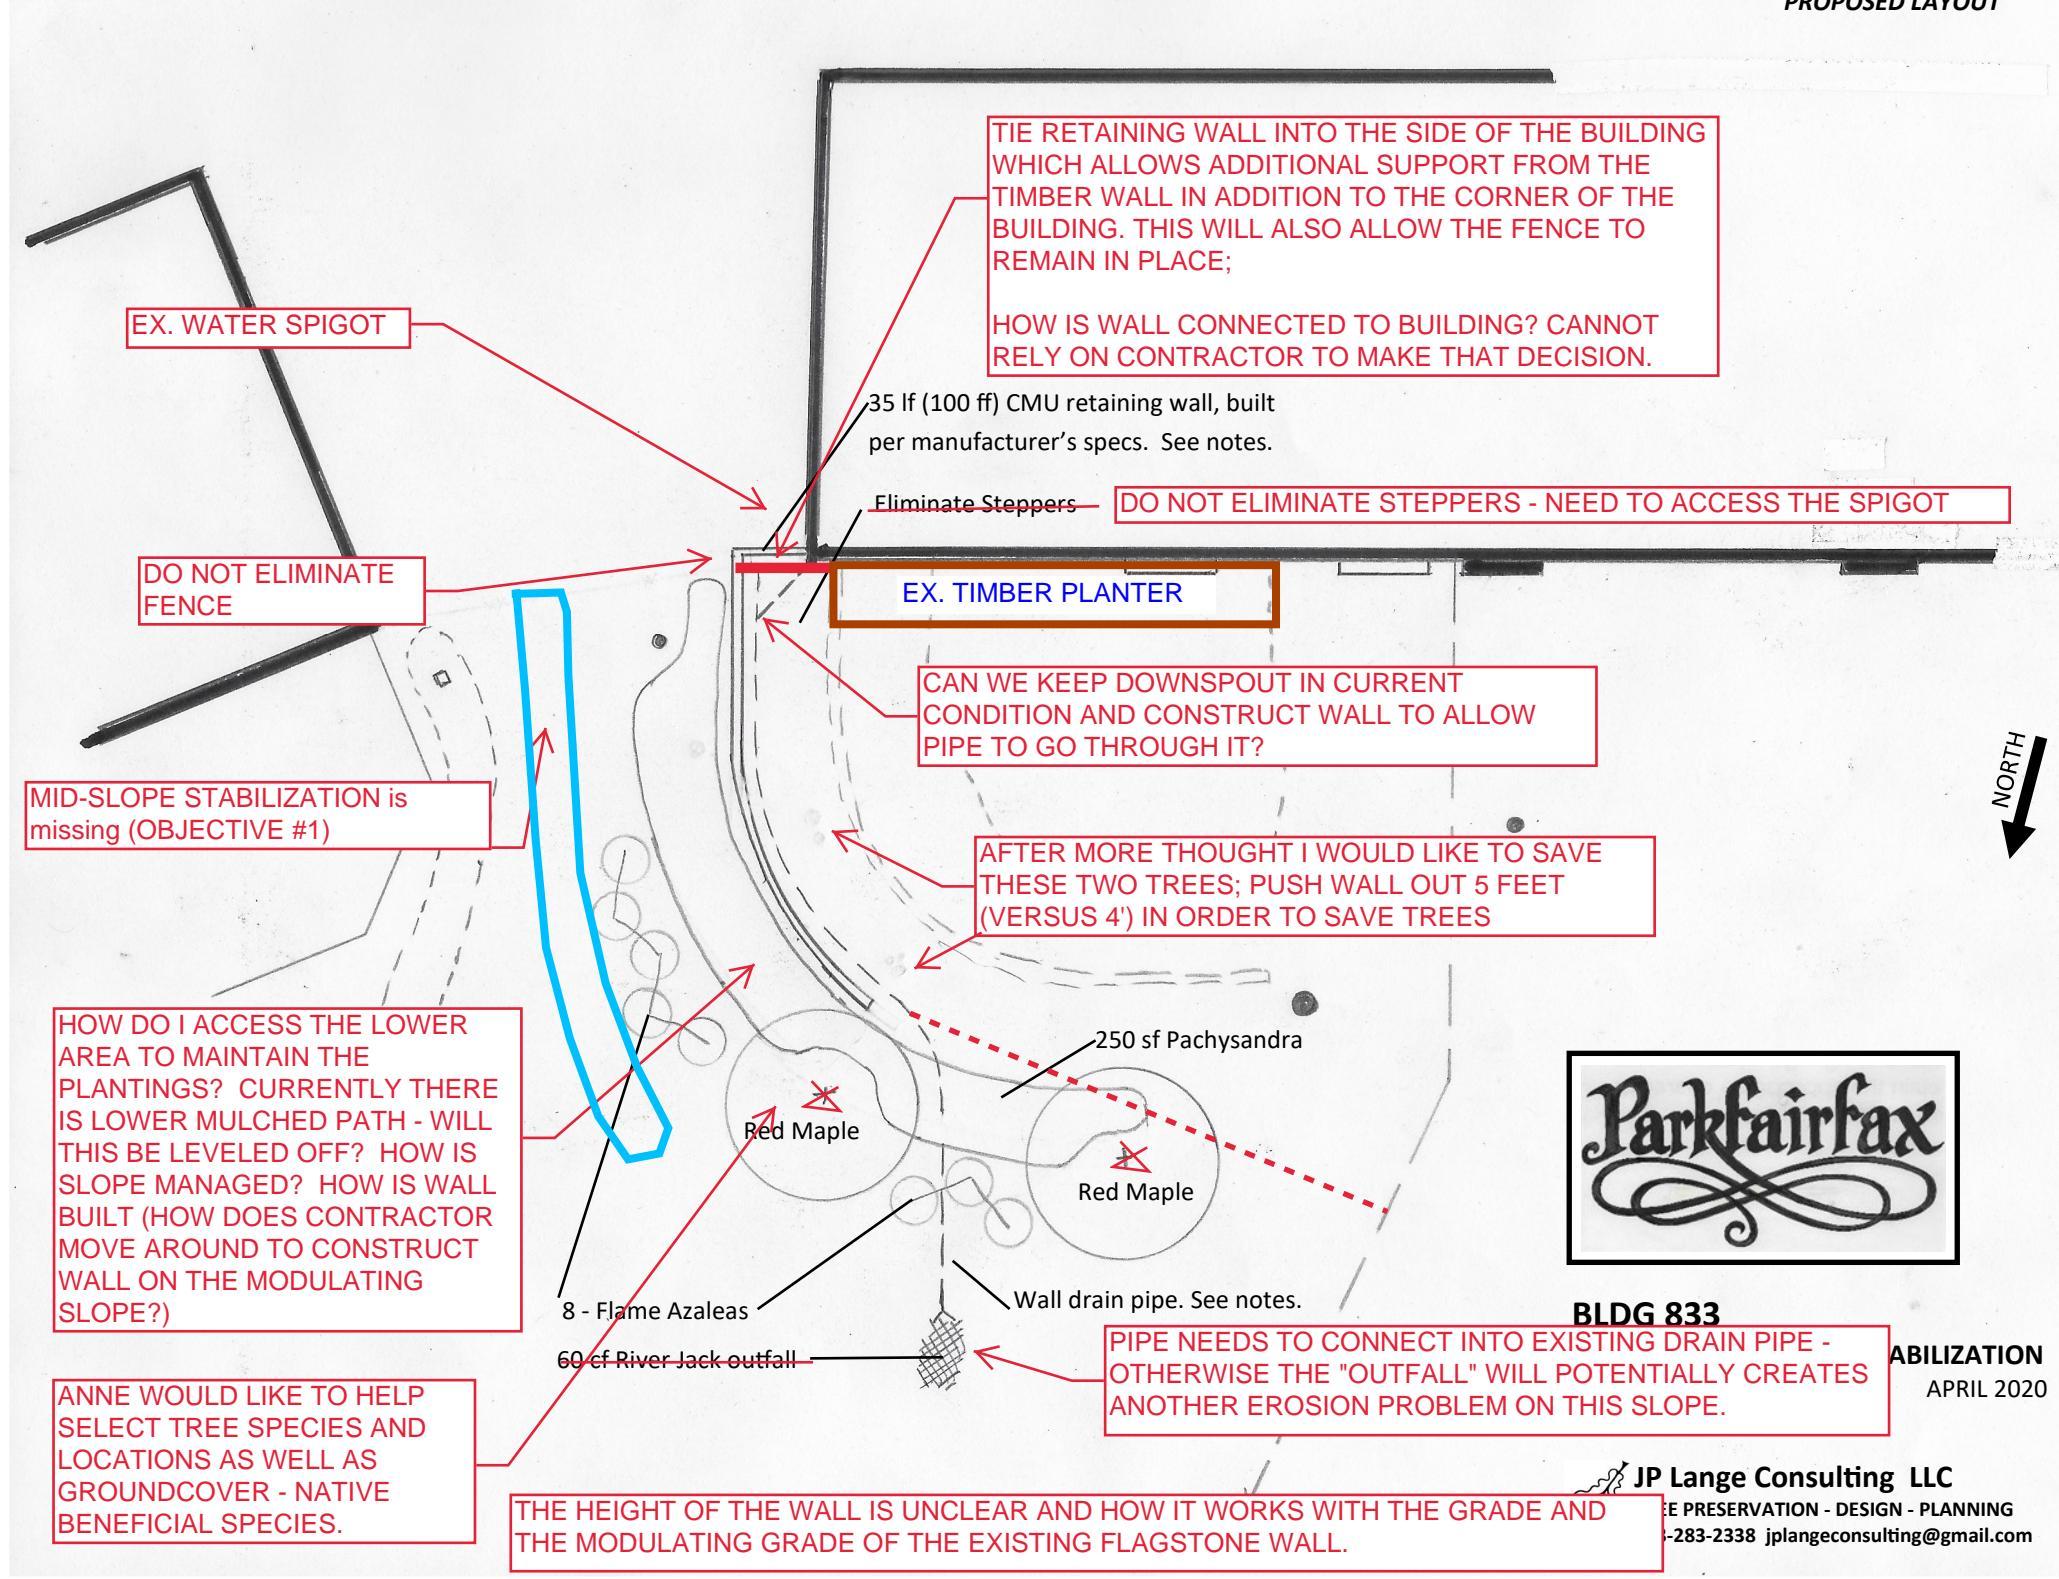
CONSTRUCTION NOTES

Parkfairfax, Bldg 833 Common Area Slope Stabilization

THE MID-SLOPE STABILIZATION IS NOT ADDRESSED.

THE LOWER ACCESS PATH AND ASSOCIATED GRADING IS NOT ADDRESSED.

FENCE!
Comment [A2]: Would like to keep the two trees and the large tree – can we offset 5' instead of 4'?
Comment [A3]: Is this historically appropriate for a property with historic designation?

Comment [A1]: NO - DO NOT REMOVE

Comment [A4]: This connection to the building needs to be designed, not just rely on installer to follow Manufacturer's specifications – a recipe for failure.

Comment [A5]: A cross section would be helpful to understand how this is constructed.

Comment [A6]: Do not redirect downspout – keep downspout in current location and build wall around it.

Comment [A7]: This is a steep slope and may cause more erosion. Connect the proposed pipe to the existing pipe from 1633 that ties directly into the catch basin.

Comment [A11]: The Mid-Slope Stabilization has not been addressed.

DO NOT REMOVE STEPPERS NEAR CORNER – ACCESS TO SPIGOT IS NECESSARY. INTEGRATE STEPS INTO THE DESIGN.

DO NOT REMOVE FENCE.

resolve many of the comments on the *Initial Plan* which I provided for the April 22, 2020 BOD Meeting. Specifically, the *Revised Plan* does not address Objective #1, the *"Mid-Slope Stabilization"* at all, nor does it adequately address Objective #2, the *"Below-Wall Stabilization."* It also does not take into consideration the surrounding undulating slopes. In addition to not resolving the main concerns, the plan did not take into account how I "use" my patio. Access to the water spigot is not possible in Lange's proposal as he removed steppers, the lower path was total eliminated so that I could no longer maintain the lower planting beds. Most egregious was not specifying how the techno-block wall is attached to the building (Lange states that the contractor shall follow Manufacturer's specifications – that is a recipe for failure!). All of my comments are highlighted in the Attachments *("Lange Revised Plan_AG Comments"* and *"Lange Construction Notes_AG Comments"*).

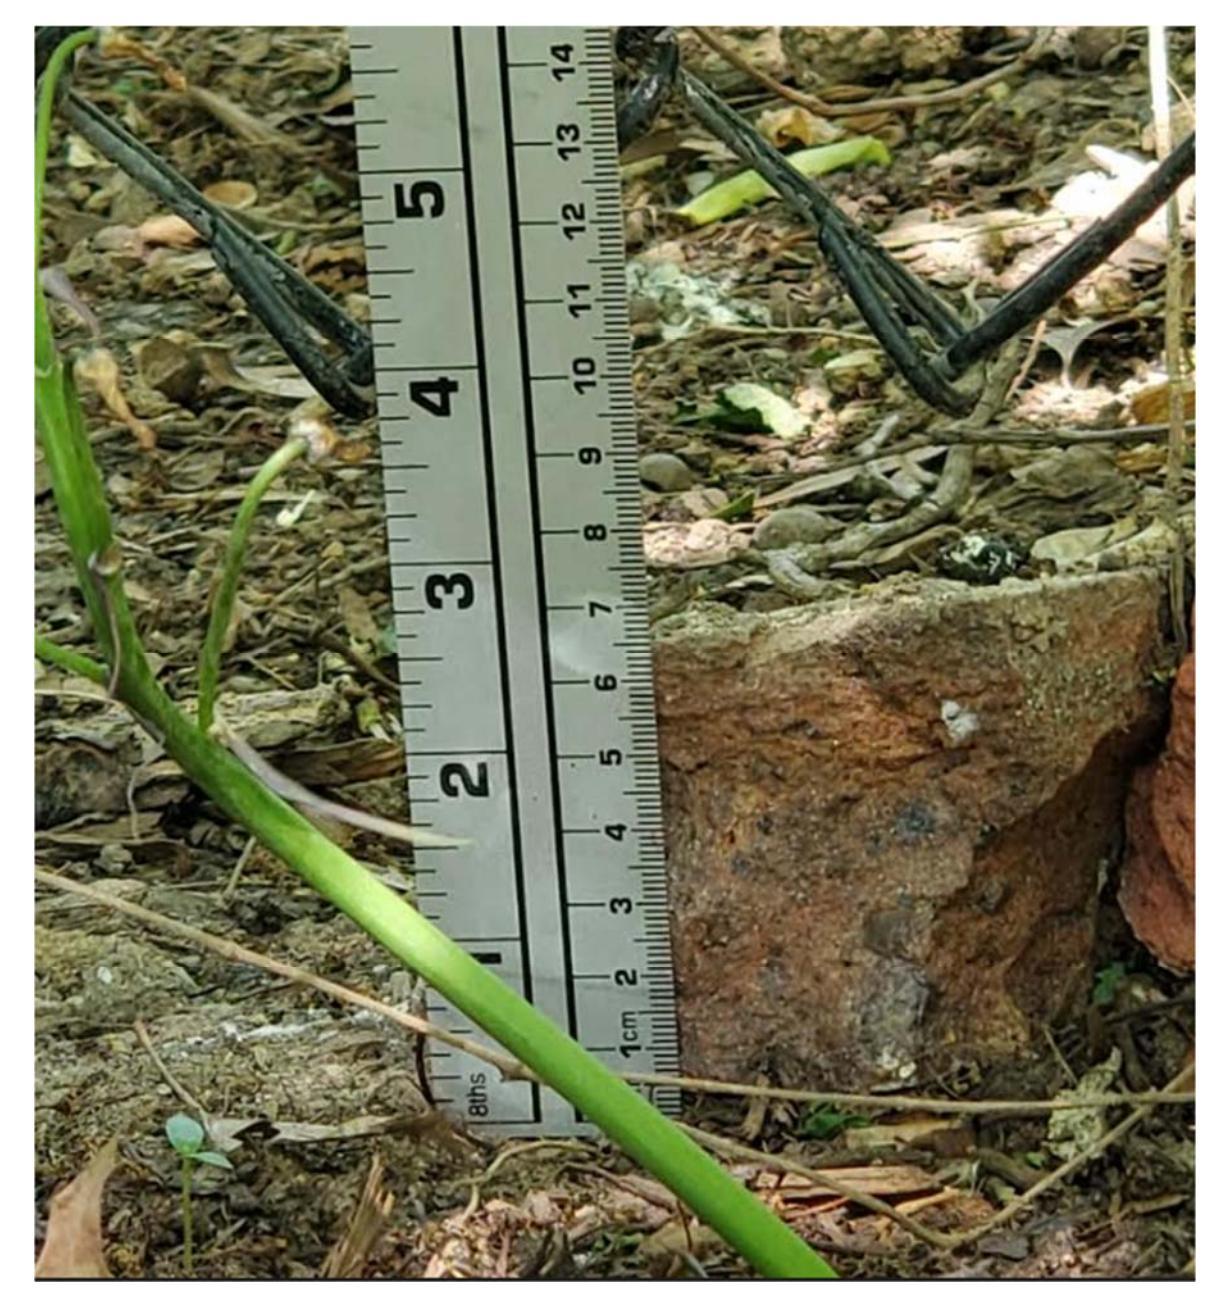
Additional Slope Stabilization needed mid-slope on the back of the hill between Buildings 833 and 835

In the Fall of 2019, a slope stabilization project on the front of the hill between buildings 833 and 835 was finally completed. At the time, the question was raised as to why erosion control measures were stopped at the fence when the steepness of the slope (1:1 per Jeff Lange) continued across the back part of the hill. Per the below pictures, you can see how the slope has been eroding for years so that the bottom of a chain link fence is now 4 inches above the surface of the hill.

More recent requests for patio restoration at the top of this hill have obscured this issue and the solution proposed by Jeff Lange fails to address the stabilization of the mid-point of the slope. His revised plan is attached and continues to focus on slope stabilization at the top of the hill around the patio, even though in a discussion on 04/30/20 he and Mark Miller agreed that mid-slope stabilization was needed. We would like to request a revised plan that includes a mid-slope stabilization measure.
